Info Regarding Drainage Needs for
City of San Antonio Bond Election May 07
East Village Neighbors' Association (EVNA)
City Council District 2
Victor V. Villarreal
President, EVNA
January 18, 2007
(210) 885-2498 Cell
(210) 565-3570 Office

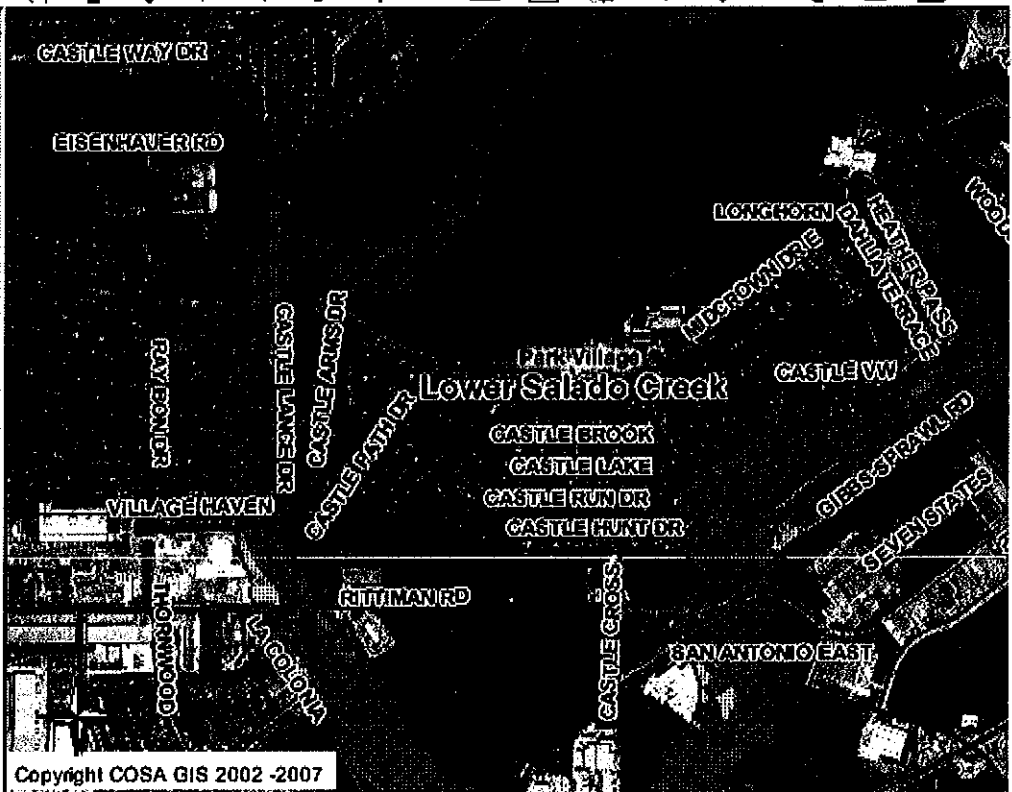
#10

Also included is an over view map (Large) (Picture #9) and a GIS Map (Small) (Picture #10) that reflects that the Lower Salado Creek runs right behind Castle Lance in which at least 5 homes are in the flood zone and have been flooded before. The GIS Map also shows the Lower Salado Creek runs along Castle Hunt and by Castle Cross. These maps reflect that our neighborhood is surrounded for the most part by The Lower Salado Creek.
