THE ALAMO CENOTAPH

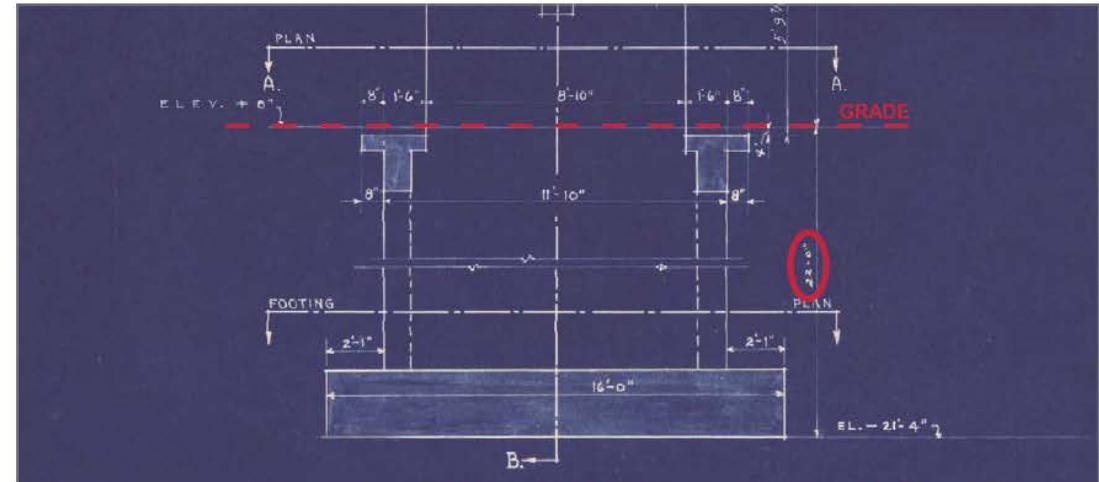
We can infer from the construction documentation that the disturbance was significant since the proposed bottom of the footing was placed at approximately 22 feet below grade [Figure 8 - 31], which would result in total loss of any archaeological evidence. Furthermore, if there were any burial sites in this location, all evidence and remains would have been lost.

Figure 8 - 31: Detail of Cenotaph Section Drawing. The bottom of the footing is indicated as 22 feet below grade at Alamo Plaza. [Blueprints and Drawings Collection, Archives and Information Services Division, Texas State Library and Archives Commission]

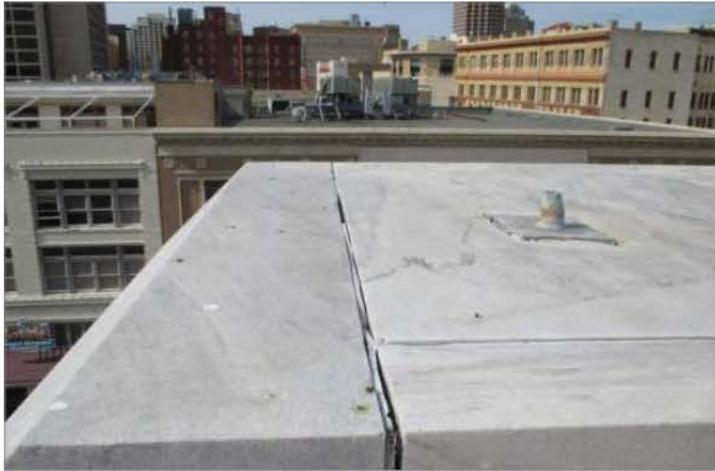
A Visual assessment of the Cenotaph indicates that there are significant structural and material deterioration concerns. The condition of the joints and the displacement and cracking of the marble blocks are indications of concealed deterioration, such as deterioration of metal concrete reinforcement and stone anchors, that needs to be addressed [Refer to Figures 8 - 34 through 8 - 39]. In addition, if in fact it has been constructed as indicated in the drawings, the concrete structure may have carbonation, a “disease” of the concrete that may have compromised its structural integrity.

Figure 8 - 34: Condition at the Top of the Cenotaph. Joint failure is visible that is permitting water to infiltrate the interior of the structure. [Photograph from 2014 Alamo Cenotaph conditions assesment prepared by Jaster Quintanilla and Building Monument Conservation for the City of San Antonio]

- Carefully disassemble the monument
- Conserve, clean and prepare all individual marble blocks for reinstallation
- Provide a non-corrosive supporting structure for reassembly of the Cenotaph
- Use non-corrosive, non-ferrous anchors and connections to avoid future corrosion
- Establish a cyclical inspection and maintenance program
- Install sensors to monitor changing conditions and / or moisture infiltration

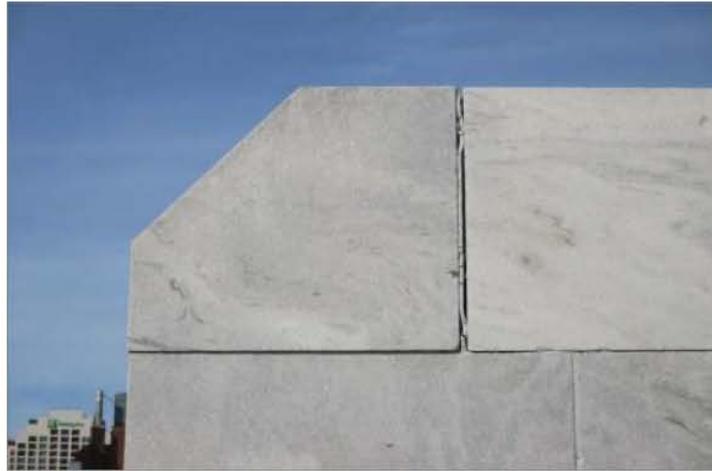
Figure 8 - 35: Joint Sealant Failure and Shifted Stone at the Top Course of the Alamo Cenotaph. [Photograph from 2014 Alamo Cenotaph conditions assesment prepared by Jaster Quintanilla and Building Monument Conservation for the City of San Antonio]

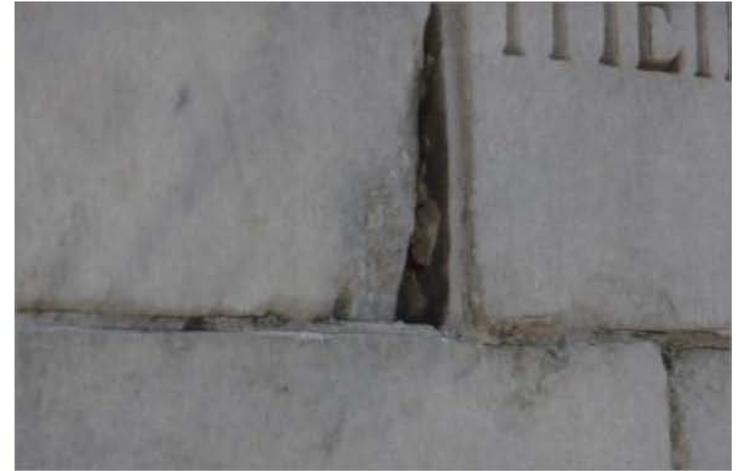
Figure 8 - 36: Example of Significant Mortar / Joint Sealant Failure and Stone Movement on the Side of the Alamo Cenotaph. [Photograph from 2014 Alamo Cenotaph conditions assesment prepared by Jaster Quintanilla and Building Monument Conservation for the City of San Antonio]

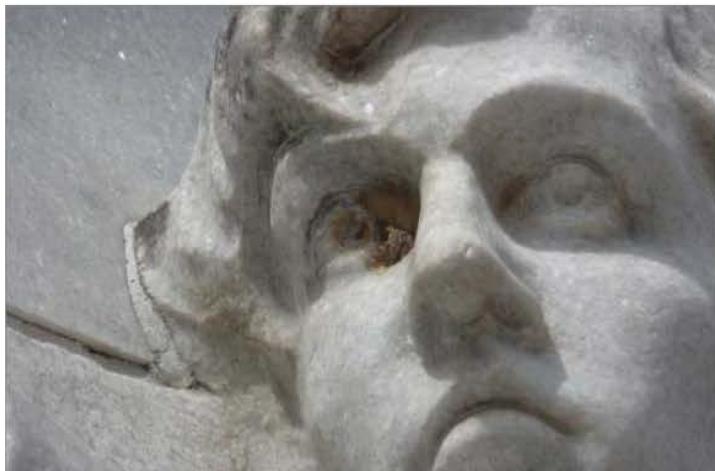
Figure 8 - 37: An Example of Deteriorated Marble at One of the Cenotaph Sculptures. [Photograph from 2014 Alamo Cenotaph conditions assesment prepared by Jaster Quintanilla and Building Monument Conservation for the City of San Antonio]

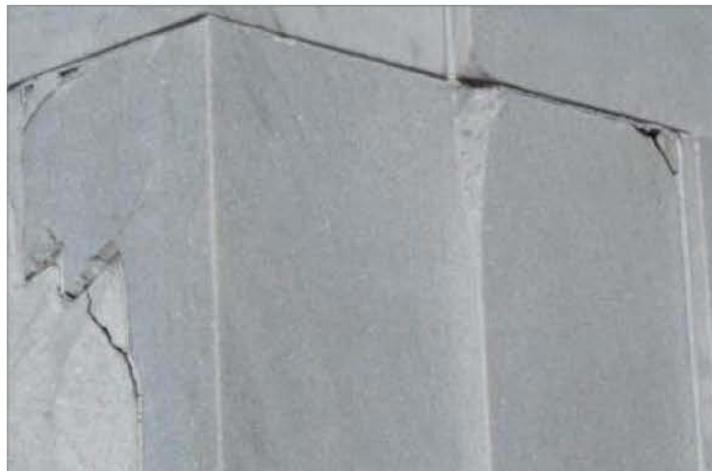
Figure 8 - 38: An Example of Stone Cracking and Spalling, as well as Joint Sealant Deterioration. [Photograph from 2014 Alamo Cenotaph conditions assesment prepared by Jaster Quintanilla and Building Monument Conservation for the City of San Antonio]

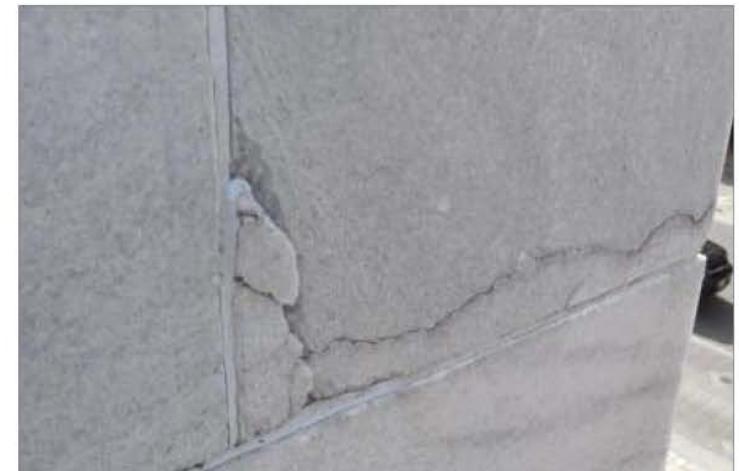
Figure 8 - 39: Detail of Significant Stone Cracking. This is a result of water infiltration to the interior of the monument structure. [Photograph from 2014 Alamo Cenotaph conditions assesment prepared by Jaster Quintanilla and Building Monument Conservation for the City of San Antonio]
