**Archaeological Survey and Archival Research
of the Naegelin Tract (41BX1600) in
San Antonio, Bexar County, Texas**

by
Jennifer L. Thompson
and
Antonia L. Figueroa

Center for Archaeological Research
The University of Texas at San Antonio
Archaeological Survey Report, No. 354
2005

Texas Antiquities Permit No. 3597

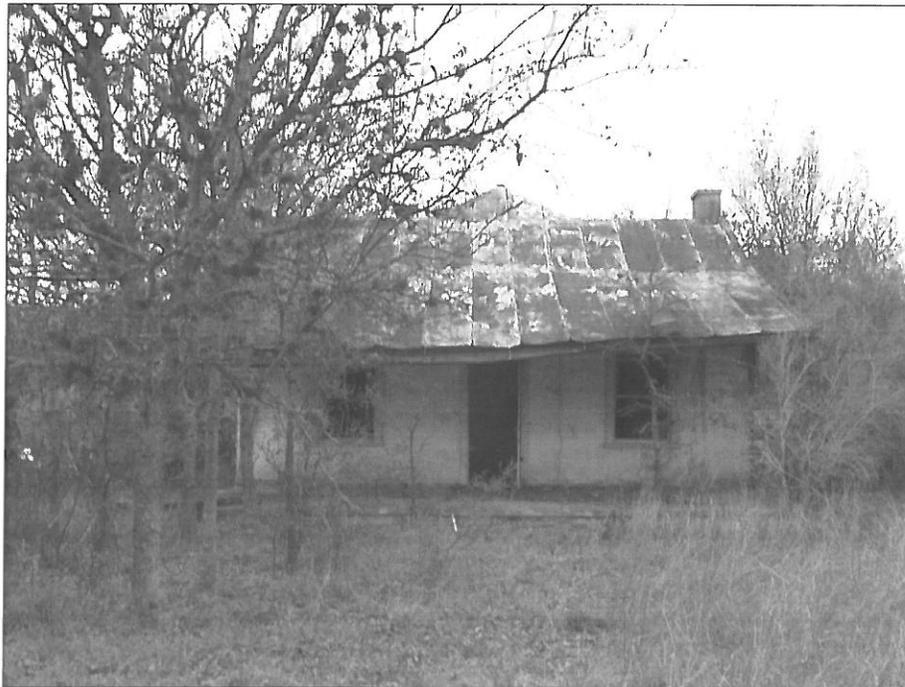
The first of the two wooden additions to the basic cut stone L plan was a porch added to the east elevation to shelter the front door and entrance. The porch had a concrete floor and was covered by an extended secondary roof of corrugated metal (Figures 18 and 19). No porch supports were present at the time of the survey; instead, tree limbs supported the roof.

Figure 15. *Eastern façade of the stone residence (Resource 1).*

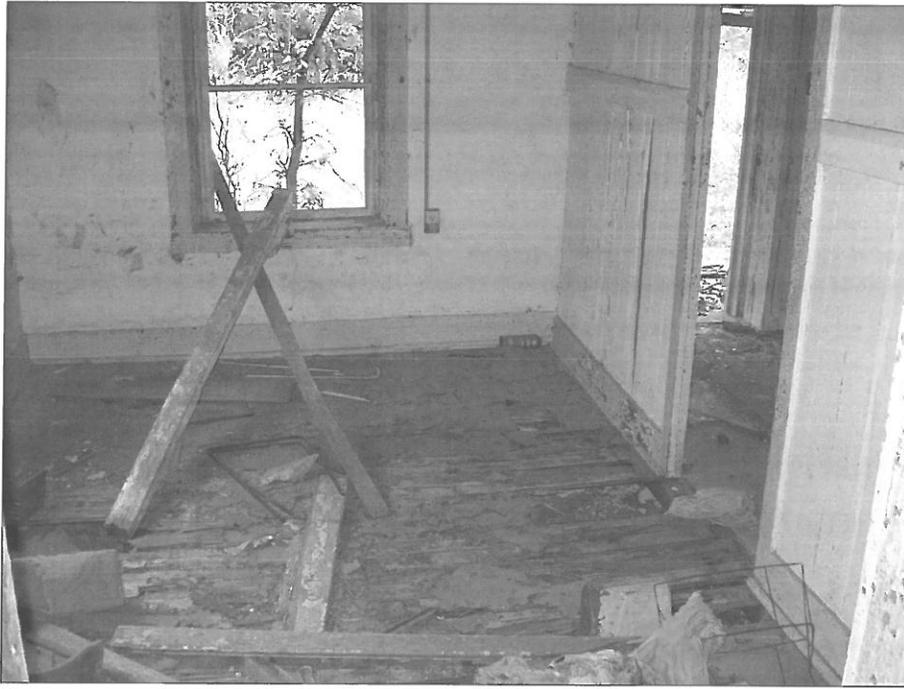
Figure 16. *Detail of room division and condition of flooring (Resource 1).*

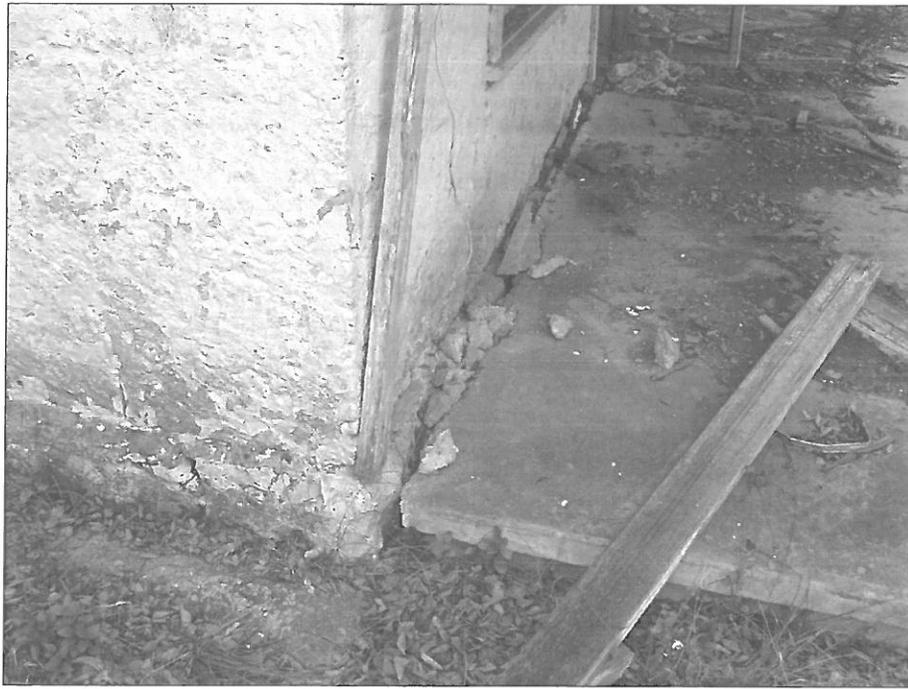
Figure 18. *Porch floor and house foundation (Resource 1).*

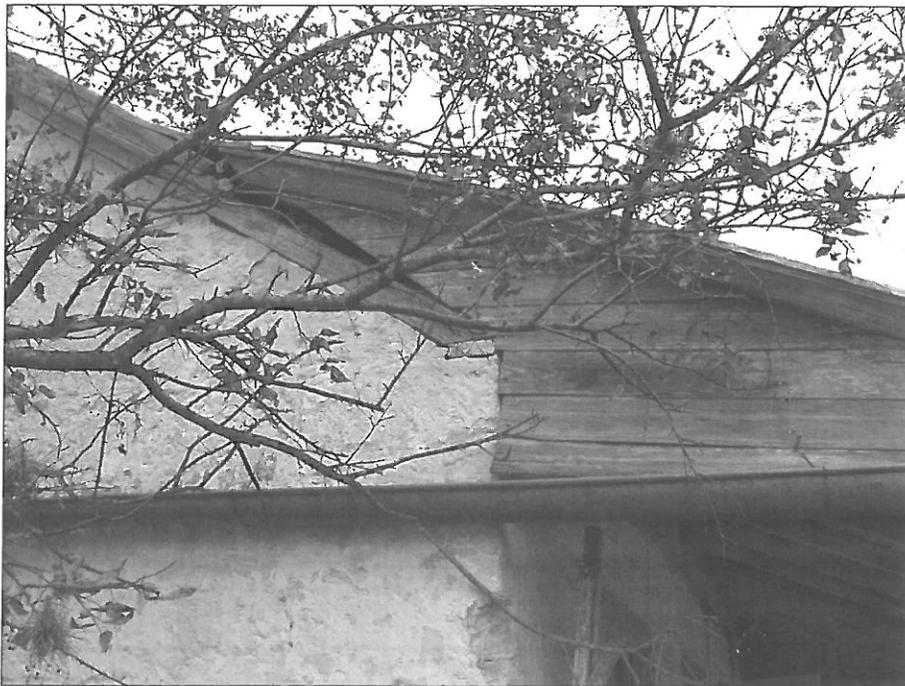
Figure 19. *Roof detail of porch addition to the original house.*

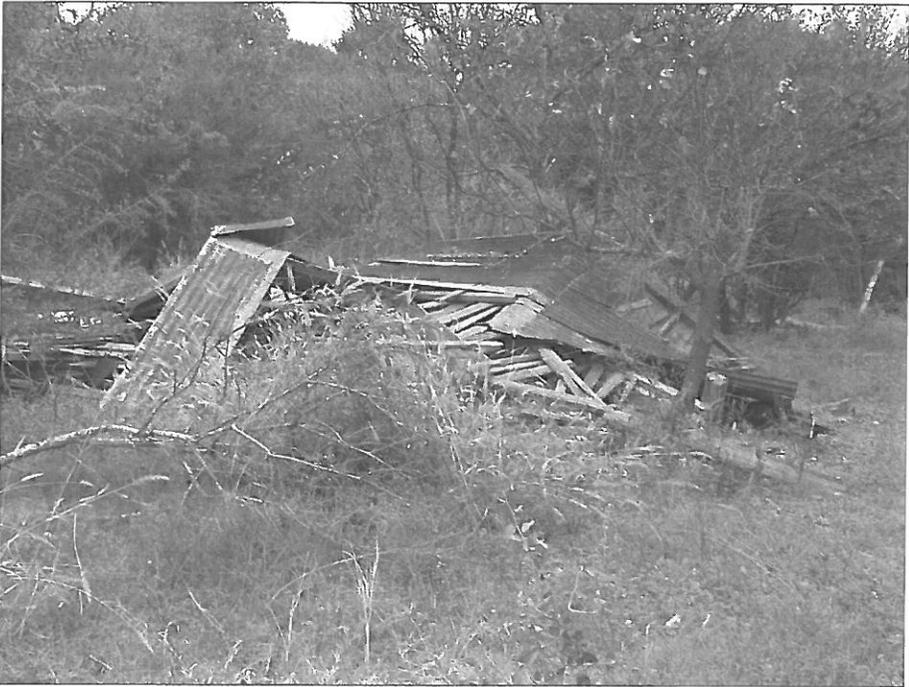
This is a third collapsed wood-frame structure with a corrugated metal roof. It is northwest of Outbuildings 1 and 2 (Figure 24). Resource 4 does not retain historic integrity.

Figure 24. *Outbuilding 3 (Resource 4).*

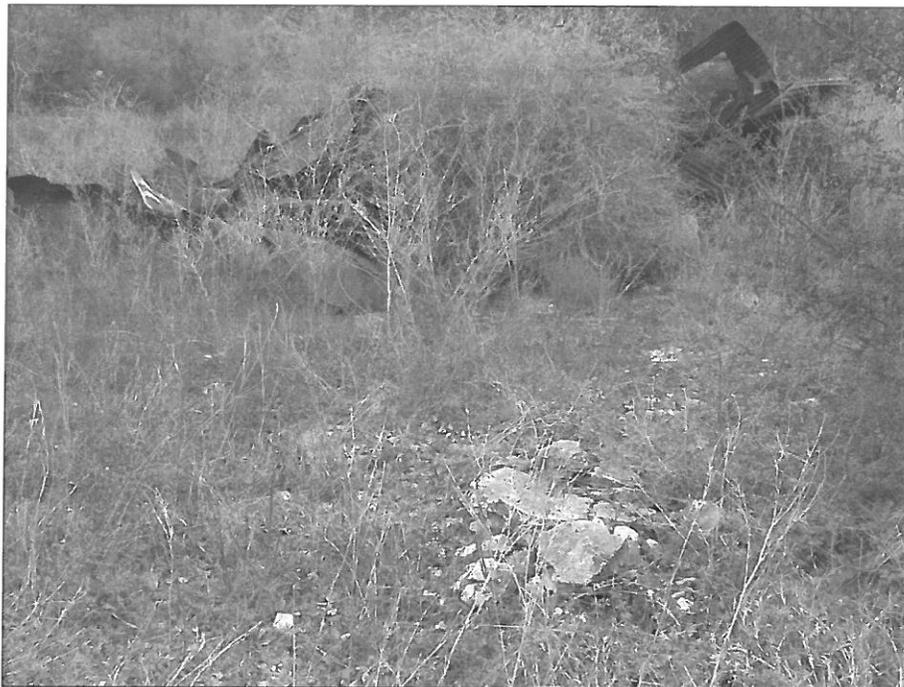
All that remains of Outbuilding 4 is a rock foundation (Figure 25). The remnant wood and metal were likely placed in one of the two trash heaps in the backyard of the house. The materials represent the remains of the main barn of the homestead. Resource 5 does not retain historic integrity. This outbuilding does appear on the 1939 aerial photo, therefore, it is likely that the foundation is minimally 50 years old.

Figure 25. *Outbuilding 4 (Resource 5)*.

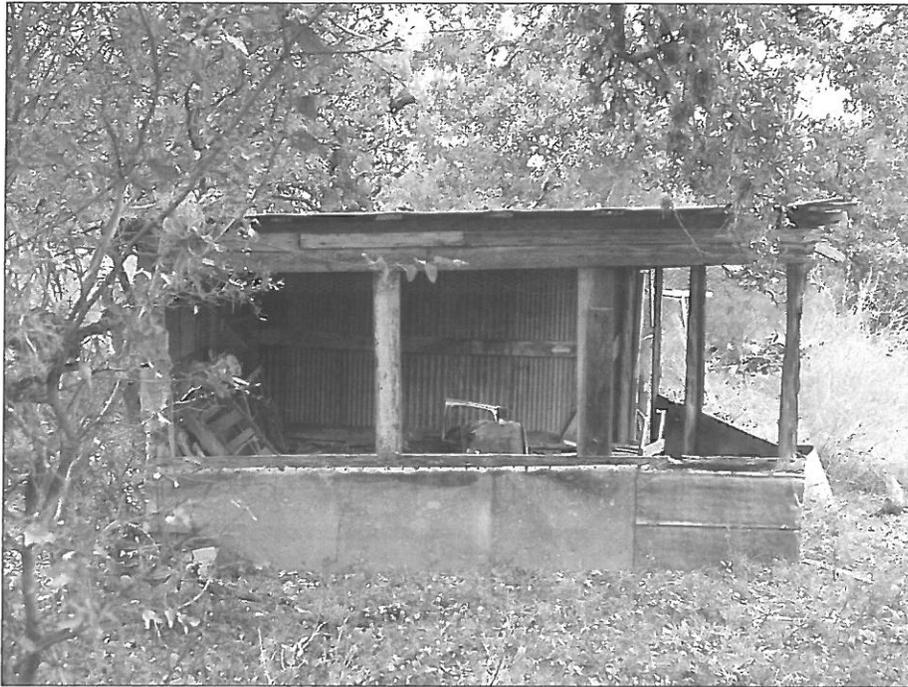
This structure is a wood-frame building with metal sheet siding (Figure 29). Large openings in the front of this

Figure 29. *Outbuilding 8 (Resource 9).*

structure may have been covered in chicken wire and the structure used as a chicken coop. Resource 9 does not retain historic integrity. This outbuilding does not appear on the 1939 photograph, therefore, its construction likely post-dates 1939.

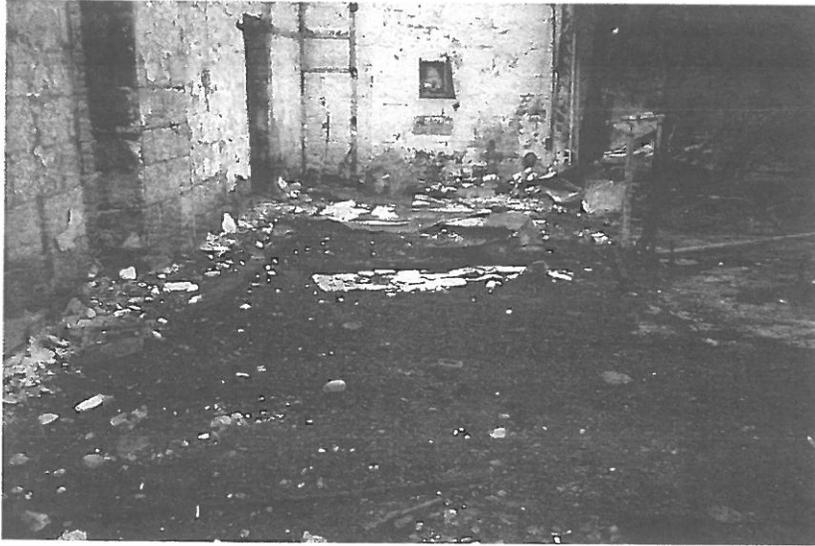
As a result of the fire, the asbestos containing materials was reduced to charred debris (See Photos 9, 10 and 11). Due to the historical significance, it was determined that it would be possible to shore the structure in order to complete the asbestos abatement if completed on a timely basis. If subjected to rain events, this option would not be possible due to the rain effects on the mortar of the limestone which would significantly reduce the structural integrity. On February 23, 2005 the structure was still in a condition to shore (See Photo 12).

PHOTO 9: View of asbestos containing debris present within the footprint of the structure after the fire.

It is strongly recommended that the remaining structure be demolished as soon as possible from the exterior under NESHAPs regulations governing structures containing asbestos. The debris will require disposal as asbestos containing material. This is recommended since this structure is now considered to represent a significant safety risk to the public since the area is not secure. It is suspected that vandals set the fire since the structure was also tagged with paint from the near by residential development. It is also suspected that vandals returned to cause the most recent destruction of the south wall. If vandals return again, they in fact would significantly endanger themselves if they attempt further destruction. In addition, if any homeless individuals seek shelter during inclement weather or strong winds, they would be at great risk due to not only the collapse of walls, but also exposure to asbestos. Therefore any delay in demolition is considered to greatly increase the safety risk present to the public and represents significant liability to the owner.

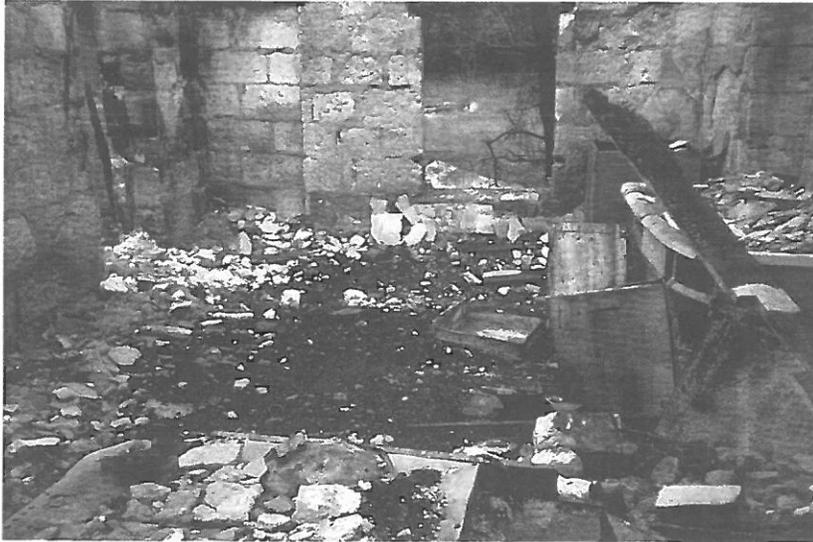
PHOTO 11: Additional view of asbestos containing debris present.

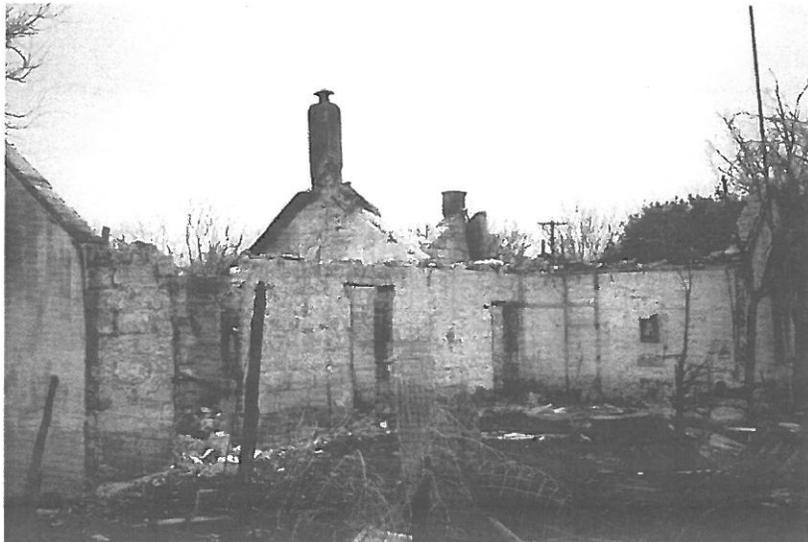
PHOTO 12: View of structure condition up to March 9, 2005.

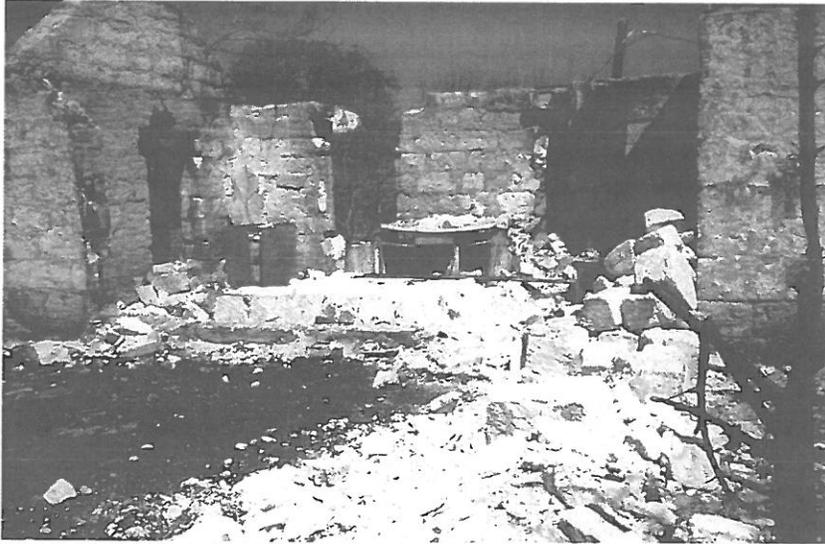
was still intact. However on March 11, 2005 when STC visited the site to design the required shoring, the south wall on the west end of the structure was laying on the ground (See Photo 13). It is suspected that vandals caused the destruction since a portion of the wall was lying inside the structure (See Photo 14) while another portion was lying outside the structure (See Photo 15 and 16). Weather had not been a factor since March 7, 2005 and the structure was still intact on March 9, 2005.

As a result of this wall destruction it is no longer considered feasible to shore the structure in order to complete the asbestos abatement. In fact the structure is now considered structurally unsafe and is considered to represent a **significant safety risk**. This has resulted since now the west wall is free standing with no support (See Photo 13). A strong wind with a cold front passing could bring this wall down. In addition, the center wall with the chimney also has lost the support of the south wall. This center wall has now become unstable (See Photos 17 and 18). A strong wind could topple the top of this wall. As a result, it is now considered unsafe to allow asbestos abatement activities to be conducted.

PHOTO 13: View of same wall in Photo 12 on March 11, 2005. Also shows west wall remaining as a free standing wall.

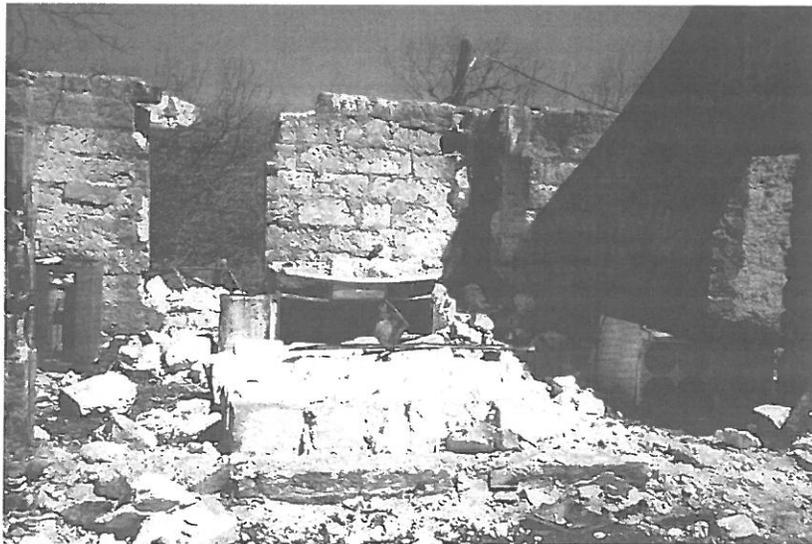
PHOTO 14: View of south wall section that collapsed inward.

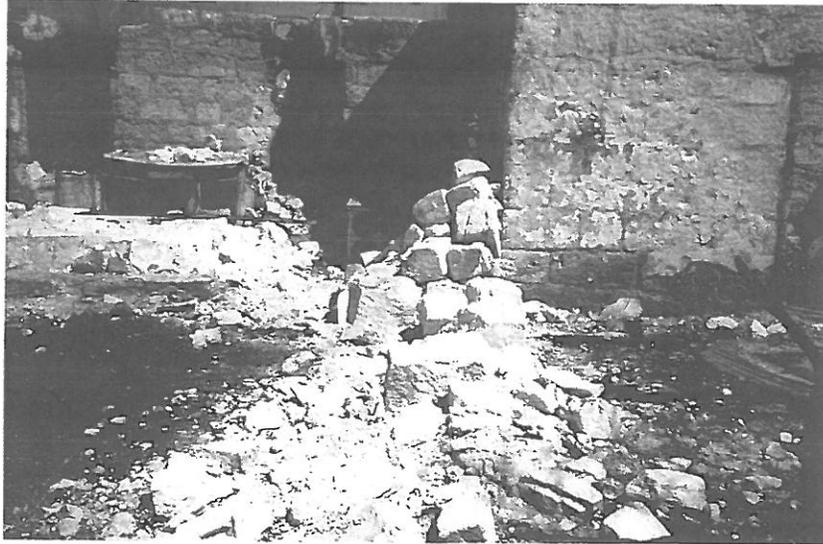
PHOTO 15: View depicting the extent of south wall outwards.

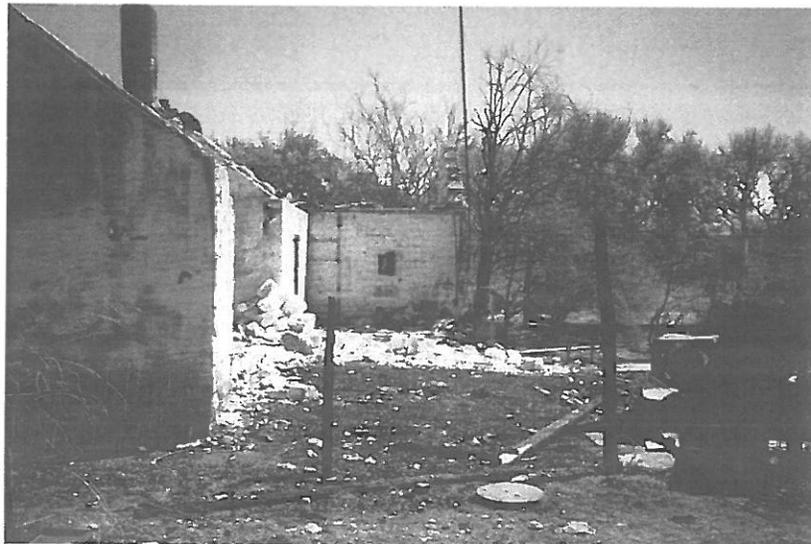
PHOTO 16: View depicting the extent of south wall outwards.

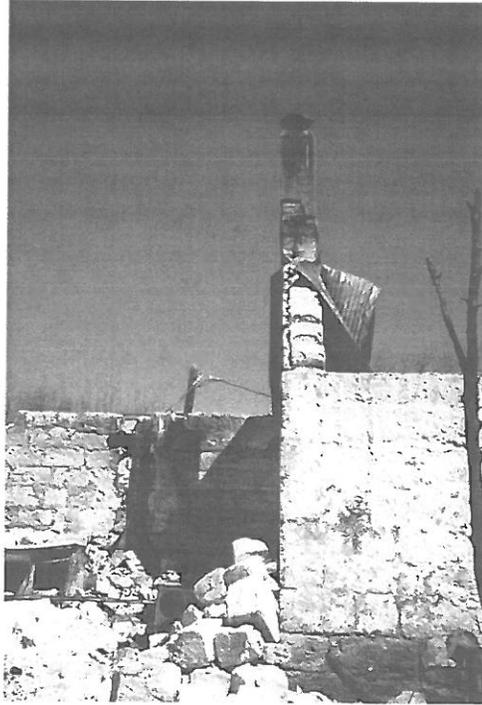
PHOTO 17: View of center wall with chimney now without the support of the south wall.

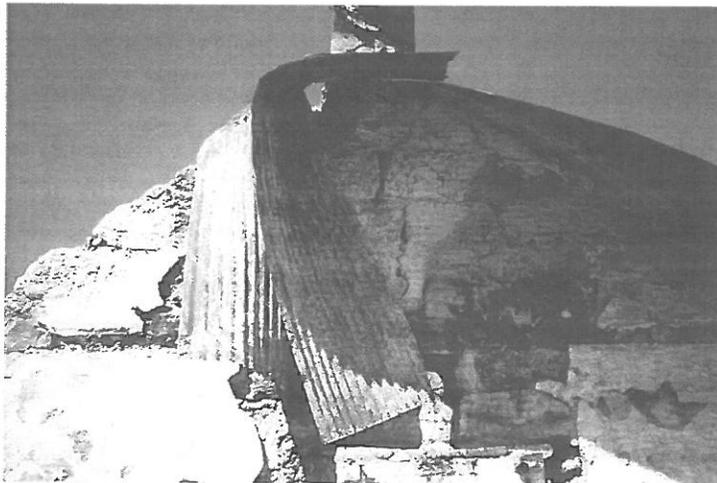
PHOTO 18: View of chimney base that has been weakened.
