**LETTER REPORT ON ARCHIVAL AND ARCHITECTURAL RESEARCH FOR  
BUILDINGS LOCATED ON THE CROWNRIDGE PROPERTY,  
SAN ANTONIO, TEXAS**

By Mindy L. Bonine

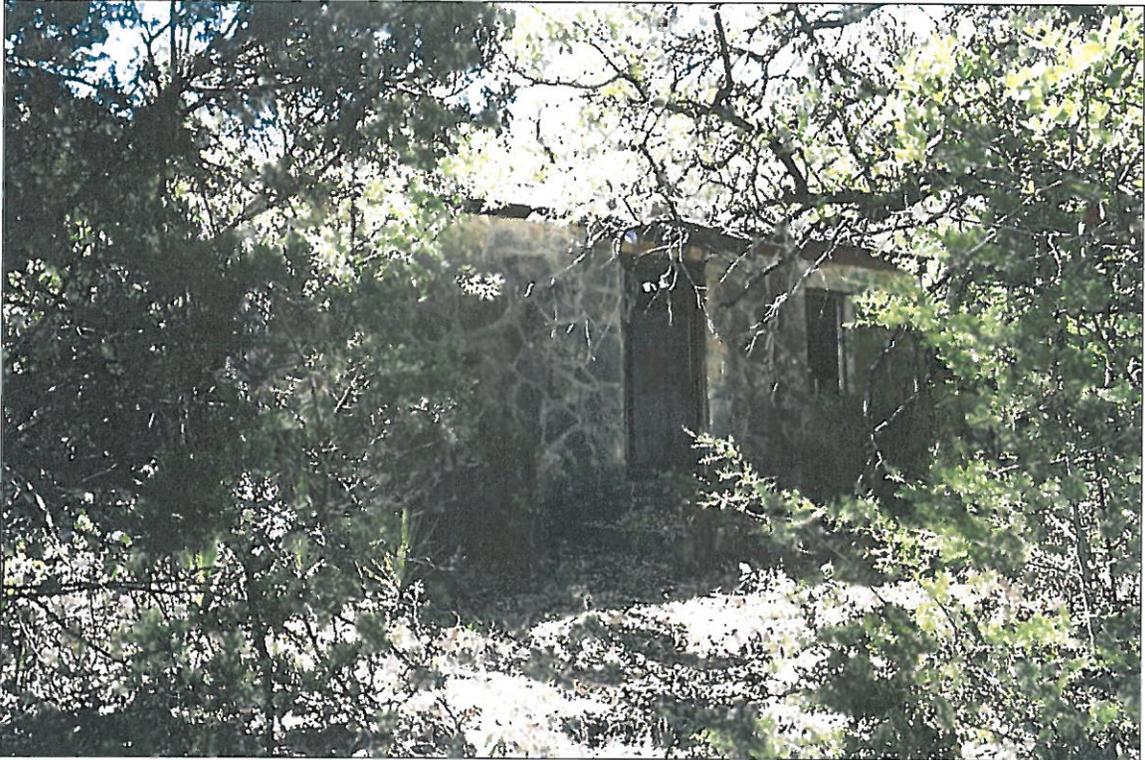
The residence is a one room mortared coarse stone building with two doorway openings and two window openings, covered with an asphalt shingle side gable roof (Figure 4). A small shed roofed stone addition is split into two equally sized rooms. One room shows evidence of being a shower, with water pipes sticking out of the wall, while the other room is of unknown function. A short floor to ceiling interior wall separated the two rooms and extends slightly into the main room, but no other walls or dividers were observed. The interior is coated with plaster or drywall, and all of the windows and doors have been removed. Evidence of a fire was seen in the rafters, and one half of the wood floor was burned away (Figure 5).

Figure 4. Residence.

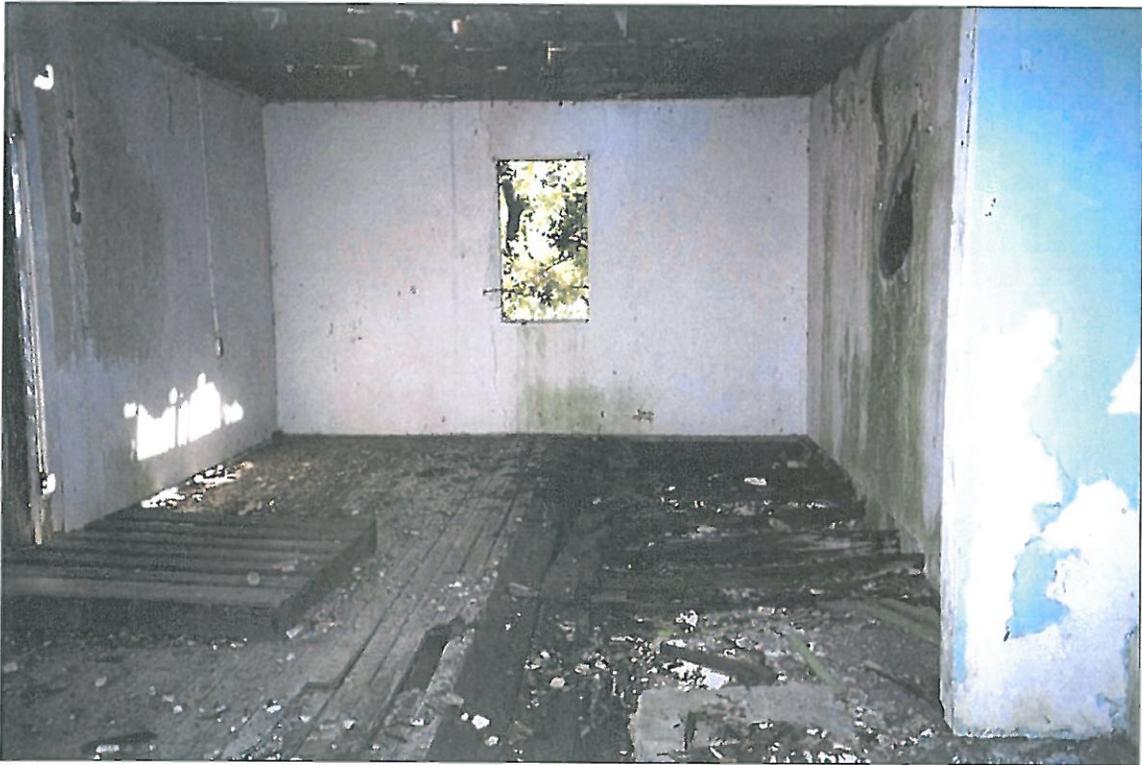
Figure 5. Interior of residence.

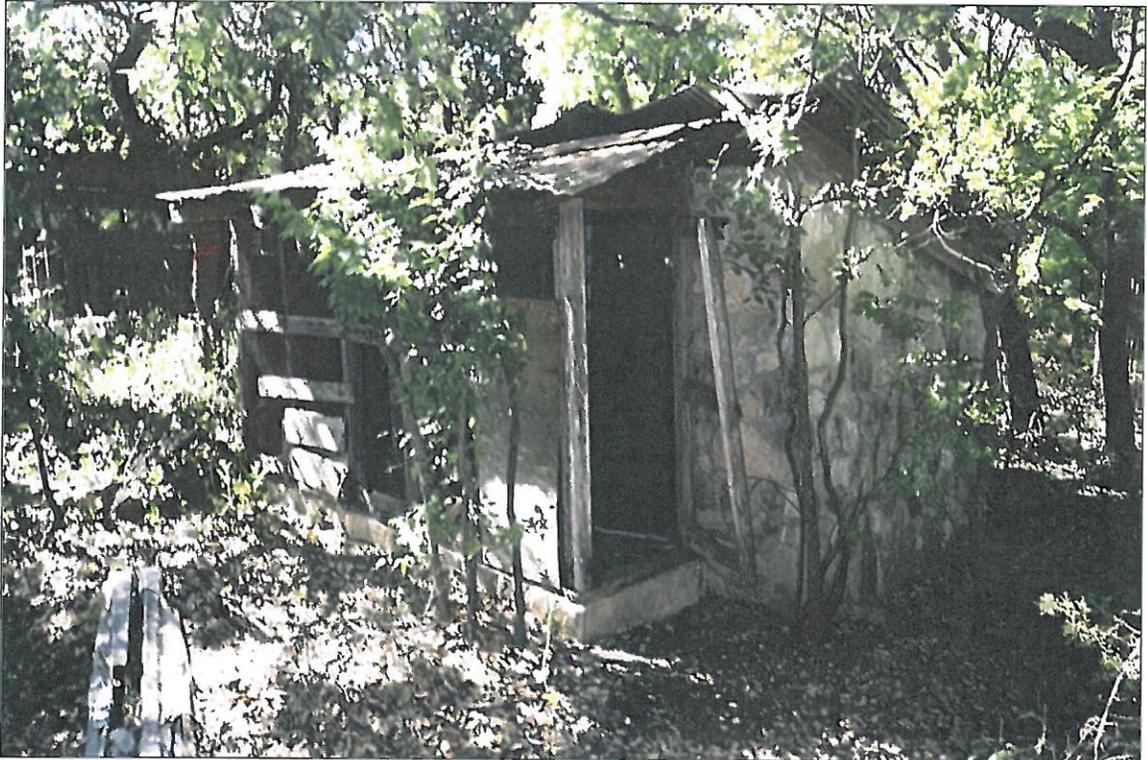
The adjacent chicken coop is also made a mortared coarse stone, and consists of a corrugated tin shed roof on the main part of the structure, and a small bumpout with a stone foundations, wooden frame walls, and a corrugated tin shed roof (Figure 6). The walls are partially covered with wooden boards, plywood sheets, and chicken wire. A “door” of wood and chicken wire is located in this addition, and a small hole in the bottom of the stone structure covered on the inside by tin was observed.

Figure 6. Chicken coop.

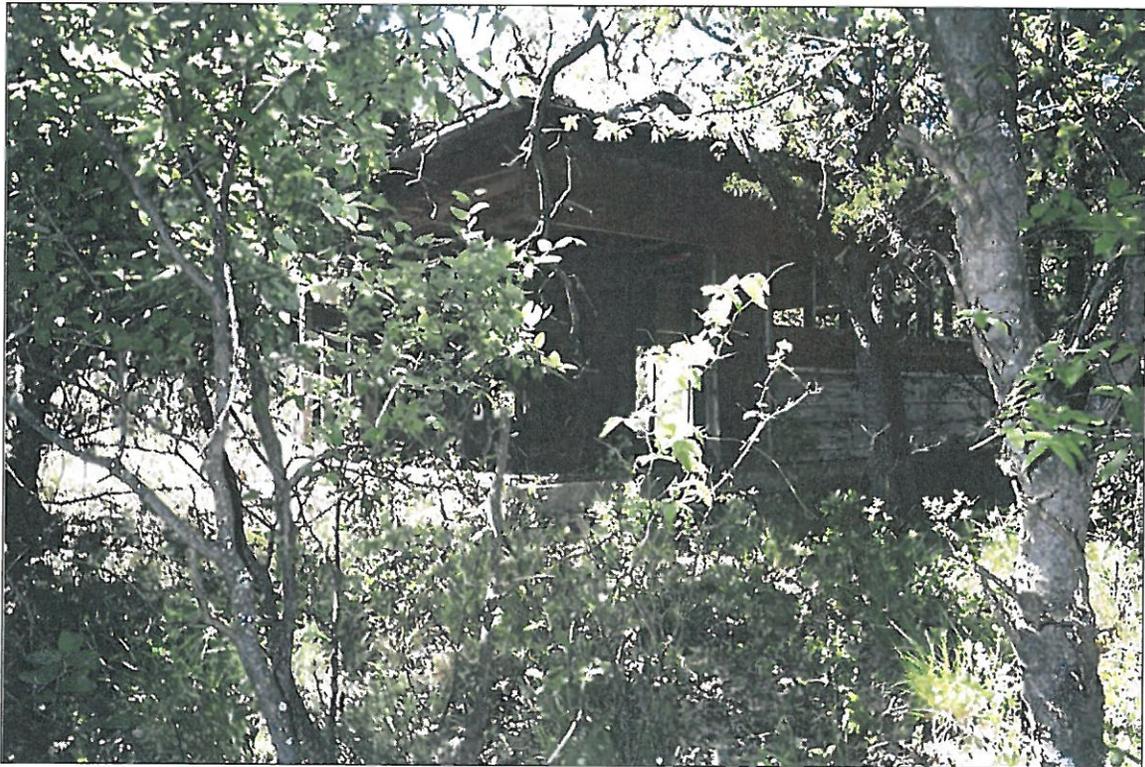
West of the chicken coop, a large structure at least partially used as a feeding shed was seen; it has a poured concrete foundation, wood frame walls, and a shed roof covered by corrugated tin (Figure 7). Large portions of the walls were not seen with sheathing of any kind, but other portions are covered with plank siding. The structure is divided into two rooms, separated by wood walls and plank siding, and one room contains a feeding troth for a medium or large sized animal, such as an adolescent to adult horse, mule, or cow (Figure 8). Portions of the wood floor have rotted away.

Figure 7. Feeding shed.

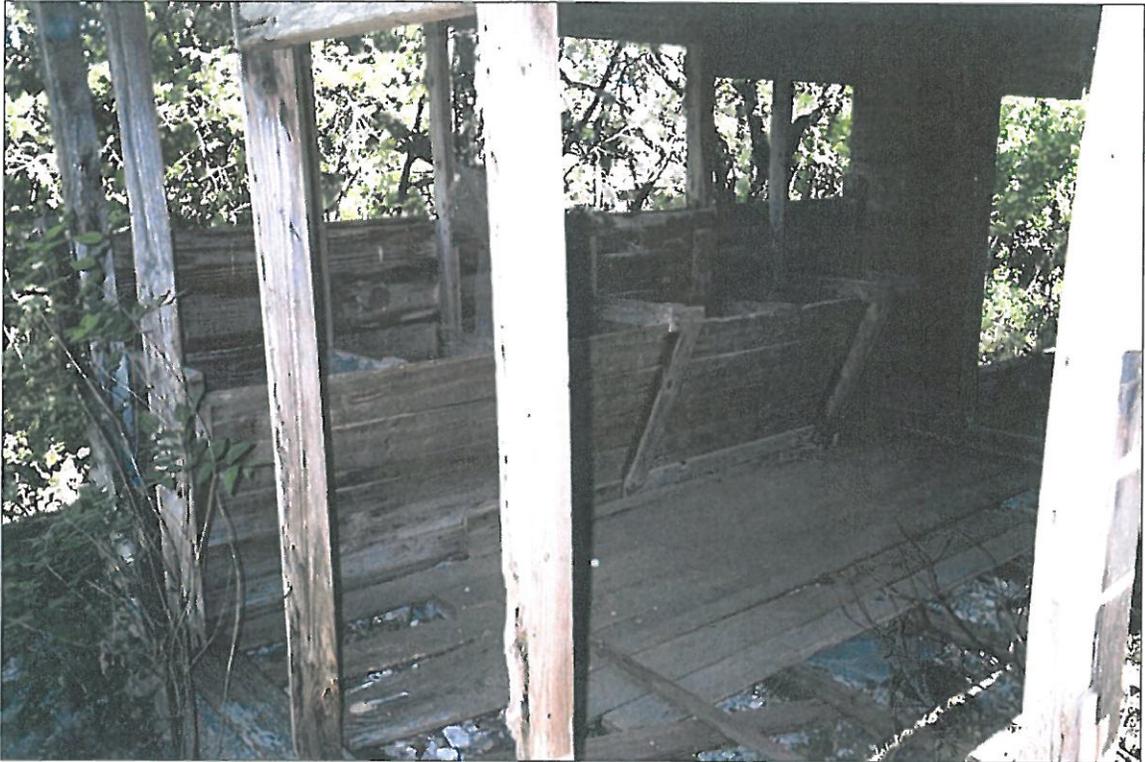
Figure 8. Trough inside of feeding shed.

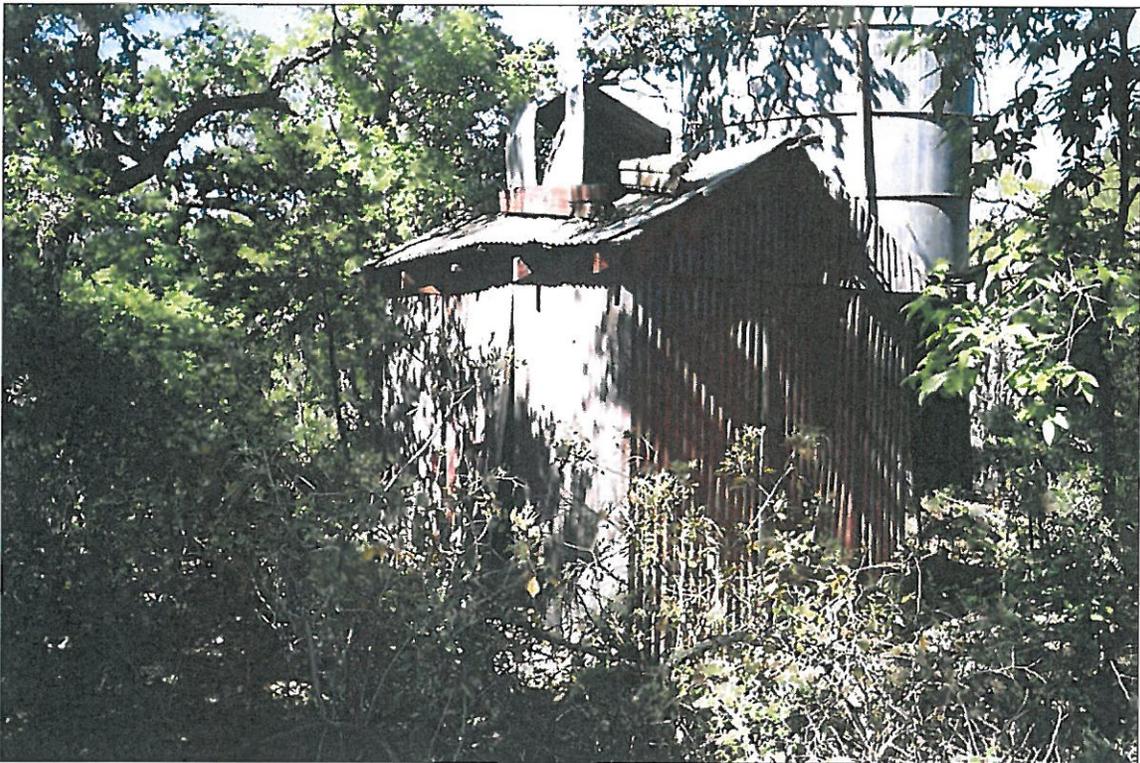
North of the chicken coop, a cluster of three structures was found during the survey, and include a small corrugated tin shack with wood frame walls, a gable roof, and a small entryway (Figure 9), a concrete septic tank, and an elevated water tank (Figure 10). The foundation of the water tanks is constructed similarly to the residence, of mortared coarse stone walls about 6 feet high. Large wooden posts were laid across stone pillars inside the building, and a wooden floor was constructed for the water tank. The tank appears to be relatively new, with no signs of rust, and the manufacturing stamps still visible. A doorway and window opening are present in the stone base, and the structure may have been used for some activity that required a cool damp environment.

Figure 9. Tin shack.

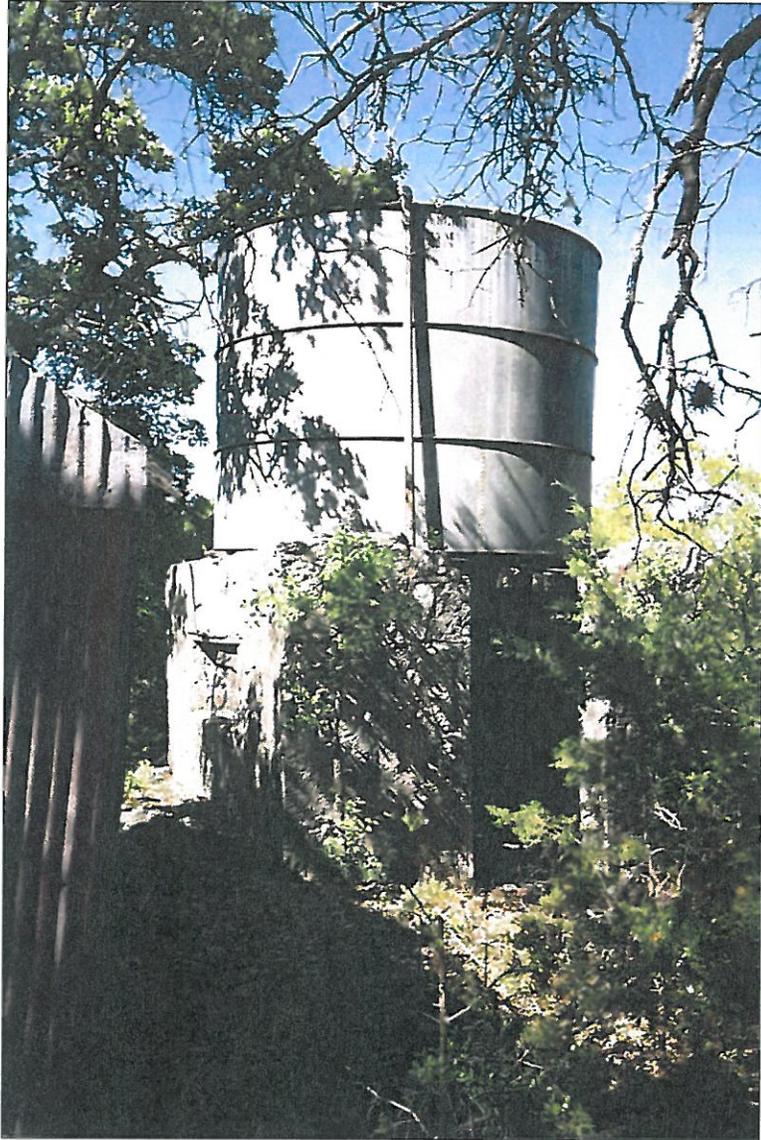
Figure 10. Elevated water tank.

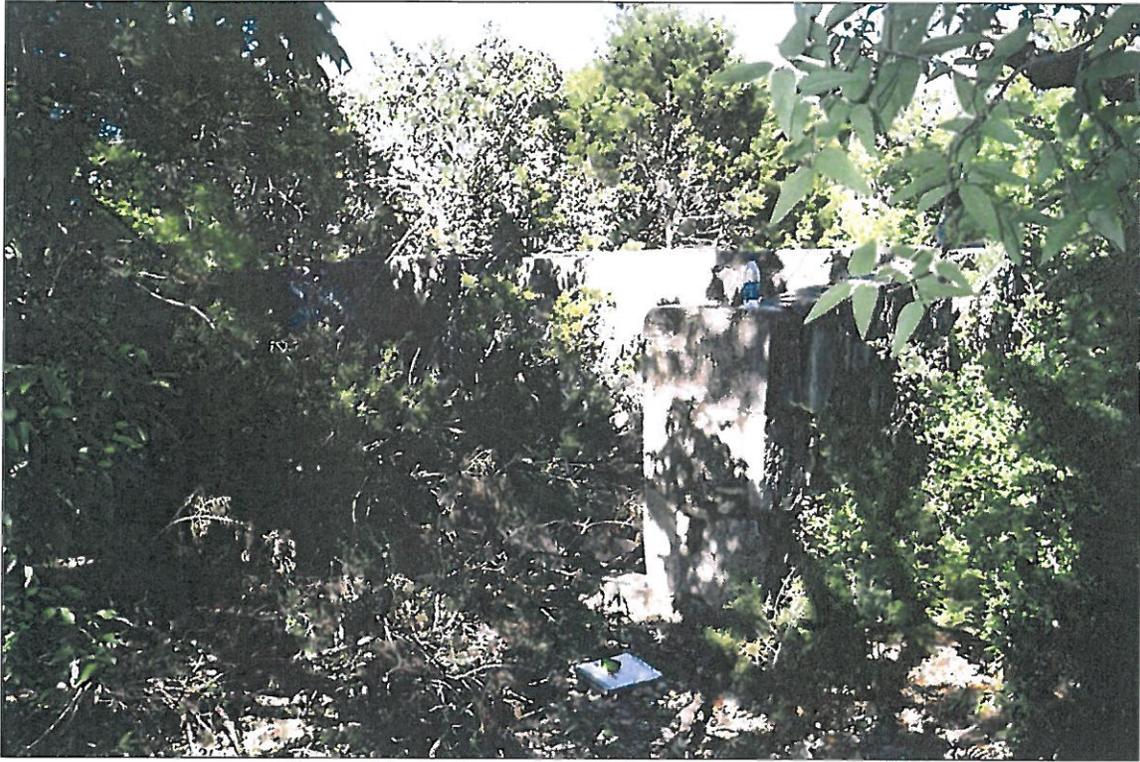
The last standing structure is also made of stone, but the walls extend only to 5 feet or so, and one side of the structure is completely open, with just a low wall connecting it to the other walls (Figure 11). No roof was seen during the survey, but rotten wooden planks inside may have been the roof at one time. A doorway with the remains of a wooden door are present, as well as a small opening covered with chicken wire. Portions of the wire mesh fence can be seen more prevalently around this building, forming a “U”.

Figure 11. Unknown building with open wall.

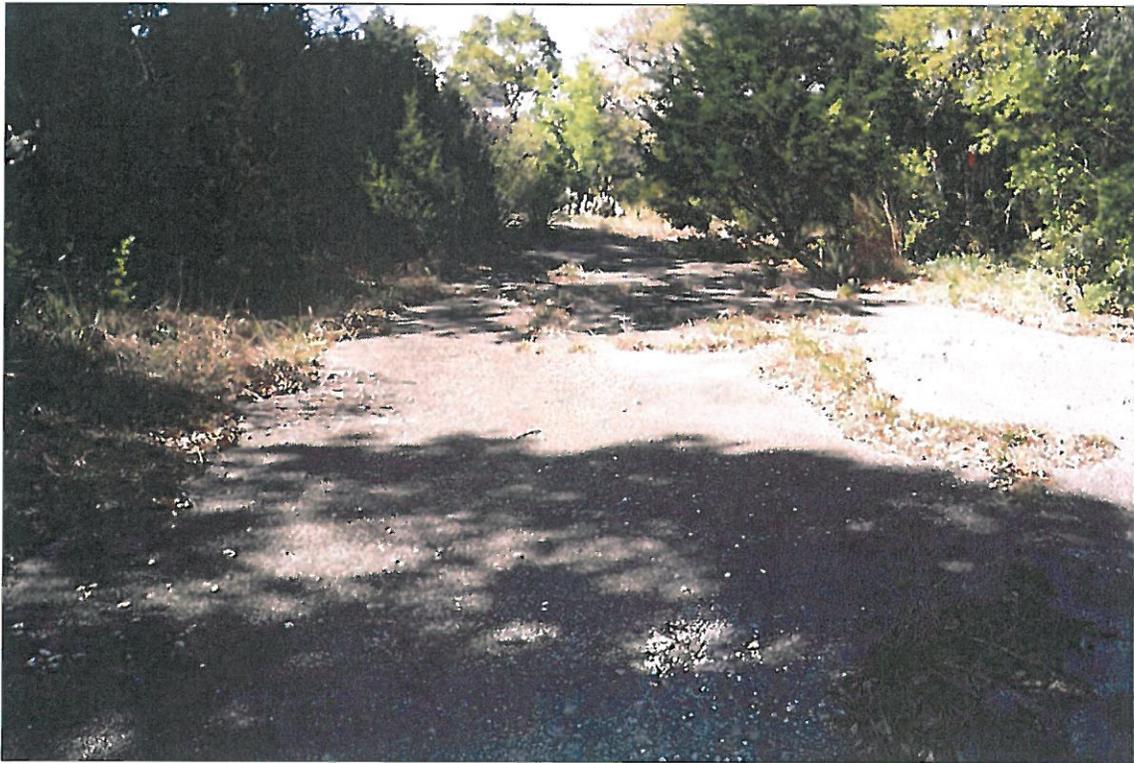
The other observed features on the property include a square concrete foundation pad of unknown use, a square-shaped cut in the limestone bedrock downslope of the buildings, and segments of an asphalt drive weaving up the hill between the frontage road and the structures (Figure 12). The asphalt was too patchy to determine a definitive path, and no observable route to the residence was observed.

Figure 12. Asphalt paving.
