Monitoring the Planting and Removal of Plants at the Commander's House (41BX351) San Antonio, Bexar County, Texas

Texas Antiquities Committee Permit No. 5595

Prepared by:
Center for Archaeological Research
The University of Texas at San Antonio
One UTSA Circle
San Antonio, Texas 78249
Technical Report, No. 19

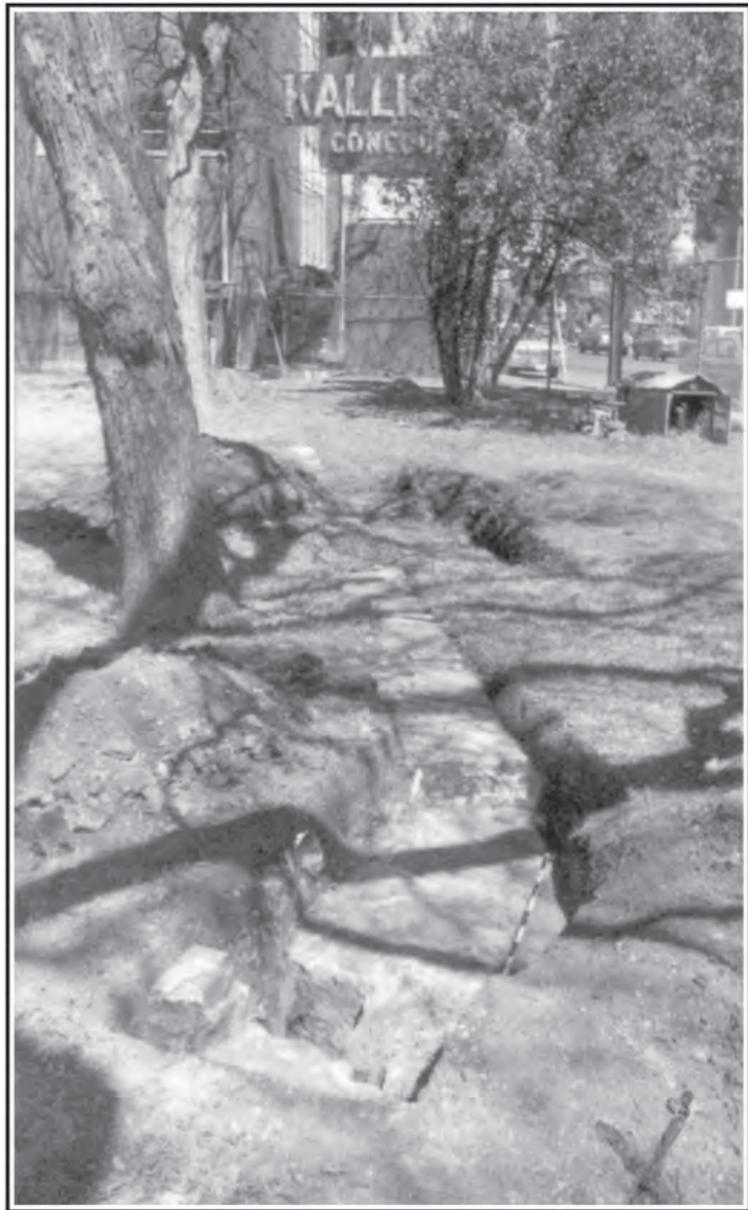
The excavations showed that this portion of the acequia was stone-lined with a cement cap that had been added on top of the walls at some point in the past (Fox 1978:3). The excavations also found cement plugs at each end of the acequia. Fox (1978:7) speculated that this closed-off portion had been used as a fish pond after the acequia was no longer in use. There were also cement plugs blocking the two laterals that were encountered, one going west and the other east (Figures 1-2 and 1-3).

Figure 1-3. *Photograph of the west wall of the San Pedro Acequia on the grounds of the Commander's House taken during excavation by CAR, showing curve of the acequia and a gate to a lateral that led west (foreground). Facing North.*

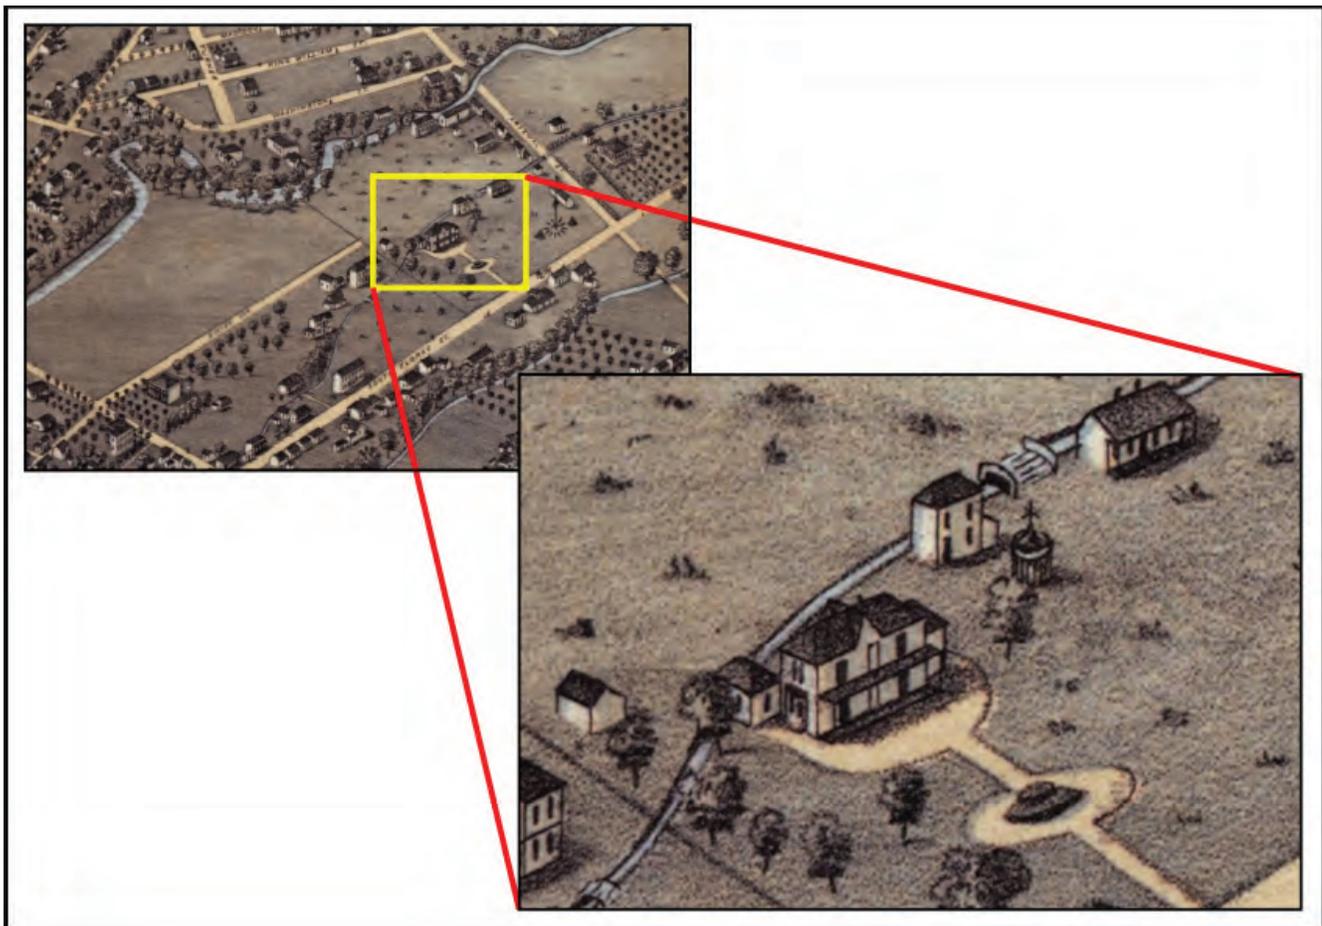
A note should be made that the Commander’s House originally fronted on South Flores Street, as can be seen in Figure 2-1. Today the “front” of the house is considered to face South Main, which did not exist at the time the house was built and for some time thereafter (Figure 2-2). Unfortunately, the Sanborn Fire Insurance maps are of no value in this case. Beginning with the earliest available Sanborn maps, the project area is shown only as a blank labeled “U. S. Government” (Digital Sanborn Maps 2010).

Figure 2-1. *The Commander's House in 1873, from a Bird's Eye map of San Antonio. The inset is a closer view of the grounds. Note the San Pedro Acequia and the small house built adjacent to it. Map faces southeast.*

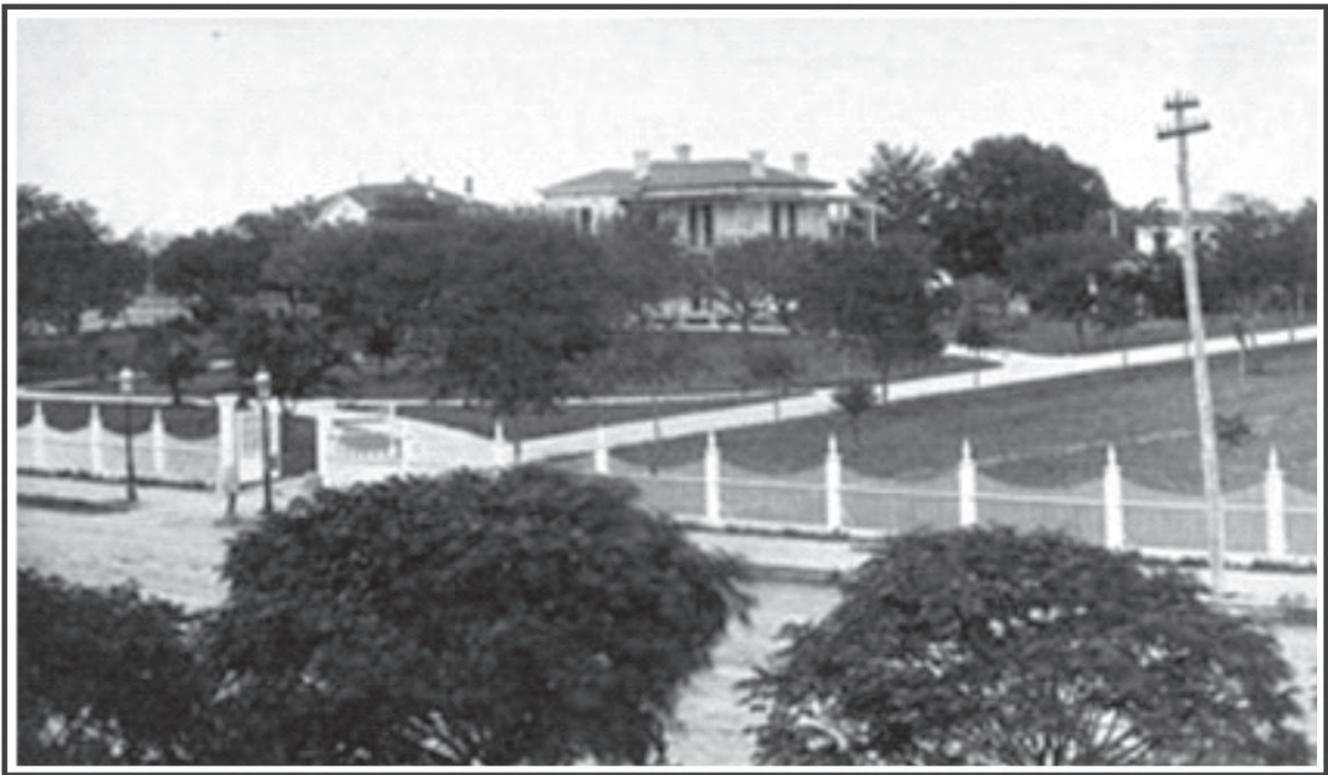
Several references, in particular the web site of the Office of Historic Preservation (City of San Antonio 2010b), state that the house was completely rebuilt about 1883. However, the drawing of the building in the 1886 Bird's Eye map (Figure 2-2) appears to show the same building as that seen in the 1873 Bird's Eye map (Figure 2-1), with the exception of the bay window, including the double narrow windows at the north and south ends of the building. Note that these windows are clearly evident in a photograph taken about 1888 (Figure 2-3).

Figure 2-3. Photograph of the Commander's House taken about 1888 (Photograph is in the collection of the Institute of Texan Cultures, #073-1684).

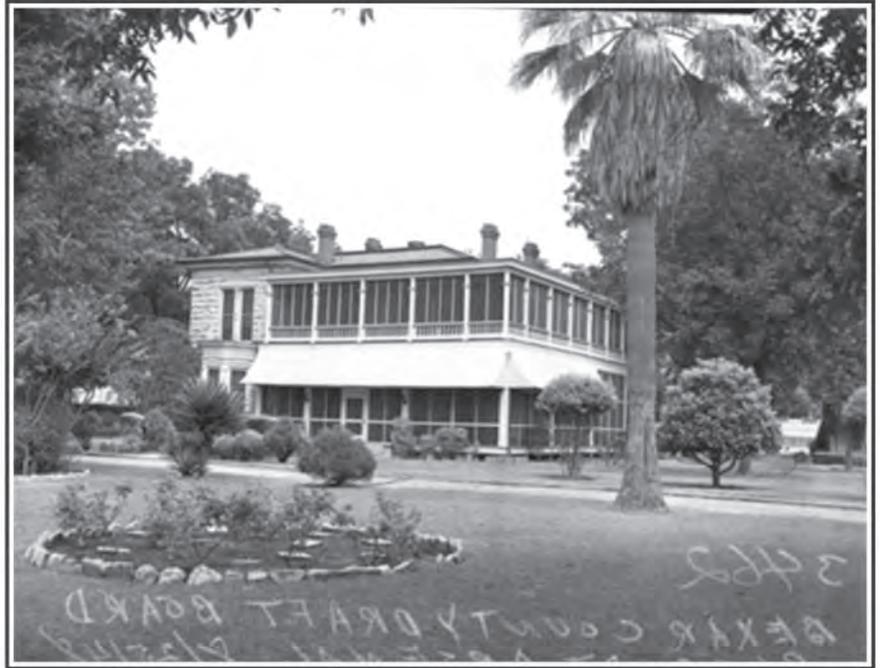
Figure 2-4. Photograph of the Commanders House taken in 1948. Note that the balconies have been enclosed (Photograph is in the collection of the Institute of Texan Cultures, #L-6432-F).

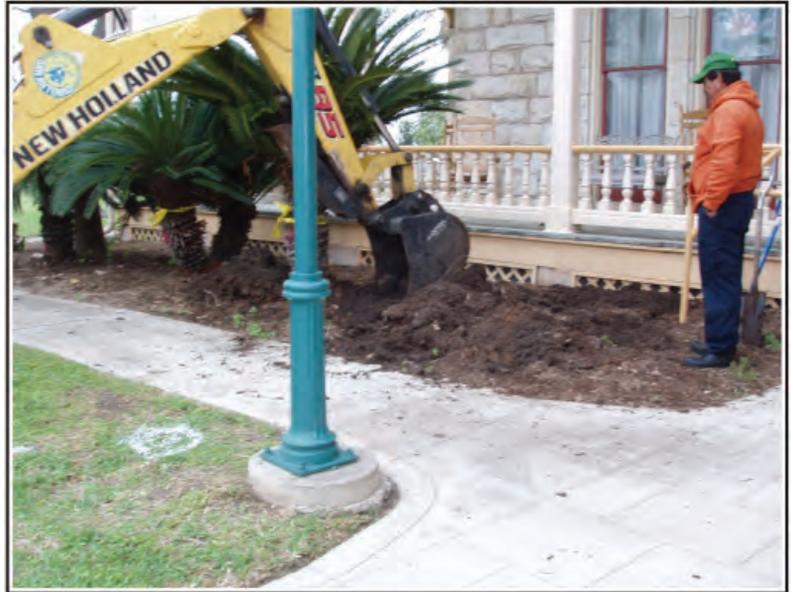
Two cycads and one palm were removed during the project. The palm was replanted in a side flowerbed (see location #7 in Figure 1-2). They were removed by digging around them enough to cut most of the roots and then pulling them free of the ground with a backhoe (Figure 3-1). No artifacts of any kind were observed during this operation, nor were any cultural features impacted.

Figure 3-1. Removing plantings from the front flower bed. The twin trunk of the final cycad to be removed is visible at the upper left of the photograph.

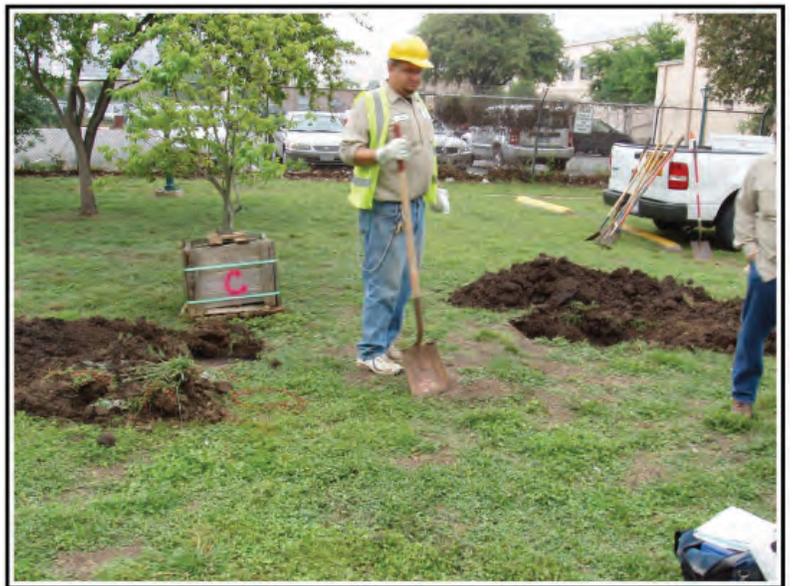
Hole #2 was dug to plant a Mexican Buckeye (*Ungnadia speciosa*) tree west of the northern parking lot (Figure 1-2). The original hole had to be abandoned when the backhoe struck a 2-inch PVC water line that fed the irrigation system (Figure 3-2). The final depth of the hole was 58 cm. The sediment was brown sandy clay loam with ca. 5 percent small

Figure 3-2. Moving Hole #2 after encountering an irrigation line. The final location is on the right. Facing North.

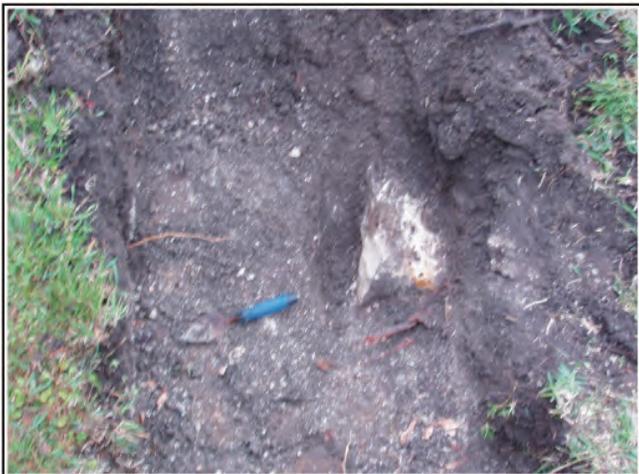
Hole #5 was dug in front of the house (though, as noted above, historically this would have been considered the back of the house) (Figure 1-2). The sediment in the original location of the hole, which was southeast of the stump of a dead palm, was medium brown sandy clay loam with ca. 5 percent small gravels. The percentage of gravel increased and numerous caliche nodules became apparent with increasing depth. At 45 cm bs, the excavation exposed a large limestone block. The block was very roughly shaped into a rectangle and was stacked onto another large rock (Figure 3-3).

To limit disturbing this apparent architectural feature, Feature 1, the upper limestone block was not uncovered completely. The exposed portion measured 23 cm by 31 cm. Its location was measured from the sidewalks found to its west and north (Figure 1-2). The corner of the stone was 2.97 m east of the north/south running sidewalk and 3.25 m south of the sidewalk running east/west. The hole that exposed the limestone block was backfilled without disturbing the stones.

The limestone blocks appear to be part of an architectural feature such as the corner of the foundation of a structure of some kind,

Figure3-3. Limestone block in Hole #5.

possibly an outbuilding or the footer for a wall. Given the location, behind the house as it was originally used, it is possible that it is the upper part of a stone-lined privy. However, as the purpose of the project was not to investigate this feature, it was simply recorded, and an alternate hole was excavated.

Cultural materials and/or features were encountered in only one hole, #5. This hole, located in front of the house, encountered two roughly trimmed limestone blocks set on top of each other (Figure 3-3). The feature appears to be part of a foundation although this cannot be determined with certainty unless and until a larger area is exposed in the future

The Commander's House, site 41BX351, represents an important part of San Antonio's history. It was originally built as the home of Doctor James M. Devine, three-time mayor of the city, and was later used as the home of the Commander of the U.S. Army Arsenal. In addition, the San Pedro Acequia (41BX337) runs through the eastern side of the property and a lateral of the acequia runs just north of the house. Because of the importance of this site and the associated acequia, we recommend that any future projects involving sub-surface disturbances in the park be assessed for their potential to disturb historic features and/or deposits. At a minimum, any project that requires disturbance of the ground within the park should be monitored by an archaeologist. If future opportunities arise, also we recommend that the nature of the stacked limestone blocks found in the vicinity of planting Hole #5 be more fully investigated.

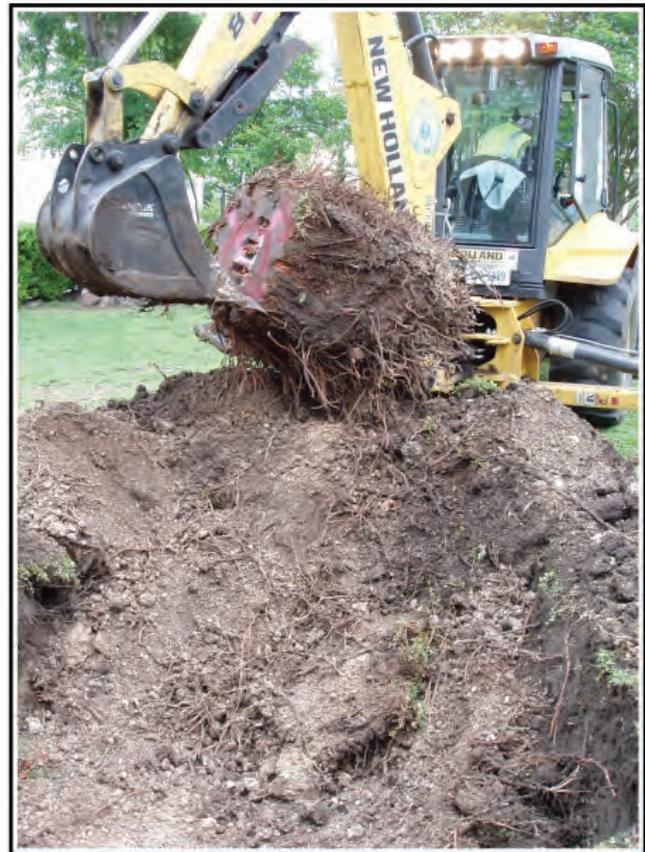
Hole #6 was dug in the southwestern part of the park (Figure 1-2). The removal of the stump required the digging of a much larger hole than the previous holes (Figure 3-4). The final hole measured 3.45 m by 3.95 m and was 1.25 m deep. The sediment was medium brown silty clay loam to about 60 cm bs and then changed to a much lighter gray very sandy clay with approximately 50 percent gravels most of which were 5 to 7 cm in maximum diameter. This layer continued to the bottom of the hole and appeared to be a natural sediment. No cultural materials were observed.

Figure3-4. Removal of palm stump prior to planting of new palm.
