**ARCHEOLOGICAL SURVEY FOR THE CULEBRA CREEK NWWC  
DRAINAGE PROJECT, SAN ANTONIO, BEXAR COUNTY, TEXAS**

LETTER REPORT NO. 922

**FINAL REPORT**

TEXAS ANTIQUITIES PERMIT NO. 8145

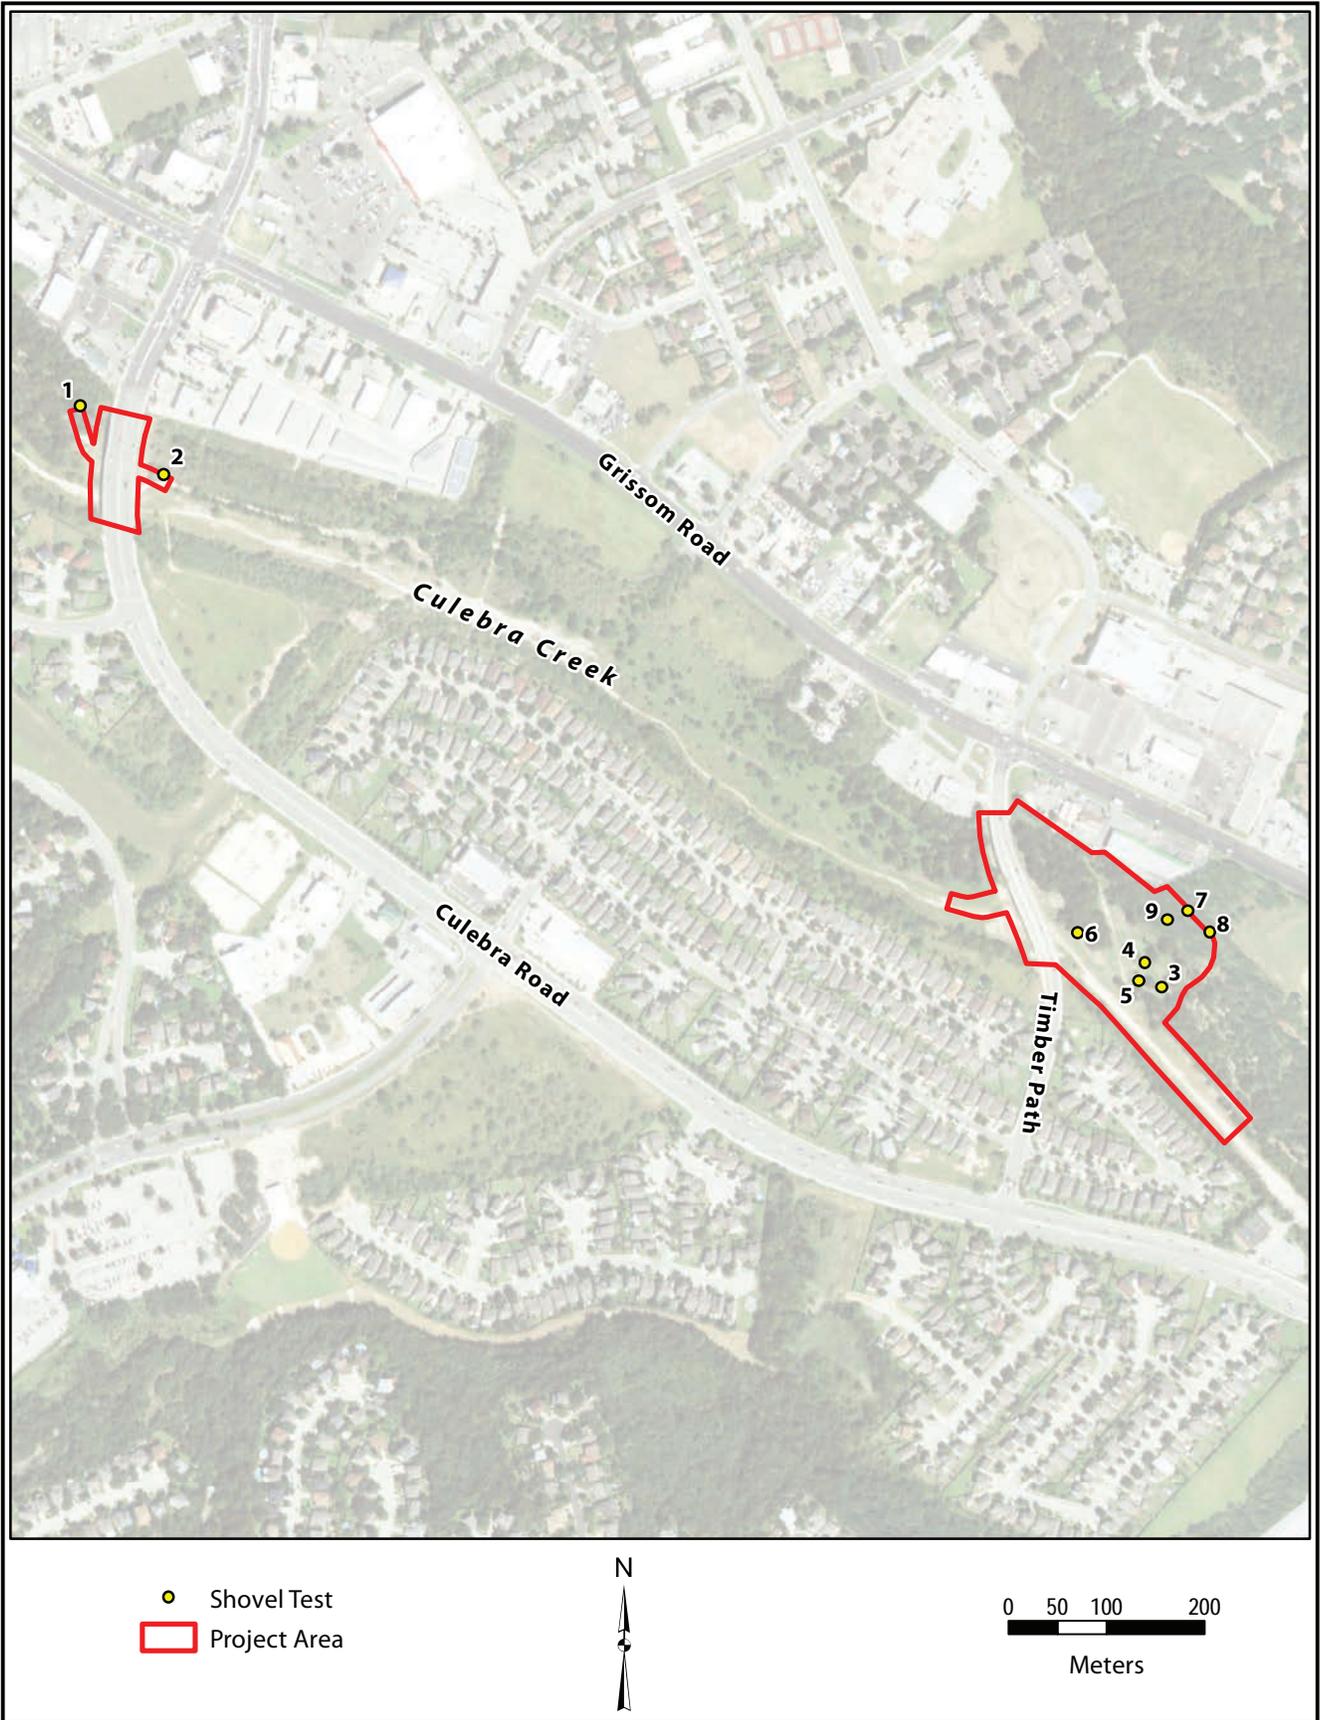
**Figure 2.** Modern aerial photograph of the project area showing the APE and shovel test locations. The Culebra Road survey area is on the west, and the Timber Path survey area is on the east.

Surface visibility in the APE typically varied from 0 to 30 percent, with higher visibility on the channel floor, on cut banks and bench margins along existing channel segments, on portions of the north bank wall, and along two-track roads and abandoned roads. Nine shovel tests were excavated in and immediately adjacent to the APE (Figure 2). Shovel Tests 1 and 2 were placed near the ends of the proposed pilot channel below Culebra Road. Shovel Tests 3–9 were southeast of Timber Path on the channel floor, at the foot of the channel wall, and on terrace margins north of the creek. Shovel tests were not systematically spaced along survey transects. Most of the tests were placed in locations that appeared to be relatively undisturbed and/or appeared to have the greatest potential for archeological deposits according to landform. Some of the tests were excavated to demonstrate the character of the subsurface deposits in areas otherwise obscured by surface vegetation. If the APE acreage is rounded up to 11 acres, then the resulting shovel test density of 1 test for every 1.2 acres exceeds the Texas Historical Commission's minimum archeological survey standard of 1 test every 2 acres on tracts of this size. This level of effort is considered sufficient given the geomorphic setting of the APE and the extent and level of natural and artificial disturbance within it. Backhoe trenching is considered unnecessary within the APE for the same reasons.

Shovel tests were approximately 30 cm in diameter and were excavated in 20-cm levels when sediments allowed. Excavated sediment was screened through 1/4-inch-mesh hardware cloth or carefully sorted through with a trowel when too difficult to screen efficiently. A Shovel Test Record form was used to record brief sediment descriptions and notes about the presence of natural inclusions (e.g. snail shells), modern trash, and construction materials. The average shovel test depth was 29 cm, with depths ranging from 13 to 60 cm.

Shovel Test 1 was on a bench between the north bank wall and the existing stream channel near the west end of the proposed pilot channel. Natural benches in this location stand about 1.5 m above the floor of the channel, and these consist of 40 to 50 cm of sediment atop a thick gravel base. No artifacts were observed in the inspected cut banks, and none were recovered in Shovel Test 1. Sediment in the top 28 cm of the test consisted of moderately consolidated brown silt loam that graded to silty clay with depth. This sediment contained occasional fine gravels and abundant snail shells. Pieces of plastic and rubber were common in the top 15 cm. The next layer of sediment, exposed to a depth of 35 cm, consisted of well-consolidated, light

Shovel Test 2 was on a vegetated gravel bar along the north edge of the proposed pilot channel east of the bridge. This 15-cm-deep test revealed 3–4 cm of grayish brown clay loam and roots above well-consolidated yellowish brown silty and sandy clay with abundant rounded gravels and carbonate flecks. The existing channel cut roughly 5 m south of the test shows a heterogeneous deposit of fine to coarse gravels (up to 45 cm across) with little intervening sediment that is at least 1 m thick.

Shovel Tests 3–6 were in relatively flat areas on the broad channel floor, between abandoned road segments and the current channel cut. Surfaces at these four tests were covered with a dense mat of grasses and forbs. Shovel Tests 3–5 were within 20 to 30 m of each other on what appeared to be a wide bench flanked by the bedrock-floored channel to the east and northeast. Shovel Test 3 revealed 7 cm of loose sandy loam with a few gravels and some asphalt shingle fragments above tightly packed gravels interspersed with loam and silty clay; it extended to a depth of 13 cm. Shovel Test 4 exposed 12 cm of dark brown clay loam and clay with fine lenses of medium-grained sand over 18 cm of dark brown clay mottled with pale gray silt with few gravels. Beneath this was 30 cm of dry, strongly granular, dark brown clay with scattered fragments of indurated limestone that increased in frequency with depth. The test ended at limestone bedrock at 60 cm. Partially buried segments of rubber tubing were observed in an area of softer surface sediments about 5 m south of this test. Shovel Test 5 was about 10 m east of an abandoned road segment and excavated to a depth of only 20 cm because it revealed dry brown loam and sandy loam mixed with high-density small gravels and some asphalt fragments. Shovel Test 6 was on a flat area composed of fine-grained sediments and surface gravel deposits south of a braided channel segment. The test revealed 6 cm of moderately consolidated, granular, silty clay over 9 cm of dark brown, granular, silty clay and clay with few gravels and *Rabdotus* shells. Sediment in the remainder of the test (to a depth of 45 cm) was very dark brown clay with a few small gravels and scattered carbonate flecks.

Shovel Tests 7–9 were north of the existing stream channel. Shovel Tests 7 and 8 were on top of the north bank on the leading terrace edge. Shovel Test 9 was on a bench below a 25-m-long by 15-m-wide mechanical cut in the bank wall. These tests ranged from 25 to 28 cm in depth. Shovel Test 7 revealed 25 cm of strongly granular, reddish brown silt loam with abundant fine gravels and some snail shells above tightly packed calcareous gravels interspersed with silty clay. Shovel Test 8 exposed strongly granular to blocky, dark brown silty clay with a few fine gravels to a depth of 25 cm. Shovel Test 9 revealed 22 cm of strongly granular, dark brown silty clay loam and silty clay with a few fine gravels above well-consolidated brown clay with carbonate flecks.
