# **Archaeological Investigation for the Proposed Willow Springs Golf Course Bridge Replacement Project, San Antonio, Bexar County, Texas**

**Antiquities Permit #7444**

**Report Authors: Joshua Hamilton, M.A.; and Melanie Nichols, M.Sc.  
Pape-Dawson  
7800 Shoal Creek Boulevard  
Suite 220W  
Austin, TX 78757  
March, 2016**

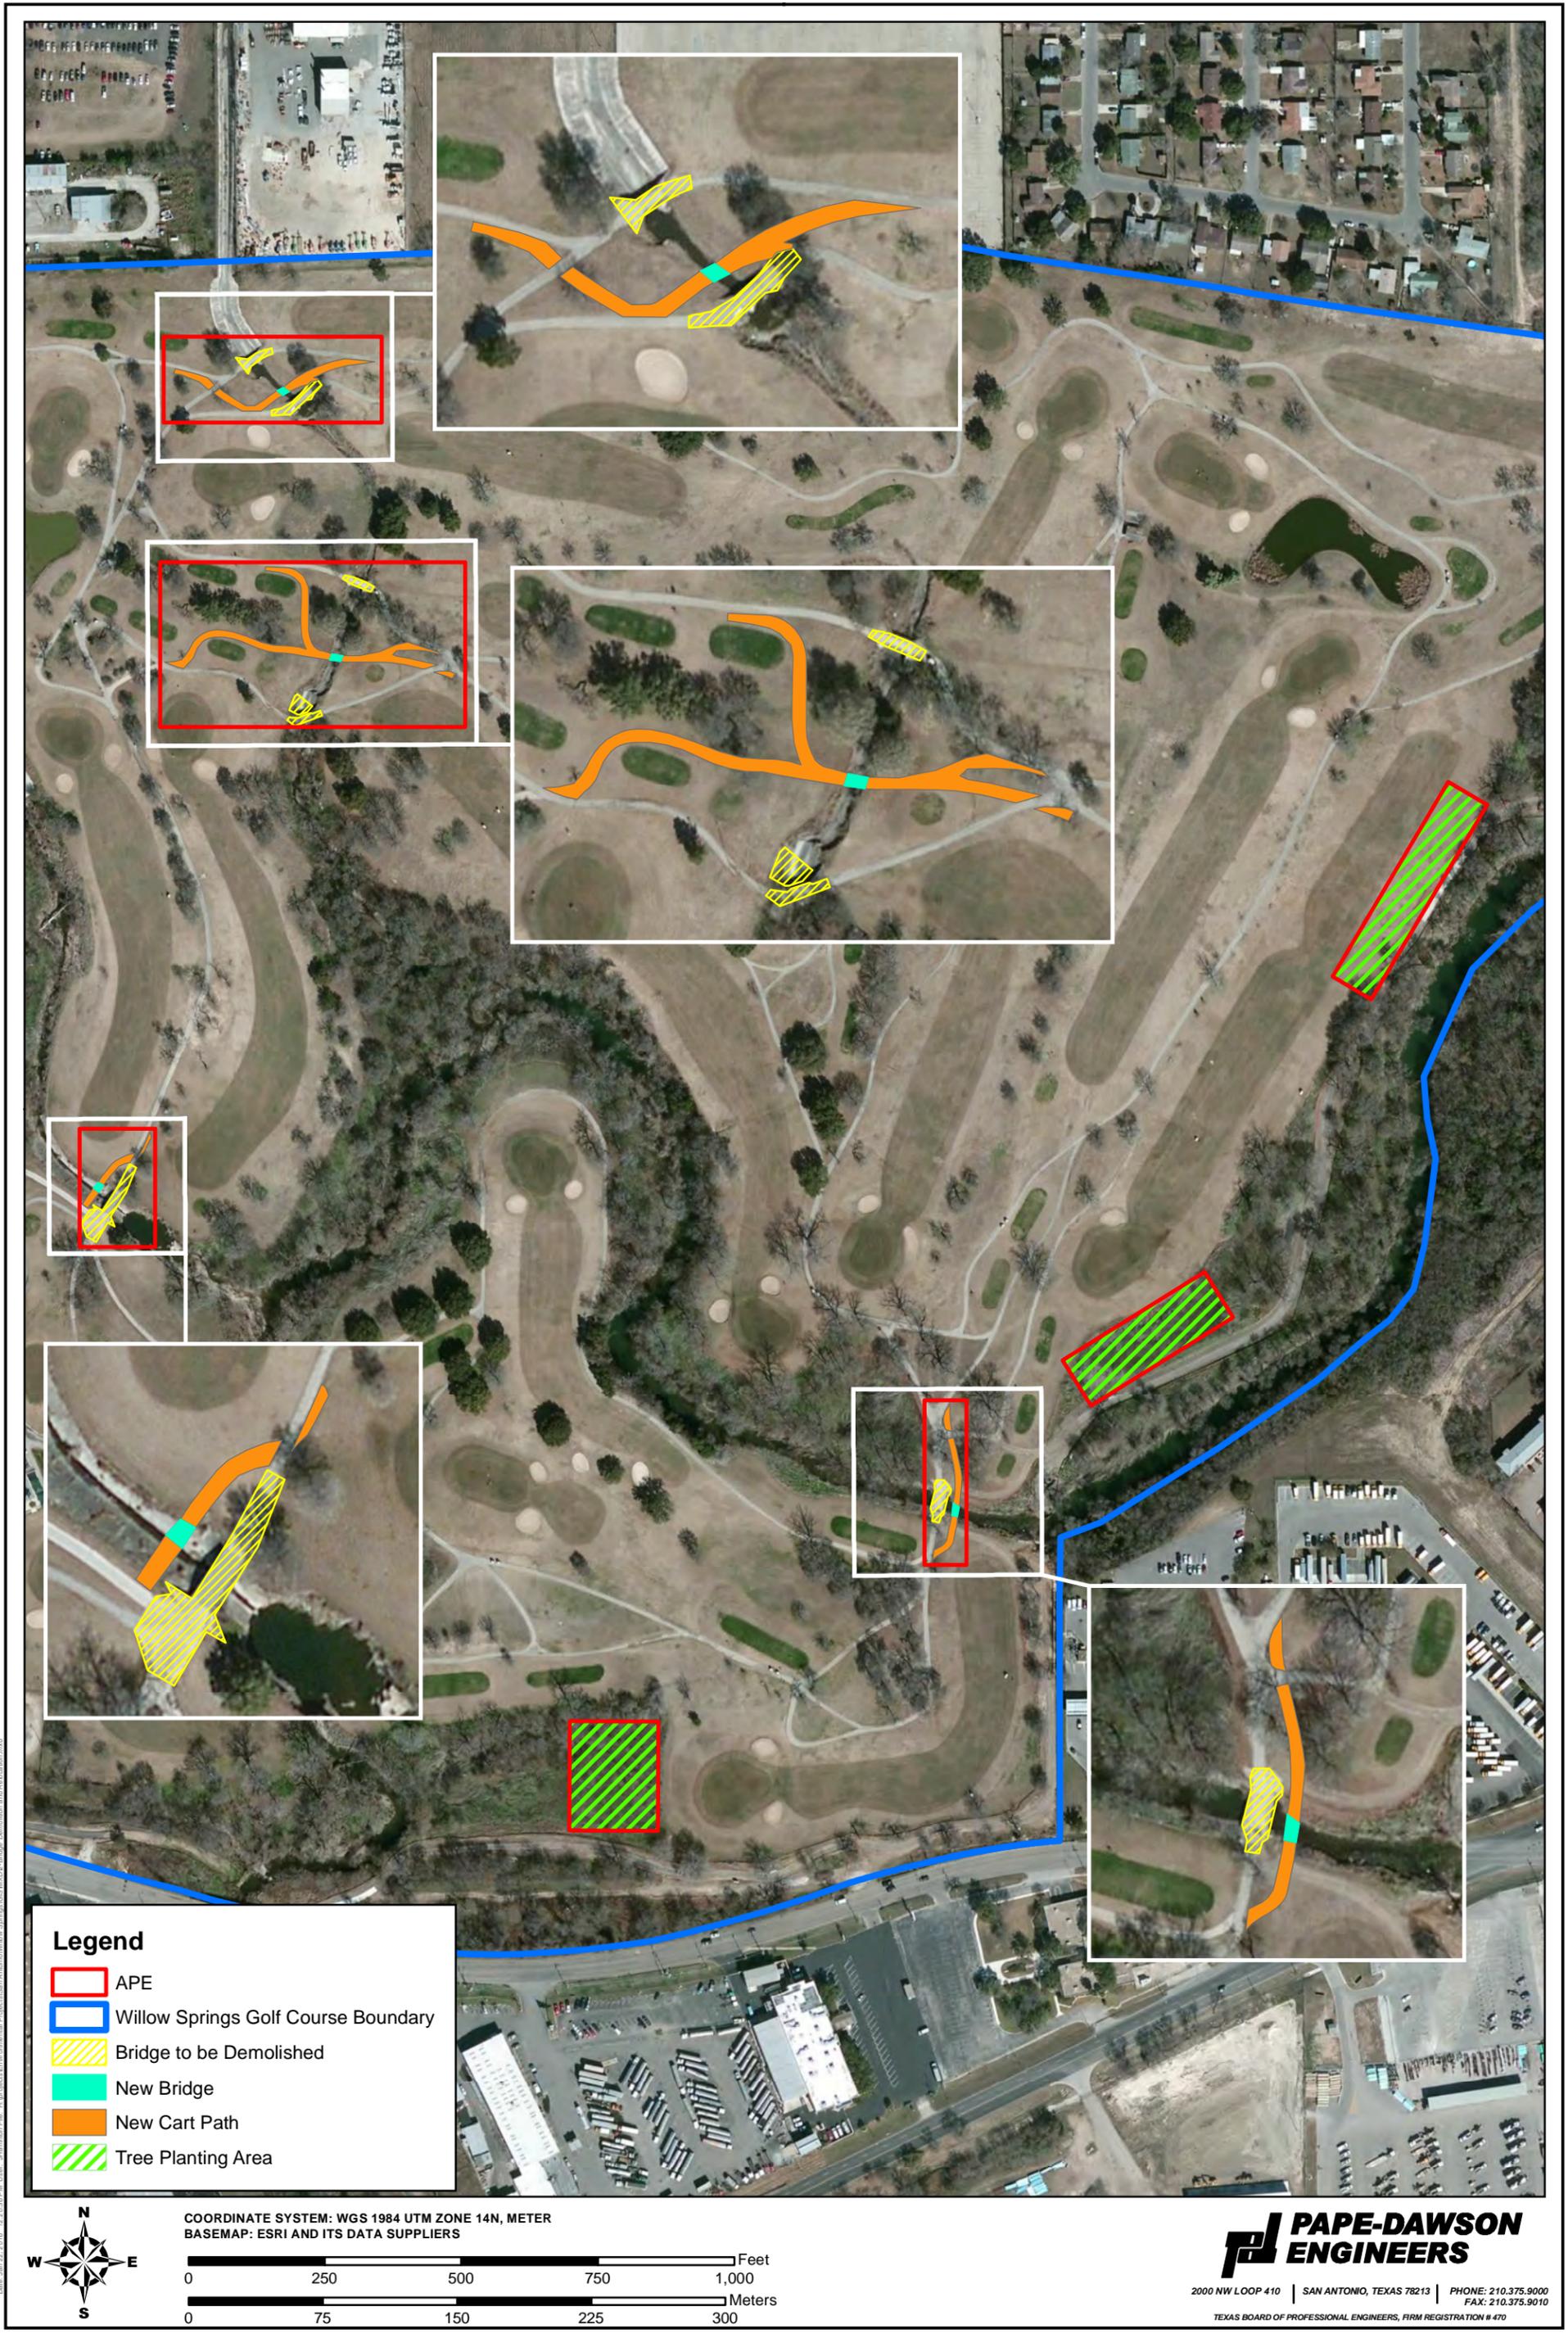
**Figure 2 : Bridge Replacement and Tree Planting Areas Map**

For the purposes of this project, the area of Area of Potential Effects (APE) has been defined as the footprint of the existing bridges and bridge replacements, realigned golf cart paths, and three tree planting areas along Salado Creek (Figure 2). The APE will consist of a total area of 8.79 acres. The vertical depth of impact is anticipated to be up to 8 feet (2.4 meters) below the ground surface based on typical bridge design.

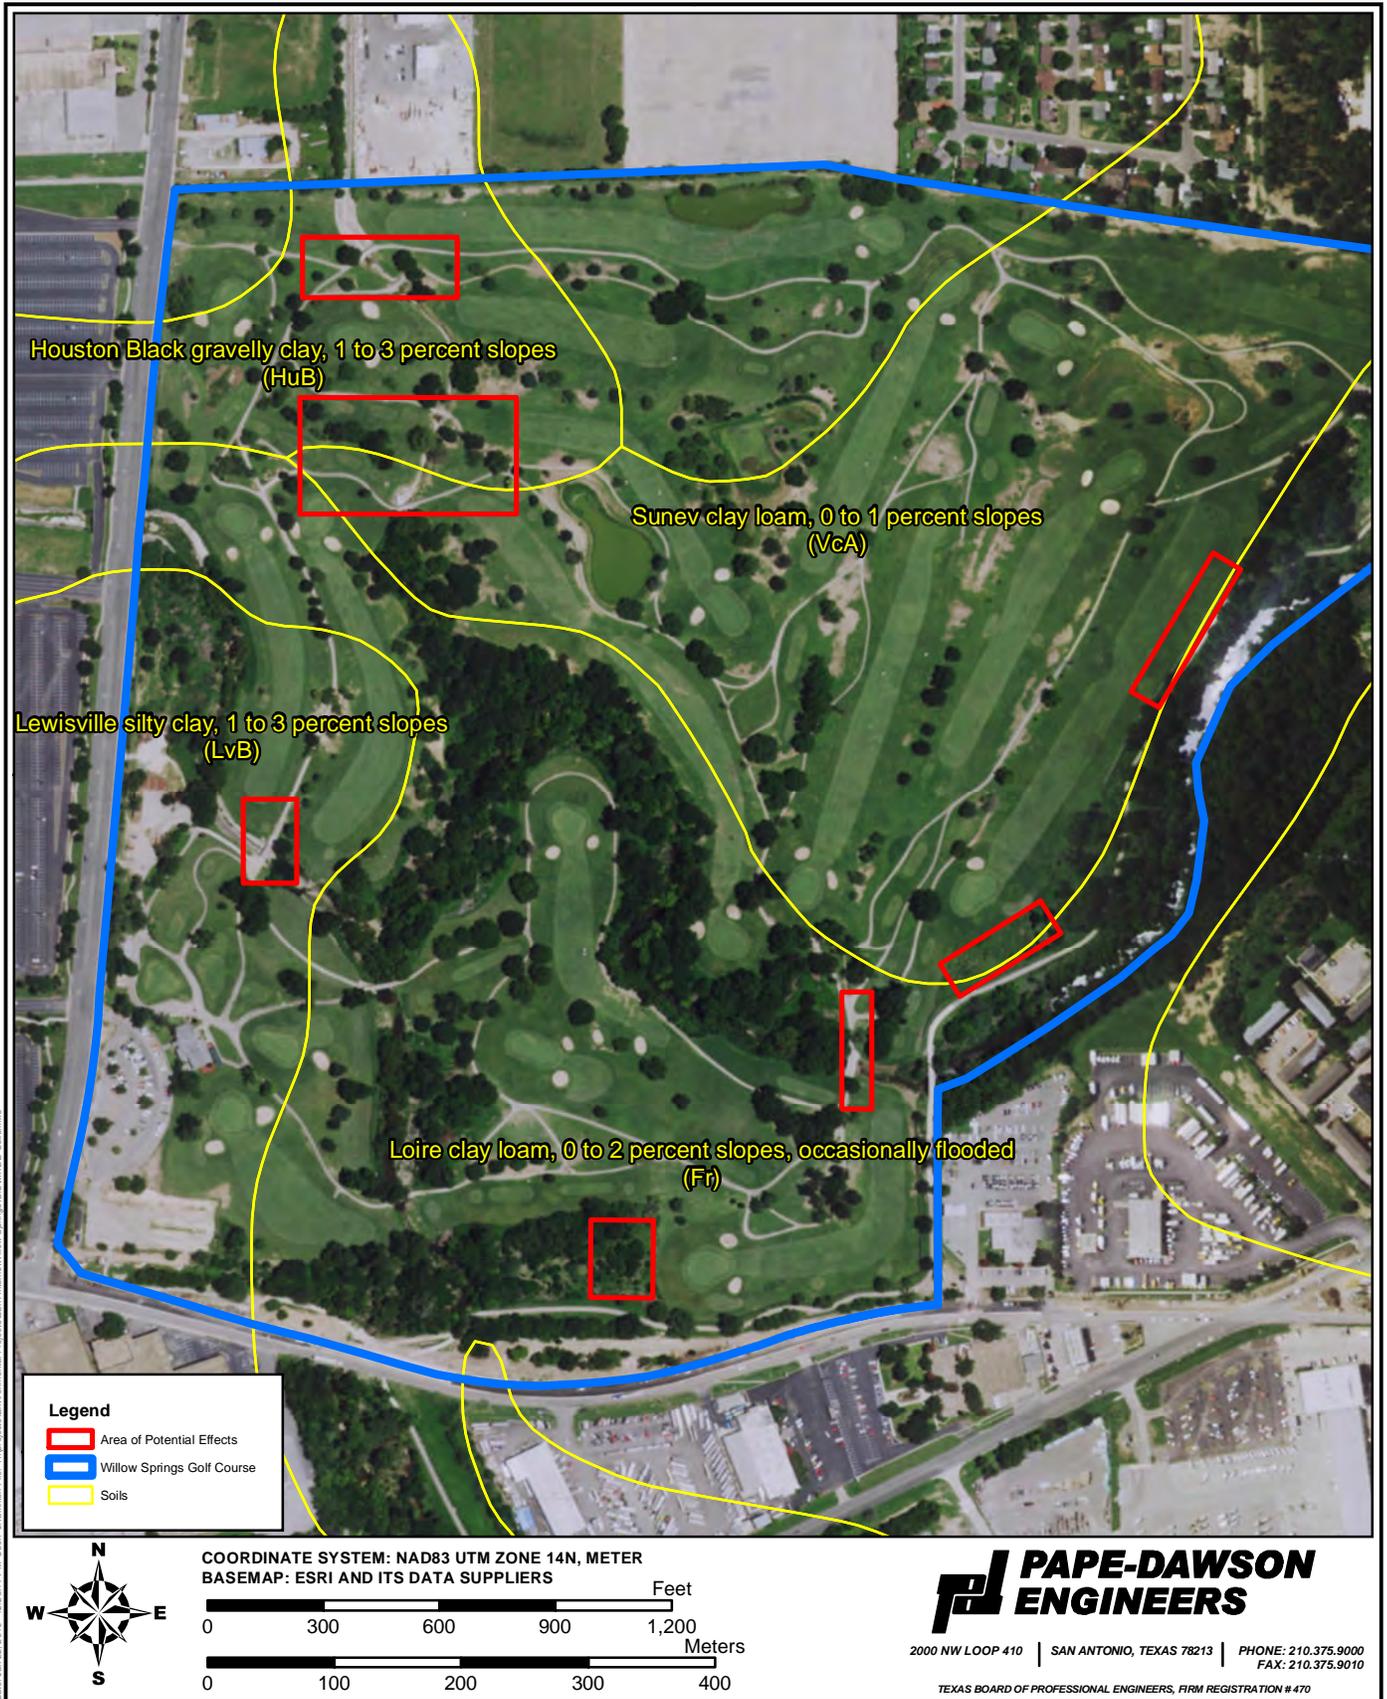
**Figure 3 : Soils Types Located within the APE**

The soils that formed within these pre-Holocene deposits belong to the Houston Black (HuB), Sunev (VcA), Lewisville (LvB), and Loire (Fr) series (Figure 3). The most prevalent soil within the APE is Houston Black gravelly clay, 1 to 3 percent slopes. Houston Black soils are classified as Vertisols and are formed in clayey residuum derived from calcareous mudstone of Cretaceous Age. Soils of the Houston Black series are found on interfluvial and along the side slopes of upland ridges and dissected plains. They consist of very dark gray clay with a granular structure (A-horizon) yielding to very dark gray clay with a blocky structure (B-horizon) at depths of approximately 8 inches (20 cm) below the ground surface. Sunev clay loam, 0 to 1 percent slopes are located primarily within the eastern portion of the golf course. Sunev soils are located on nearly level to moderately steep stream terraces or footslopes of valley ridges. These soils are classified as Mollisols and are very deep, well drained soils that form in loamy alluvium. These soils are characterized by dark grayish brown loam (A-horizon) overlying brown loam (B-horizon) at an average depth of 12 inches (30 cm) below the ground surface. The Lewisville soil series are primarily located along the western portion of the golf course. Lewisville series soils are classified as Mollisols and are very deep, well drained, and moderately permeable upland soils that form in ancient loamy and clayey calcareous sediments along stream terraces. Lewisville soils are characterized by dark grayish brown silty clay (A-horizon) atop grayish brown silty clay (B-horizon) at a depth of about 16 inches (41 cm) below the surface. Loire soils are primarily located within the southeastern portion of the golf course. Loire clay loam, 0 to 2 percent slopes, occasionally flooded are found on nearly level flood plains. Loire series soils are classified as Entisols and are very deep, well drained, moderately permeable soils that form in alluvial sediments. These soils are characterized by brown silty clay loam (A-horizon)

yielding to grayish brown silty clay loam (C-horizon) at depths of approximately 8 inches (20 cm) below the ground surface (Soil Survey Staff, Natural Resources Conservation Service, United States Department of Agriculture 2016).

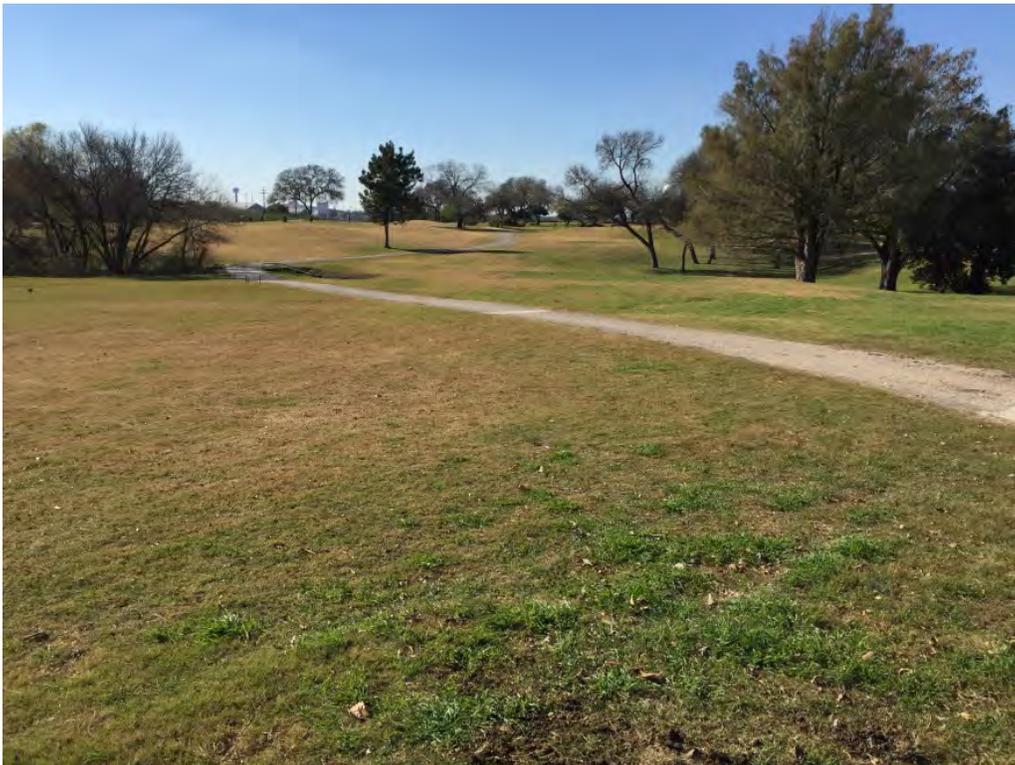
Figure 5: Overview of APE

Pape-Dawson archaeologists conducted the archaeological survey on January 18, 2016. The field crew walked the APE, visually inspecting the ground surface and cut banks for features and artifacts. Shovel tests were placed in areas displaying minimal disturbance. However, the survey found the majority of the APE to be extensively disturbed. Backhoe trenches were placed along the northern terrace of Salado Creek and within the three tree planting areas. Previous impacts to the APE were photographed and noted as part of the survey effort. The vegetation within the APE largely consisted of well-maintained short grasses. Ground surface visibility varied across the APE ranging from obscured to 30 percent and averaged roughly 10 percent at the time of the survey (Figure 5).

Disturbances to the APE were found to have resulted from both artificial and natural impacts. Artificial disturbances included historical agricultural activities and the construction and maintenance of the Willow Springs Golf Course. Natural impacts to the APE largely resulted from water erosion as evidenced by areas where soil from the channel embankments has been washed away.

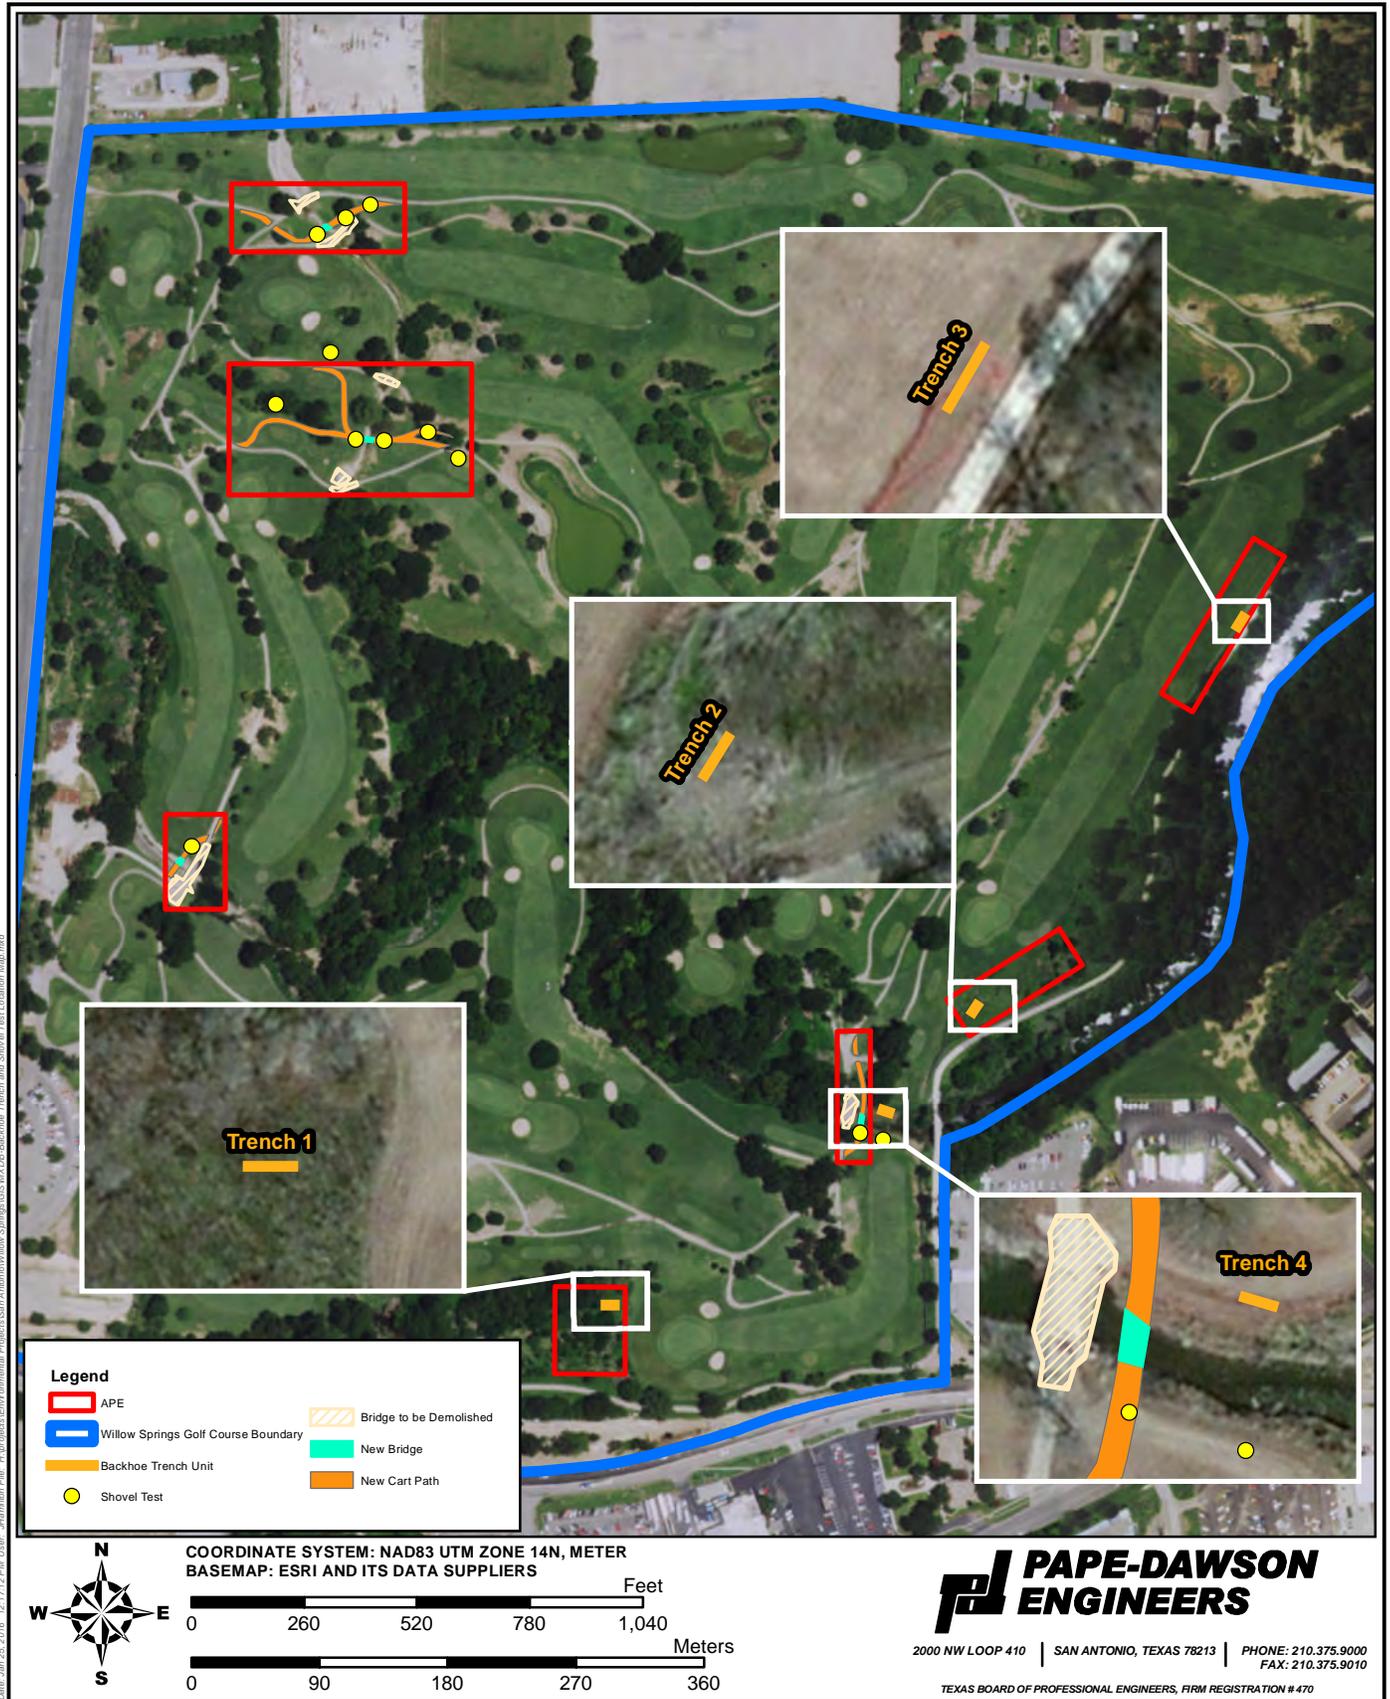
**Figure 6 : Backhoe Trench and Shovel Test Location Map**

A total of 12 shovel tests (Figure 6) were excavated during the survey of the 8.79-acre APE. Shovel tests were excavated in areas with the perceived potential for containing intact archaeological materials. Excavating shovel tests across the APE verified soils documented during the background research. Since the majority of the APE was located across terraces of uplands that emerge above the Salado Creek tributaries, the majority of recorded soils were deep clayey soils belonging to the Houston Black clay soil series. These soils were characterized as a dark grey loamy clay and compact clay ranging from a 10YR3/1 to a 10YR2/1 hue (Figure 7). However, half of the shovel tests (n=5) exposed disturbed soils as evidenced by the presence of a sandy soil that had been brought in to form the artificial contours of the golf course. While ten of the 12 shovel tests were located on upland terrain, the remaining two were placed within the southern floodplain of Salado Creek across from Backhoe Trench 4. Initially, a fifth trench was planned to be excavated within the southern floodplain of Salado Creek. However, upon conversing with the maintenance manager, it was found that numerous irrigation lines were located along the southern bank. To assess the soils within Salado Creek's southern floodplain, two shovel tests were excavated along the southern bank. One shovel test exposed an irrigation line 3.9 inches (10 cm) below the surface and the other contained a very dark grayish brown (10YR3/2) clay that was terminated at 15.7 inches (40 cm) below the surface due to the compact clay. Shovel tests were typically terminated at an average depth of 50 cmbs. Subsurface exposures, in the form of cut banks or terraces, were inspected to provide additional insight into the stratigraphic composition of the valley floor. No cultural resources were encountered during the excavation of the shovel test units.

Backhoe trench investigations were conducted within the APE to assess the overall potential for containing deeply buried cultural resources. A total of four backhoe trenches (see Figure 6) were excavated within the APE. Trench 1 was located within the southern portion of the golf course and within the southernmost tree planting area. Trench 2 was situated within the southeastern portion of the golf course and within the south-easternmost tree planting area. Trench 3 was located within the eastern extent of the golf course and within the easternmost tree planting area. Trench 4 was situated within the southeastern portion of the golf course and within the northern floodplain of Salado Creek. Trenches 1 and 3 revealed a layer of fill within the stratigraphic column. The fill layers were usually indicated by an abrupt change in soil or high gravel and/or cobble content. Fill deposits likely reflect areas where the golf course has been built up to achieve a desired elevation or slope.

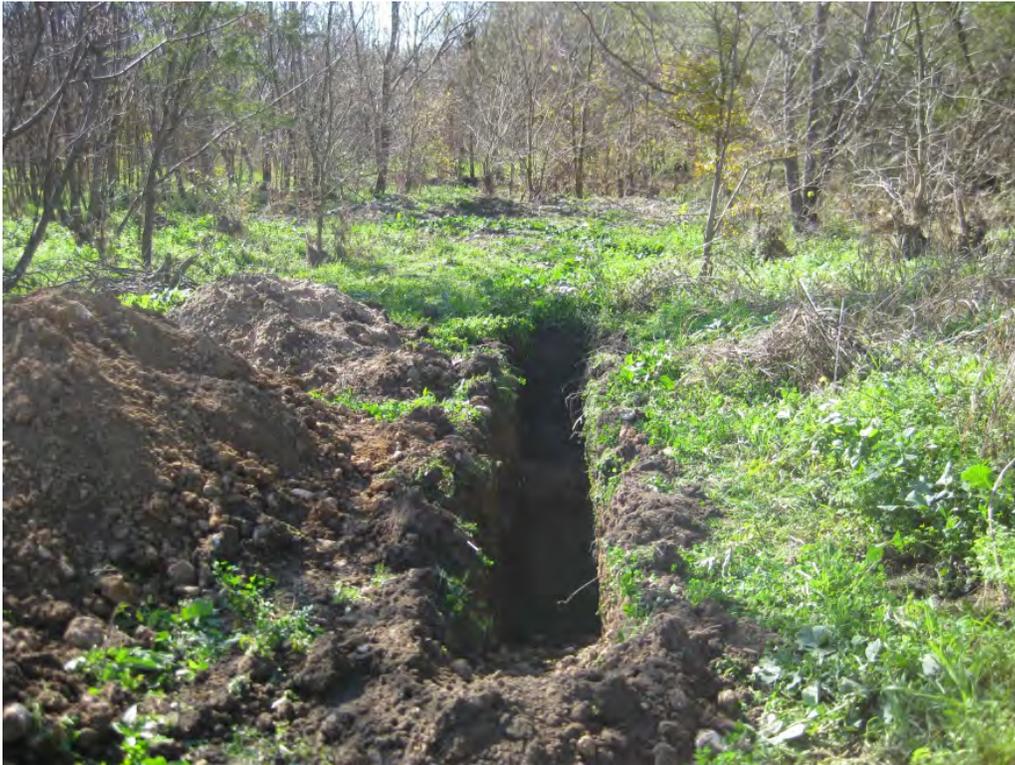
Figure 8: Overview of Backhoe Trench 1, facing west

BHT 1 was excavated on a gently sloping toe slope of a small upland rise. The trench extended 18 ft (5.5 m) in length and was 21.7 inches (55 cm) wide. During the excavation of the trench, the backhoe exposed four soil zones. Zone I consisted of a very dark grayish brown (10YR3/2) clay loam with fine yellow brownish (10YR5/6) clay mottles that extended from the surface to 11.8 inches (30 cm) below the surface. Many roots, rootlets, and gravels were observed throughout the soil zone. In addition, modern trash consisting of golf balls and plastic fragments were also observed. Directly underneath Zone I, Zone

II consisted of a dark yellowish brown (10YR5/6) clay loam that extended 31.5 inches (80 cm) below the surface. Zone III consisted of a yellowish brown (10YR5/6) silty clay loam fill that extended 50.4 inches (128 cm) below the surface (Figure 8). A few calcium carbonate flecks and masses were observed within the zone. In addition many limestone cobbles and gravels were present throughout the unit. Zone IV consisted of a brownish yellow (10YR6/6) fine sand fill that was located 47.2 inches (120 cm) from the eastern extent of the trench. The sandy fill patch extended 23.6 inches (60 cm) in length and an abandoned concrete water pipe was observed within the zone. The trench was located within one of the tree planting areas and the soils appear to have been disturbed from previous land modifying activities and flooding periods. In addition, large asphalt and concrete aggregate and many limestone cobbles were observed 49.2 feet (15 m) west of the trench.

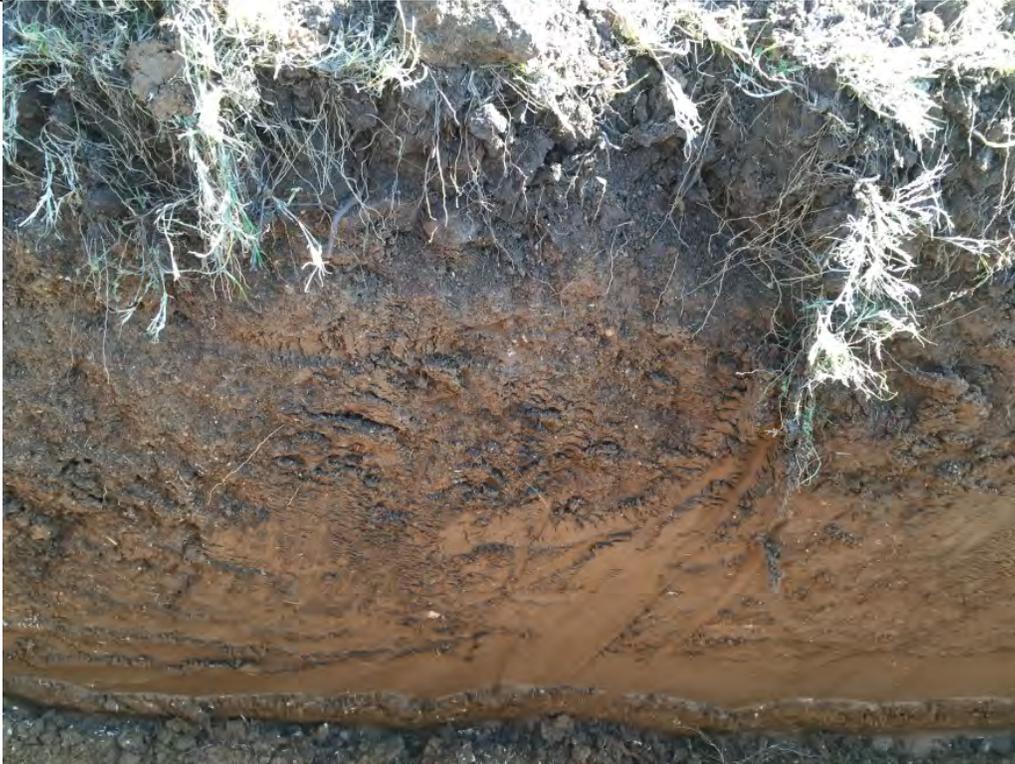
Figure 9: Backhoe Trench 3, eastern wall profile

BHT 3 was located on an upper terrace and was 87 ft (26.5 m) northwest of Salado Creek. The trench extended 16.4 ft (5 m) in length and was 21.7 inches (55 cm) wide. During the excavation of the trench, two soil zones were exposed. Zone I consisted of a very dark grayish brown (2.5YR3/2) silty clay fill that extended 9.8 inches (25 cm) below the surface. Many roots and rootlets were observed throughout the zone. A few angular chert and limestone pebbles and calcium carbonate flecks were also observed. Underneath Zone I, Zone II consisted of a dark yellowish brown (10YR4/6) silty clay that extended to the maximum depth of 46.5 inches (118 cm) below the surface (Figure 9). The zone had a moderate amount of calcium carbonate flecks and nodules and a few small shell fragments. The trench was located within one of the tree planting areas and within the boundary of site 41BX1678.

Site 41BX1678 was revisited by Pape-Dawson archaeologists during the course of the current survey. The ground surface was visually inspected, and a backhoe trench (BHT 3) was excavated to investigate the potential for subsurface archaeological deposits within and near the original site boundary. BHT 3 revealed a layer of clay fill from 0 to 25 cmbs. The disturbed soil observed within the trench corroborated with Young's assessment of the disturbed nature of the area. BHT 3 was negative for cultural material. No archaeological deposits associated with site 41BX1678 were observed with the APE during the current survey effort.

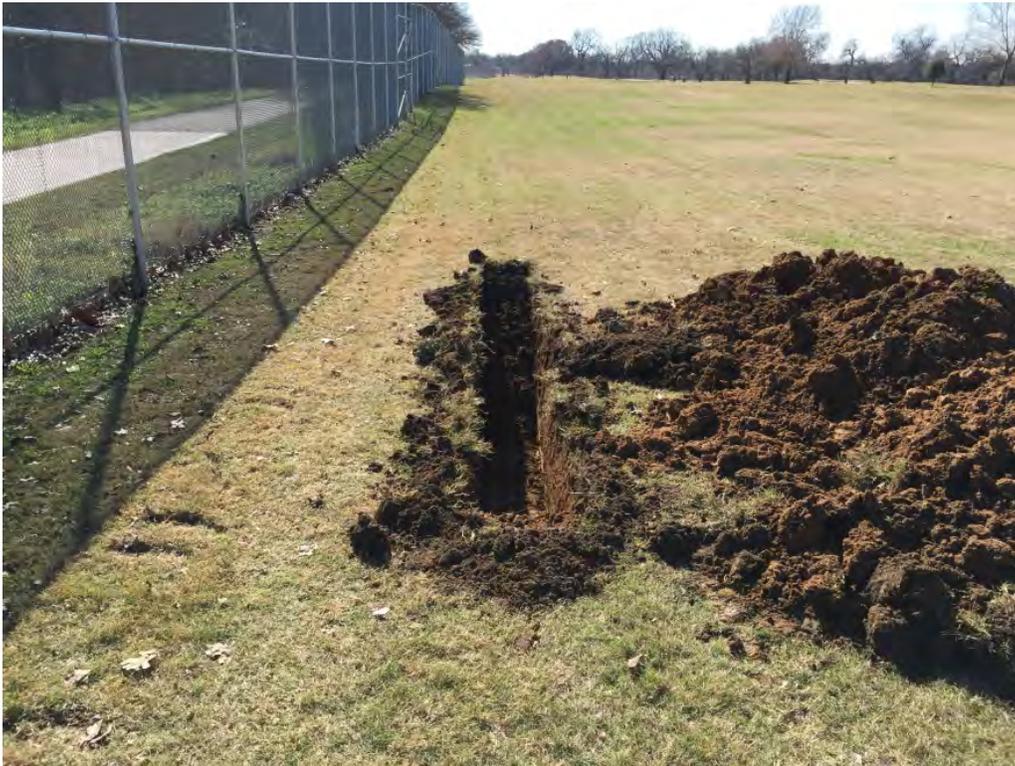
Figure 10: Overview of Site 41BX1678, facing south

Site 41BX1678 is a previously recorded prehistoric lithic scatter of indeterminate temporal affiliation. The site is located on a gently sloping upper terrace that extends along Salado Creek. The site was originally recorded by Blanton & Associates in 2006 during the archaeological investigation of the Salado Creek Hike and Bike Trail Survey. This small site extended 15-by-5 meters along a north/south-by-west/east orientation. While excavating shovel tests, a core and a chert chunk were located along the surface and a heavily patinated secondary flake was observed 5 cmbs. The integrity of the site was reported to have been largely destroyed during the construction and subsequent maintenance of the golf course (Young 2006). The site is currently characterized as well-maintained short grasses and lies along the border of the Willow Springs Golf Course and the Salado Creek Hike and Bike Trail (Figure 10). Based on the disturbed soils exposed during the excavation of BHT 3, it appears the area has undergone significant ground disturbing activities and no cultural materials were observed.
