Archaeological Monitoring Associated with the South Texas Heritage Center at the Witte Museum,

San Antonio, Bexar County, Texas

Texas Antiquities Committee Permit Number 5817

Prepared by:
Center for Archaeological Research
The University of Texas at San Antonio
One UTSA Circle
San Antonio, Texas 78249
Technical Report, No. 29

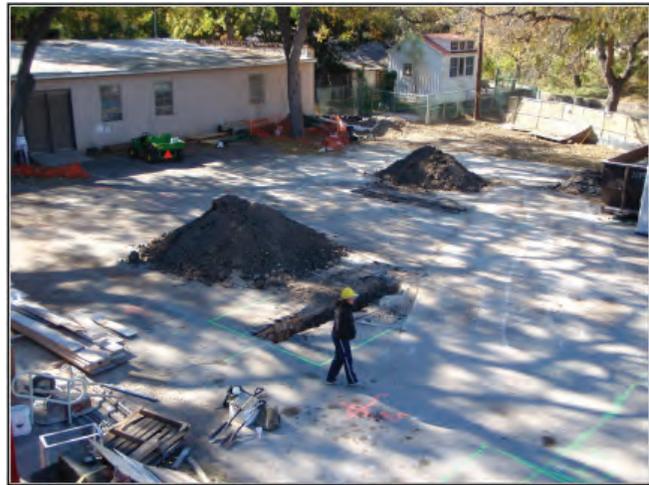
Figure 1-3. *BHT 3 (foreground) and BHT 2 (upper center) excavated behind Pioneer Hall. BHT 1 was to be located near the lower right of the photo (see green line).*

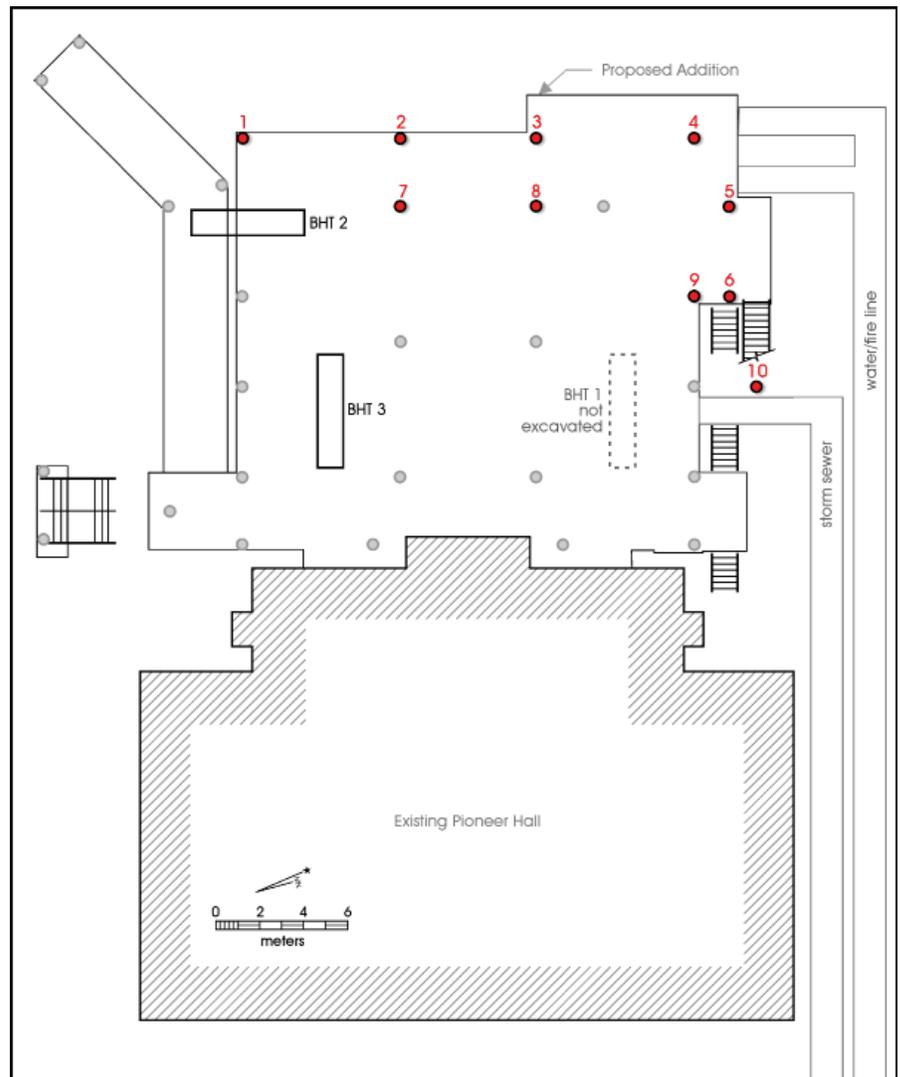
Figure 2-1. BHT 3 (foreground) and BHT 2 (upper center) excavated behind Pioneer Hall.

The backhoe trenches were placed at intervals along the area so as not to disrupt the stability of the planned building piers (Figure 2-2).

Of the thirty piers drilled within the proposed building addition footprint, ten were monitored for archaeological materials (see Figure 2-2). Pier borings utilized a mechanical auger and the CAR personnel were instructed to screen one bucket of material for every five feet of depth reached by the augers. Screening occurred to a depth of 15 feet (4.57 m) below the modern surface. Visual monitoring of the sediments continued below that depth but no additional screening occurred with these materials.

Pier 2 was located north of Pier 1 (see Figure 2-1) and included modern fill materials including red and yellow brick fragments down to 10 feet. Zone 3 (10-15 ft) consisted of a sticky, dark-brown clay and included few organic materials.

Located east of Pier 3 (Figure 2-1), the upper zone of **Pier 8** (0-5 ft) consisted of a brown loamy-clay with some gray clay and limestone gravel inclusions. Zone 2 was devoid of cultural materials, but continued to contain small limestone fragments. At the bottom of Zone 3 (at 13-15 ft) was noted a transition into a very dark-brown clay containing some limestone inclusions.

The ten borings sampled by CAR personnel represent a cross-section of the western and northern portions of the proposed expansion of the Pioneer Hall (Figure 2-1). A thick layer of modern fill was observed in all borings, although its composition varied across the site. This deposit appears to represent the same modern fill materials reported by Ulrich (2011) across much of the northern sections of the Witte Museum property. These materials were thought to have originated in the mid-1930s, soon after, or at the time of, construction of the Pioneer Museum.

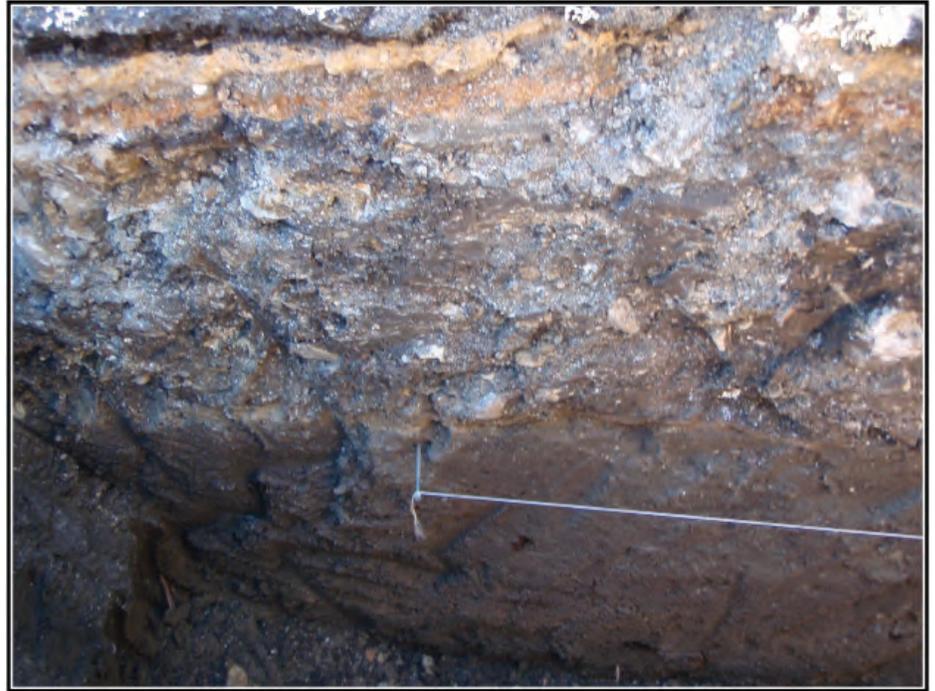
Backhoe Trench 3 was located closest to the South Texas Heritage Center and in line with the walkway and door leading into the building. It was orientated east-west and was approximately 3.5 meters in length (see Figure 2-2). In BHT 3, the asphalt layer (see Figure 3-2 Zone 1) varied in thickness between 6 to 10 cm and sat atop a yellowish-tan caliche base (Figure 3-1).

Figure 3-1. Section of south wall of BHT 3. Note fill layers extending to approximately 60 cmbs.

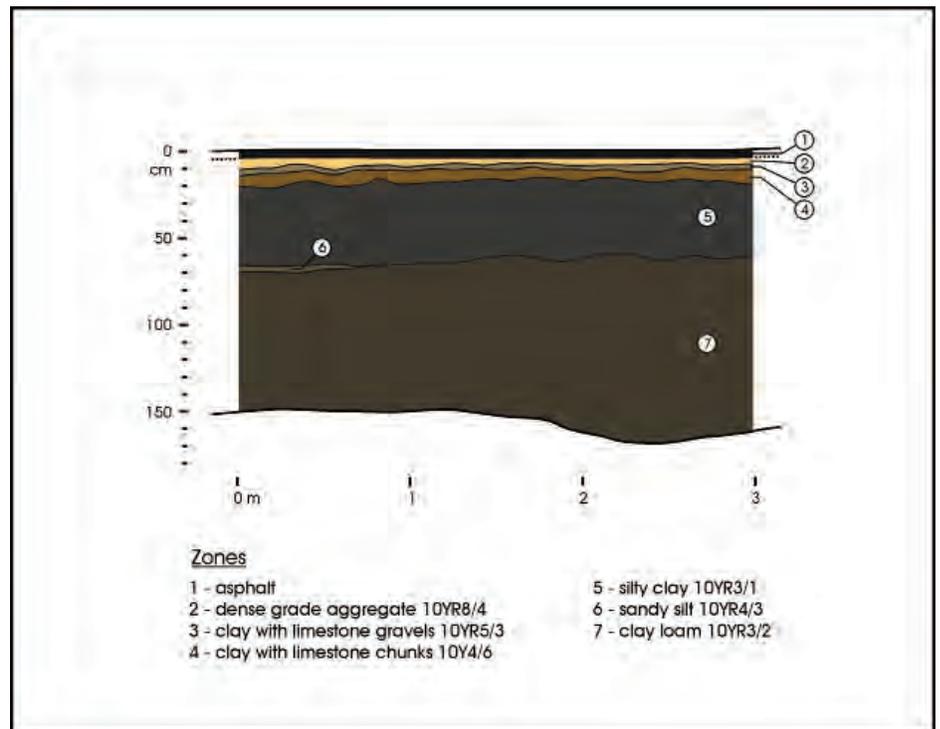
The caliche base was very thin averaging approximately 4 cm across the trench (Figure 3-2, Zone 2). Beneath the yellowish-tan caliche base was a slightly grayish matrix. This matrix appeared very similar in both texture and limestone inclusions to the caliche layer above, though it was grayish in color (Figure 3-2, Zone 3). This gray caliche zone was approximately 4 to 6 cm in thickness. Located just below this grayish caliche layer was a reddish-brown soil (Figure 3-2, Zone 4) containing angular limestone fragments. These upper four layers of soil were each fairly thin, amounting to only approximately 20 cm, but were uniformly scattered across the trench. All layers represent the fill that had been introduced to level the surface area during site preparation prior to the pouring of asphalt for the parking lot. Cultural material was not noted in these layers.

Another fill layer was present beneath the thin layers of fill, although this layer was much thicker than the prior excavated fill (Figure 3-2, Zone 5). This layer consisted of

Figure 3-2. Profile of the south wall of Backhoe Trench 3.

dark-brown, silty clay with limestone nodules and pebbles. The layer measured approximately 40 cm in thickness.

A few artifacts were noted in the backdirt during excavation throughout this level. Artifacts consisted mainly of rusted nails. During the profiling of the trench, a few nails were noted in the wall at the base of this soil layer (Figure 3-2, Zone 5). A small intrusion of brown sandy silt was noted in the western portion of the profile immediately under the limestone layer, but it did not continue across the length of the trench (Figure 3-2, Zone 6). Beneath this layer, the trench profile consisted of dark-brown clay loam (Figure 3-2, Zone 7). No cultural material was noted in this portion of the trench.

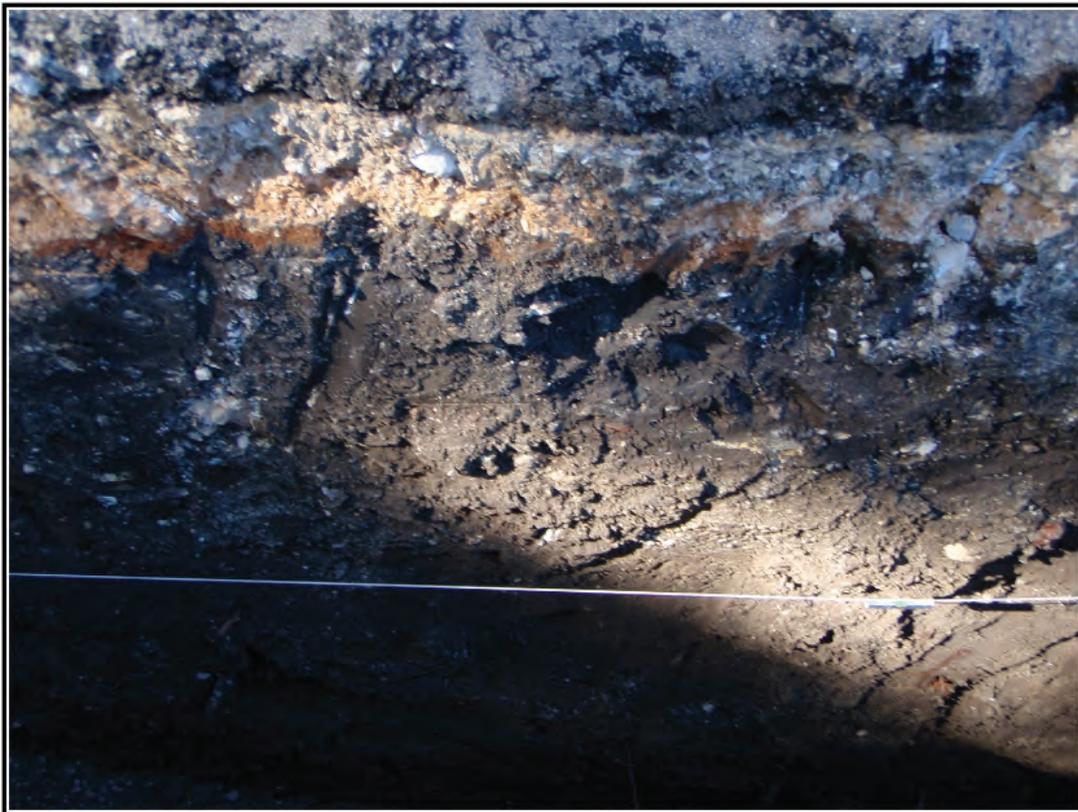
Backhoe Trench 2 (BHT 2), located to the southwest of BHT 3, was the second of the two excavated trenches. This trench was oriented north-south and was 3.5 meters in length. It was excavated to a terminal depth of approximately two meters below surface (mbs). The soils encountered in BHT 2 were similar to those noted in BHT 3, but did show some variations (Figure 3-3). The asphalt layer in BHT 2 ranged from about 10 cm to 15 cm in thickness. Just below the asphalt, there were three thin layers of caliche. Each caliche layer was slightly different in color. Each layer is approximately 4 to

Figure 3-3. Section of west wall of Backhoe Trench 2.

6 cm in thickness. In the northern portion of the west wall profile, just below the last layer of caliche, a thin lens of red sand was noted. The lens of sand was approximately 2 to 4 cm in thickness.

A layer of black clay was observed beneath the sand as well as in the northern portion of the trench. This black clay had very few inclusions. This layer of black clay was localized to an area approximately 70 cm from the southern edge of the trench. Dark-brown clay containing lime flecks surrounded the black clay. In the northern portion of the trench at the base of this black clay level, a clump of rusted nails was noted in the wall. Examination of the backdirt from this level of the trench, identified fragments of red tile, clear and brown glass, and rusted nails. In the northern portion of the trench, a pocket of grayish-yellow, silty clay was also observed. Below this, and down to the base of the trench, the matrix consisted of a dark brown clay loam. This clay loam was the same soil observed in the majority of the BHT 3 profile. As there seemed to be little change after this soil was encountered in BHT 3, the excavation of BHT 2 stopped upon encountering this clay zone. After the excavation of BHT 2, the trench was photographed and profiled. Backdirt from both trenches was left next to their respective trenches so that Guido Brothers Construction could conduct the proper backfilling at a later date. Each trench was covered with plywood prior to the CAR archaeologists leaving the site.

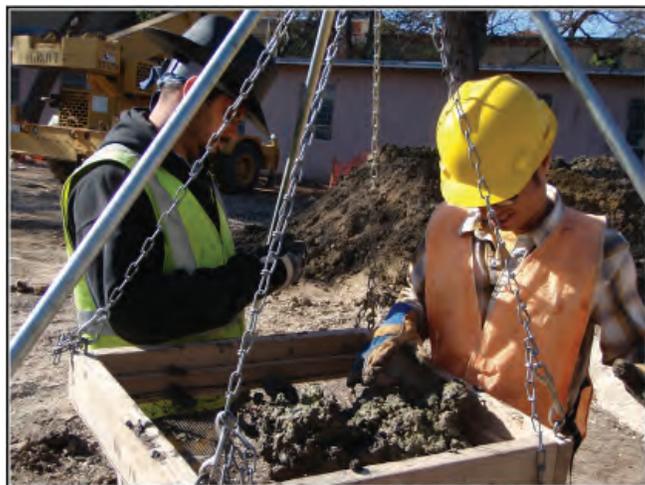
Figure 3-4. CAR staff screen excavated materials from pier borings in the footprint of the new extension.

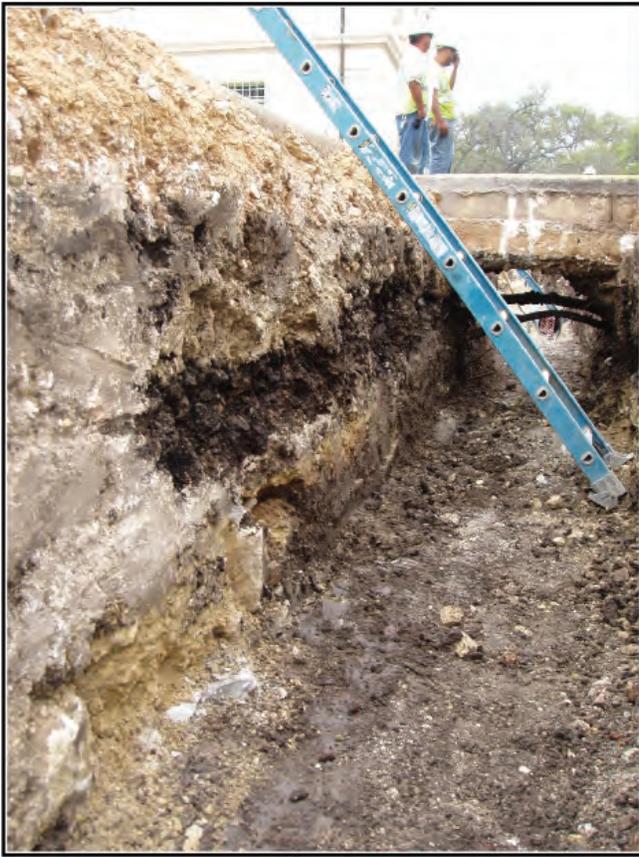
Instead, the western two-thirds of the trench was excavated entirely through fill material. The trench was expected to be excavated all the way through the fill material based on the findings of the previous testing project (Ulrich 2011; see also Figure 3-5). The upper portion of fill encountered directly below the parking-lot pavement consisted of dense grade aggregate (DGA) resting on top of a thick, yellowish layer of silty loam with yellow brick fragments and modern fill material present throughout. Below this, a layer of dark brown fill was encountered which was composed of a silty loam with modern debris integrated throughout. The lowest portions of the trench included more of the yellowish brick-

Figure 3-5. South wall profile of the fire/water line trench showing successive layers of modern fill materials.

fill materials, as well as a lighter brown, silty clay fill with limestone inclusions.

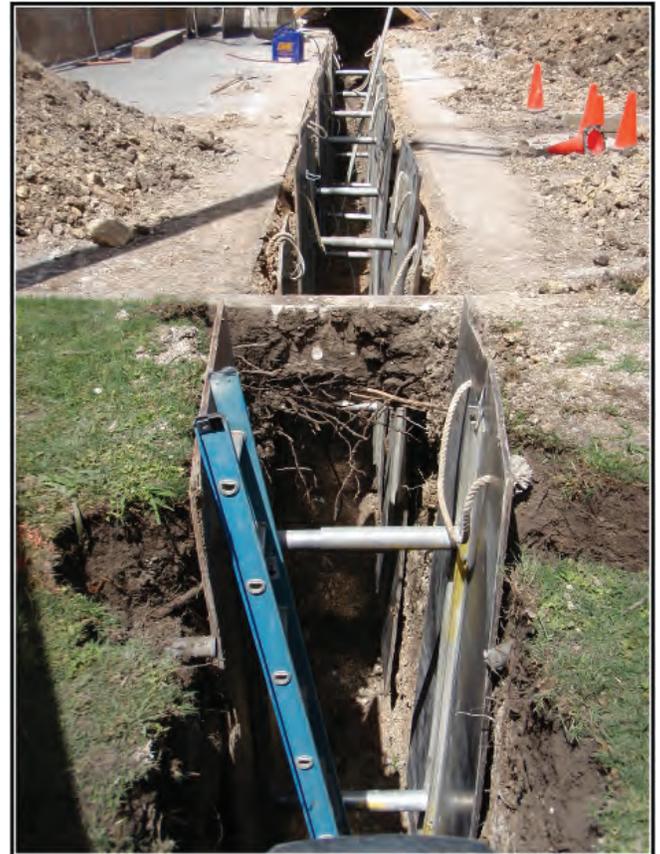
toward the north side of the South Texas Heritage Center. Regrettably, archaeological monitoring was exceedingly difficult to conduct from the present surface. Because of the depth of the trench (2.20 mbs), CAR monitors could not enter the trench without proper wall bracings in place. Once the trench was properly braced (Figure 3-6), the CAR monitor entered the trench to attempt to access the soils and to make profile drawings. Unfortunately, the placement of the wall bracings obstructed more than 85% of the profile which made the archaeological assessment of the trench exceedingly difficult.

Figure 3-6. Storm Sewer Trench showing the expansion plates obstructing a clear view of the wall profile.

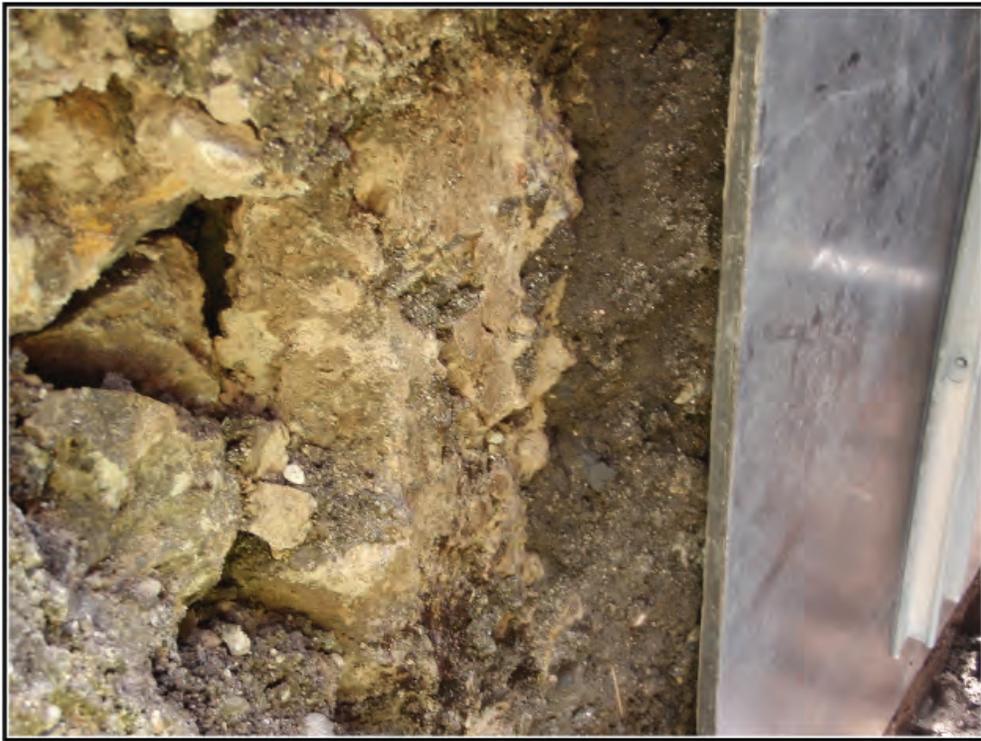
One feature, a stack of limestone cobbles, was encountered and documented (Feature 1) in the north wall of the storm sewer trench (Figure 3-7). It was relatively narrow (<40 cm) and reached a depth of about 1.45 m below the ground surface.

Since this feature was not observed in the south wall profile or in the profiles of the water line trench immediately to the north, it is believed that it represents some kind of stone pier, and was perhaps associated with the second Alligator Garden location (Figure 3-8).

Figure 3-7. Feature 1 in north wall of Storm Sewer Trench in the vicinity of the second Alligator Garden.

A single feature, a small stacked stone footer, thought to be possibly related to the second Alligator Garden location, was observed in the north wall of the relatively deep (2.2 mbs) storm sewer trench. No other culturally significant artifacts or features were observed during the course of this project. Therefore, the CAR recommends that the renovation and expansion of the South Texas Heritage Center be permitted to continue as planned. No adverse affect on significant cultural deposits or features is anticipated in this area.

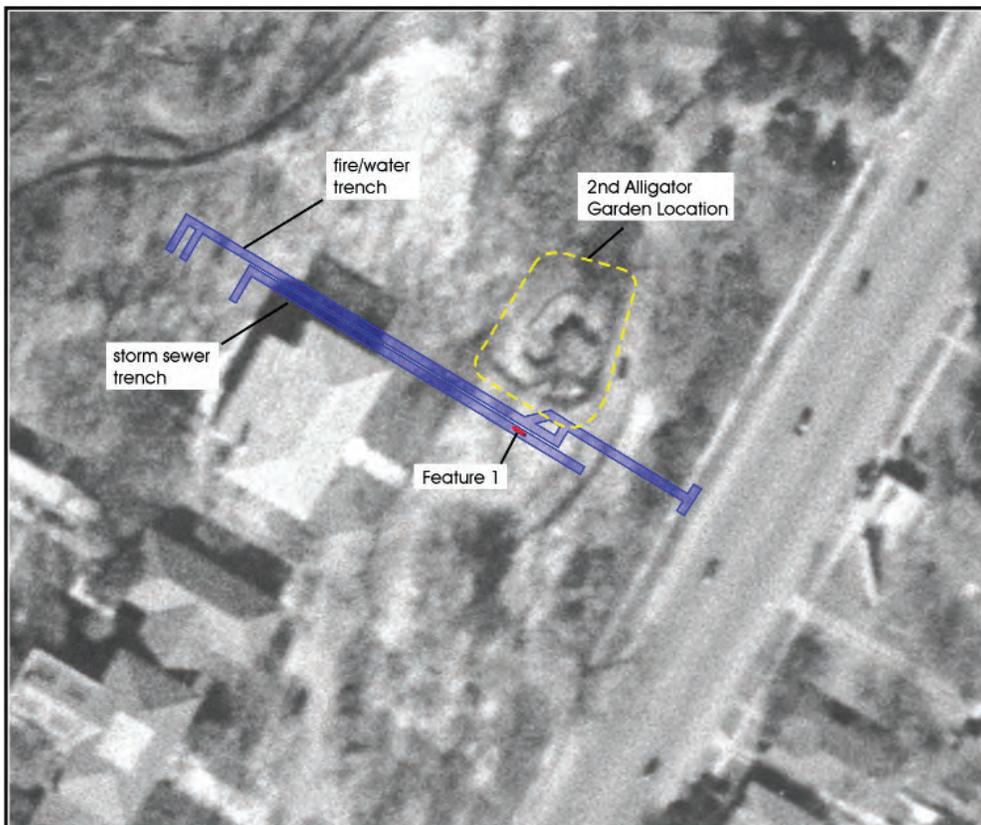
Figure 3-8. 1939 aerial view of the project area showing the backhoe trench locations, second location of the Alligator Garden, and Feature 1 in the north wall of the Storm Sewer Trench.
