# Cathedral Rock Park

**A Trail Access Information**  
*Typical Trail Qualities*

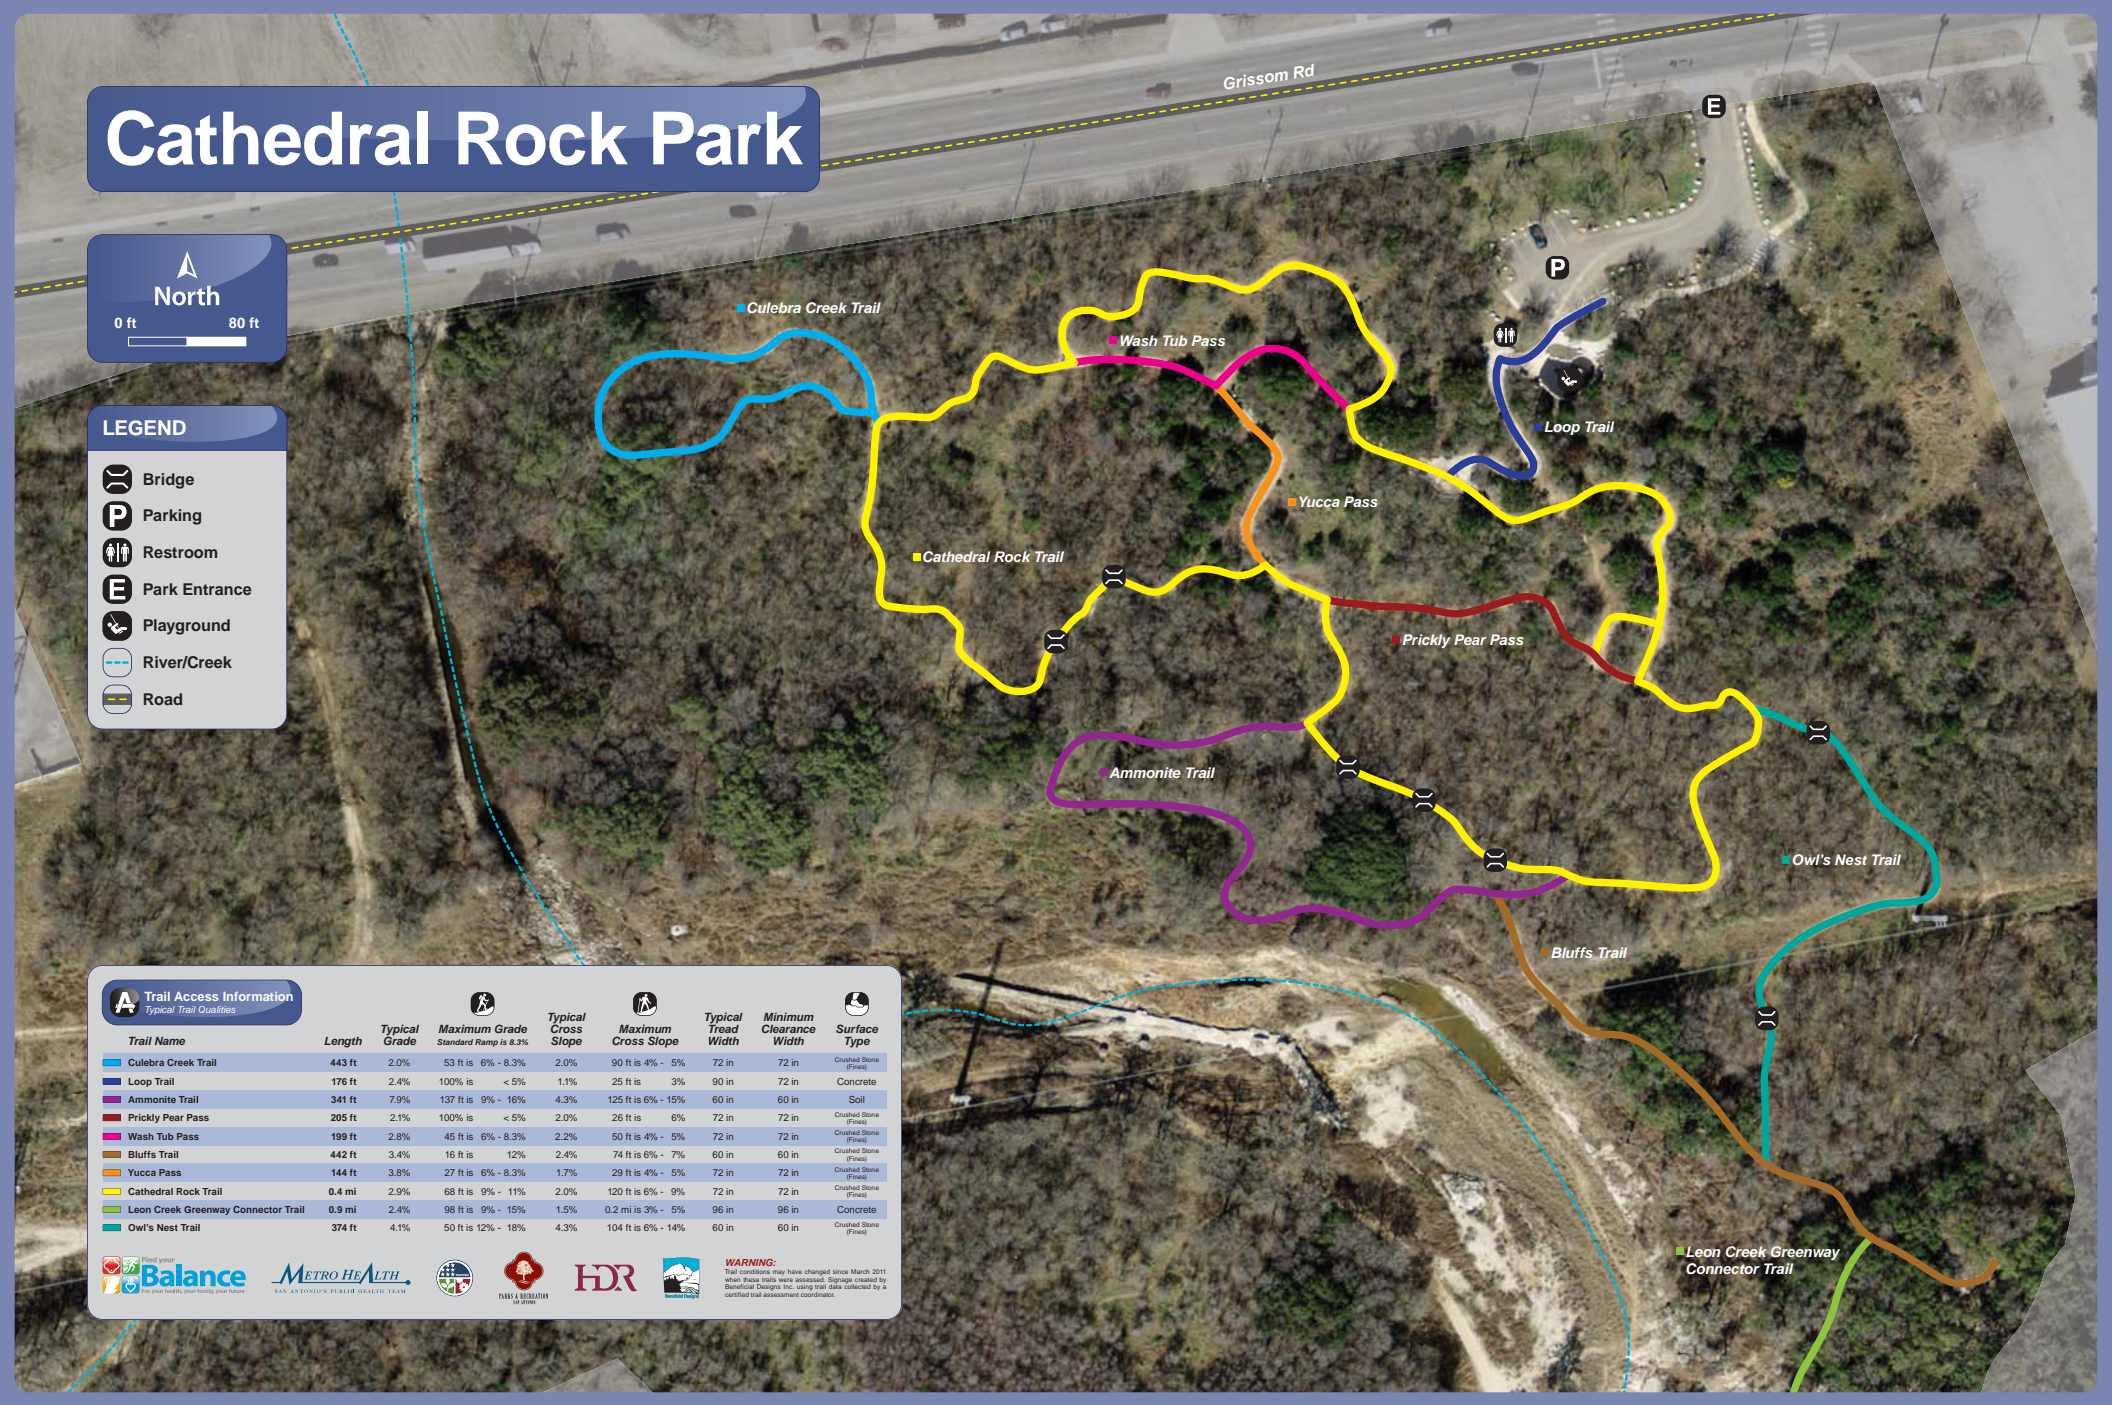
Trail Name	Length	Typical Grade	Maximum Grade Standard Ramp is 8.3%	Typical Cross Slope	Maximum Cross Slope	Typical Tread Width	Minimum Clearance Width	Surface Type
Culebra Creek Trail	443 ft	2.0%	53 ft is 6% - 8.3%	2.0%	90 ft is 4% - 5%	72 in	72 in	Crushed Stone (Fines)
Loop Trail	176 ft	2.4%	100% is < 5%	1.1%	25 ft is 3%	90 in	72 in	Concrete
Ammonite Trail	341 ft	7.9%	137 ft is 9% - 16%	4.3%	125 ft is 6% - 15%	60 in	60 in	Soil
Prickly Pear Pass	205 ft	2.1%	100% is < 5%	2.0%	26 ft is 6%	72 in	72 in	Crushed Stone (Fines)
Wash Tub Pass	199 ft	2.8%	45 ft is 6% - 8.3%	2.2%	50 ft is 4% - 5%	72 in	72 in	Crushed Stone (Fines)
Bluffs Trail	442 ft	3.4%	16 ft is 12%	2.4%	74 ft is 6% - 7%	60 in	60 in	Crushed Stone (Fines)
Yucca Pass	144 ft	3.8%	27 ft is 6% - 8.3%	1.7%	29 ft is 4% - 5%	72 in	72 in	Crushed Stone (Fines)
Cathedral Rock Trail	0.4 mi	2.9%	68 ft is 9% - 11%	2.0%	120 ft is 6% - 9%	72 in	72 in	Crushed Stone (Fines)

Leon Creek Greenway Connector Trail	0.9 mi	2.4%	98 ft is 9% - 15%	1.5%	0.2 mi is 3% - 5%	96 in	96 in	Concrete
Owl's Nest Trail	374 ft	4.1%	50 ft is 12% - 18%	4.3%	104 ft is 6% - 14%	60 in	60 in	Crushed Stone (Fines)
