Document No. 120058

Job No. 100015736

**ARCHEOLOGICAL MONITORING OF THE
CATALPA-PERSHING CHANNEL IMPROVEMENTS
BEXAR COUNTY, TEXAS**

TEXAS ANTIQUITIES PERMIT NO. 5739

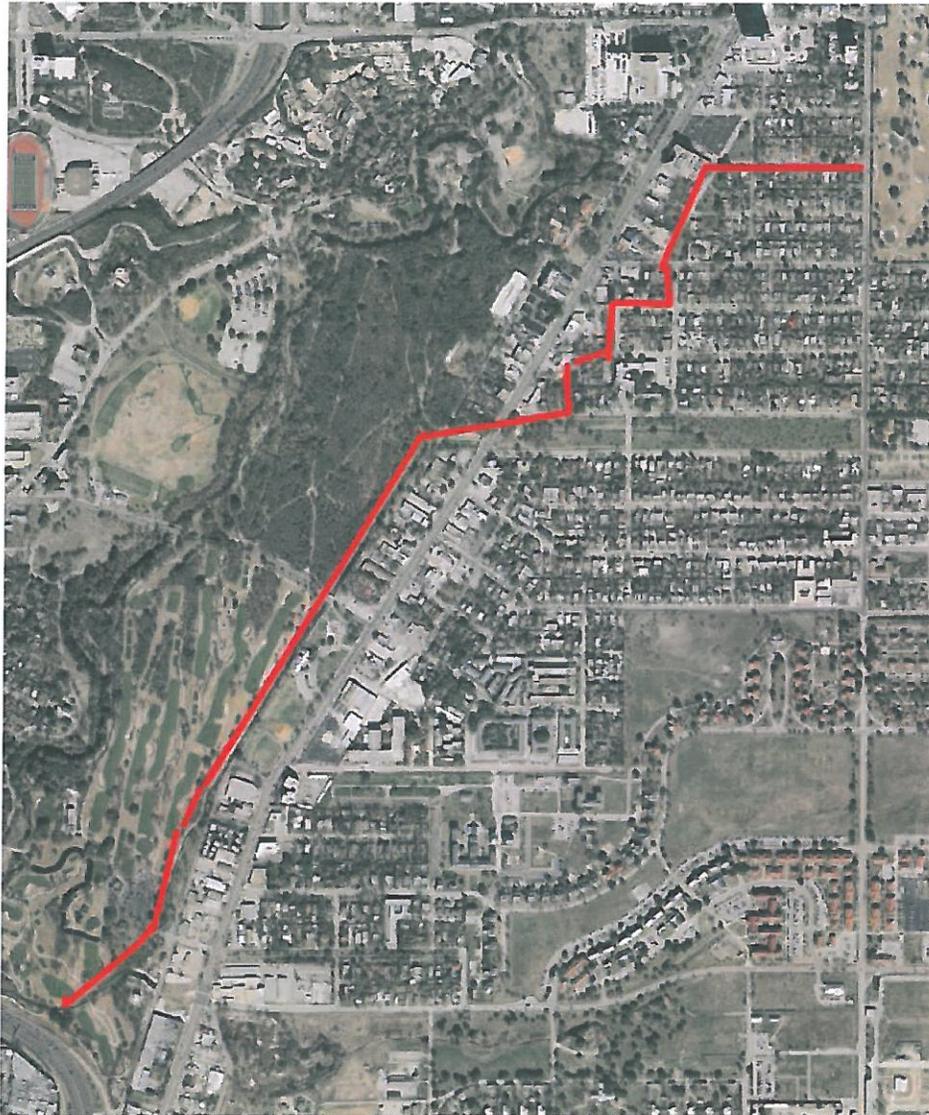
The early drainage system described above was replaced in 1977 by the Catalpa-Pershing drainage project. The purpose of Catalpa-Pershing was to collect storm water runoff from the area northeast of Brackenridge Park including the Mahncke Park neighborhood and Fort Sam Houston. The project combined both underground culverts and open, concrete-lined channels. The system, named for area streets, begins near the intersection of North New Braunfels and Allensworth. It gathers water from throughout the Mahncke Park neighborhood, carries it in culverts under Broadway, and delivers it to the open concrete-lined ditch in Brackenridge Park located just south of Parfun Way. A large headwall marks the upstream limit of the channel. Like its predecessor, the channel runs along Avenue B and continues south past Lions Field, forming the eastern boundary of Brackenridge Golf Course. Storm water continues to flow down the channel until it empties into the San Antonio River near U.S. Highway 281 (US 281). The length of the open channel is approximately 5,300 ft. Figure 10 shows the extent of the project.⁴

1977 Catalpa-Pershing Drainage Project. Source: San Antonio River Authority

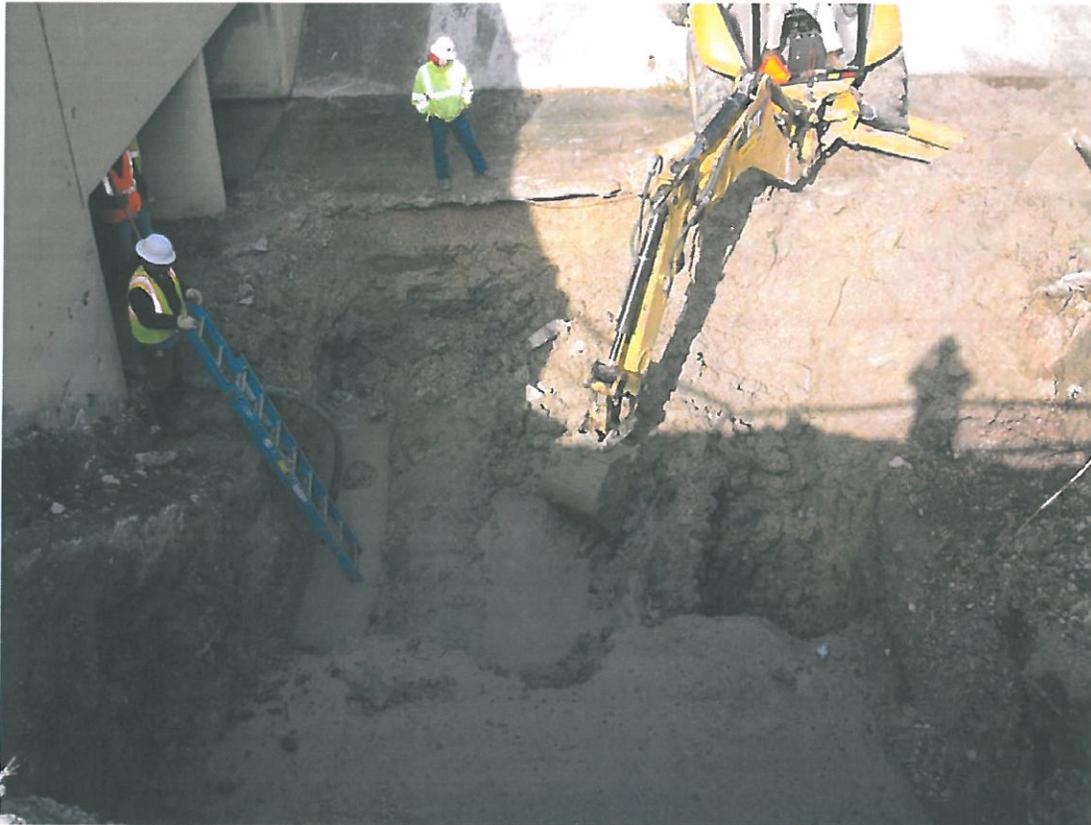
Figure 11
Sewer lines underneath channel

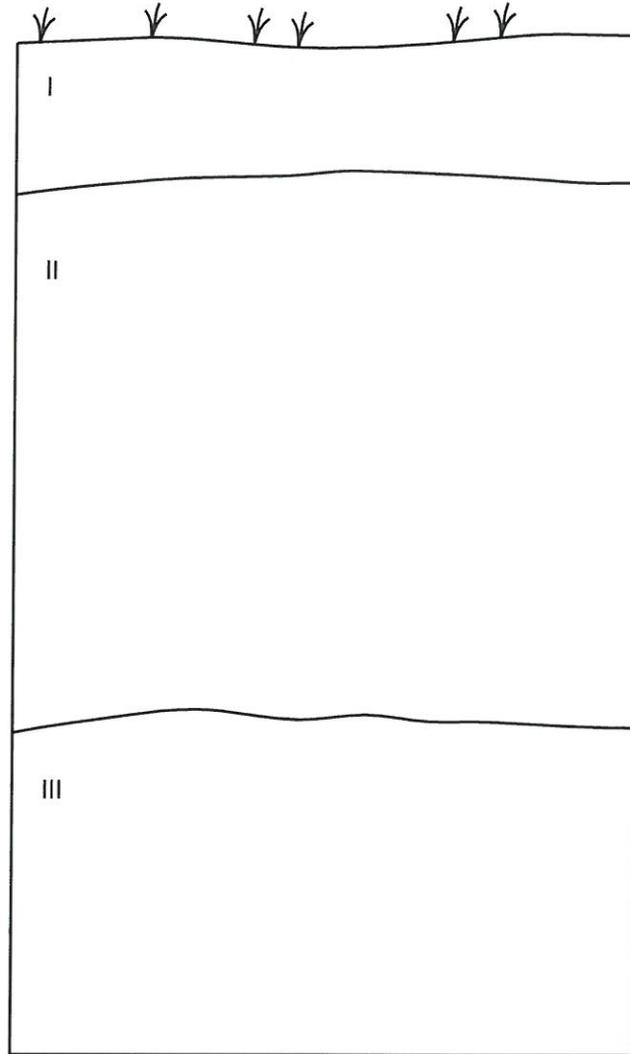
Figure 12

sewer lines on this side of the bridge, and the profile of this area demonstrates it is disturbed to about 90 cm (35 inches) below ground surface (Figure 12). No artifacts or features were observed during this work, even in the possibly intact soils.

- I 0-20 cmbs; medium bedded; mixture of 10YR 3/1 black, 10YR 4/3 brown, 10YR 6/1 gray, and 10YR 6/6 brownish yellow clays with moderate gravel and soft calcium carbonate nodules; very abrupt, smooth boundary (Fill).
- II 20-90 cmbs; thickly bedded; 10YR 2/1 black clay with common medium coarse soft calcium carbonate nodules and few modern glass bottle shards; medium angular blocky structure; very firm, many slickensides; clear smooth boundary (Fill).
- III 90-160+ cmbs; 10YR 4/3 brown clay with many fine medium soft calcium carbonate nodules; coarse angular blocky structure; extremely firm; boundary unknown.

MULBERRY AVENUE BRIDGE SITE
TRENCH PROFILE, WEST WALL

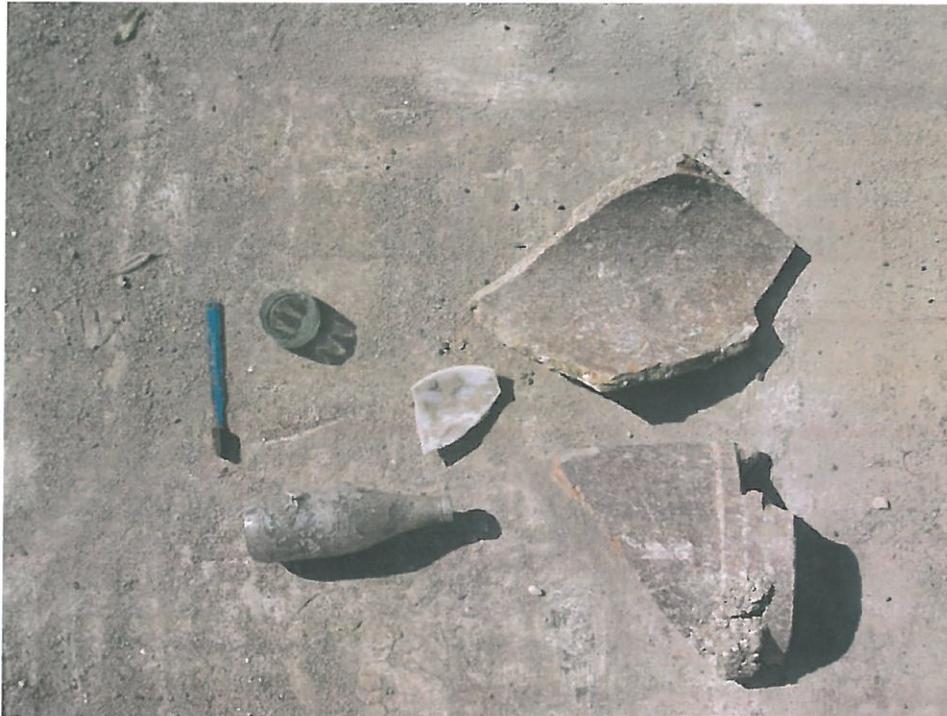
The western side of the bridge did yield a few historic-age materials associated with the sewer pipe modifications; a few clay pipe fragments (possibly an old sewer pipe), an aqua bottle base, and a milk glass fragment were recovered within the disturbed soils. However, this small collection of historic debris also contained a blue plastic toothbrush, further confirming this fill was disturbed and out of context (Figure 13).

Figure 13
Historic artifacts at Mulberry

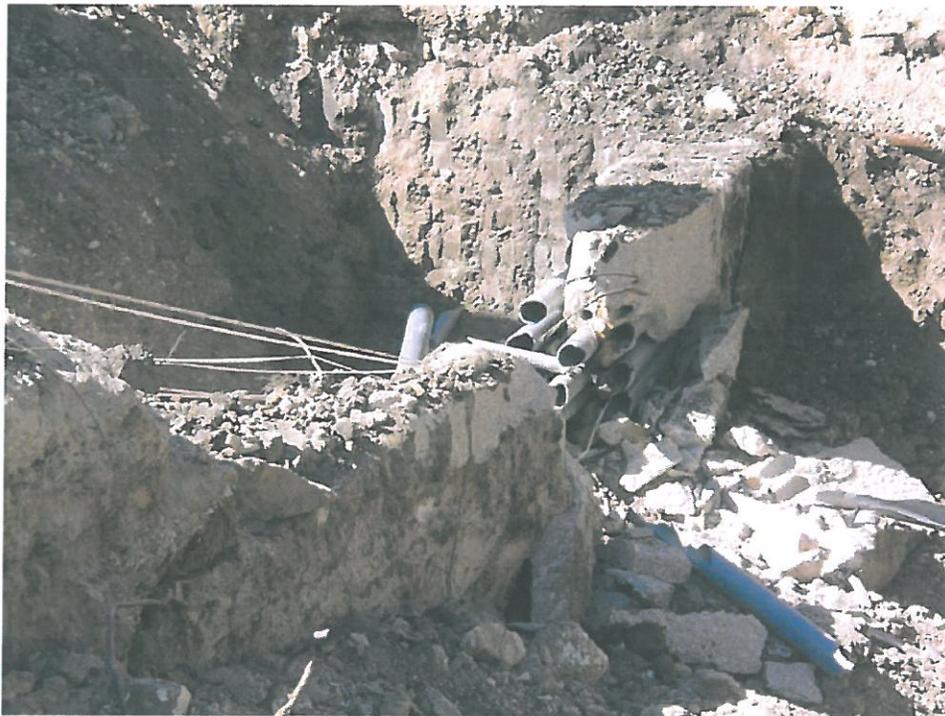
On the southwestern side of the bridge, the same pattern of soil disturbance was evident overall, although there were strips of intact soil located on this side. Utility disturbance was also present on this side, with a fiberoptics bank located near the sewer line (Figure 14). No artifacts or features were observed in this area.

Figure 14
Fiberoptic bank at Mulberry

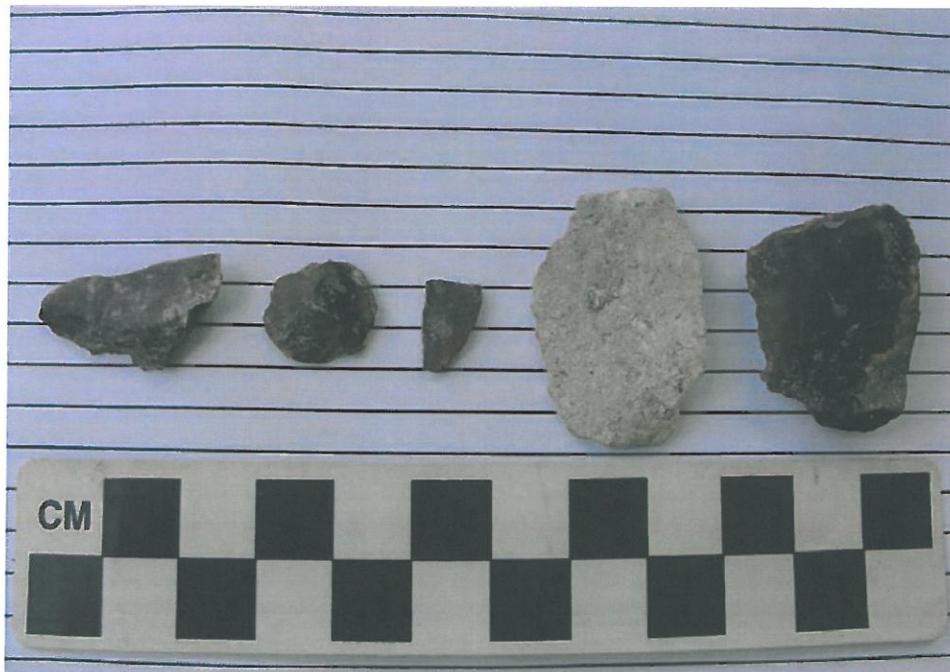
Crews demolished the Mulberry Bridge on February 2, 2011, through March 24, 2011. During this time, archeologists observed several out-of-context chert flakes. On March 8, five flakes were recovered from an area on the western side of the channel where disturbance had been documented previously during the SAWS work (Figure 15). Three additional flakes were found in the backdirt at Mulberry on March 10, 2011. No other cultural material was observed during demolition and temporary bridge construction at Mulberry, and no features were observed.

Figure 15
Flakes from Mulberry

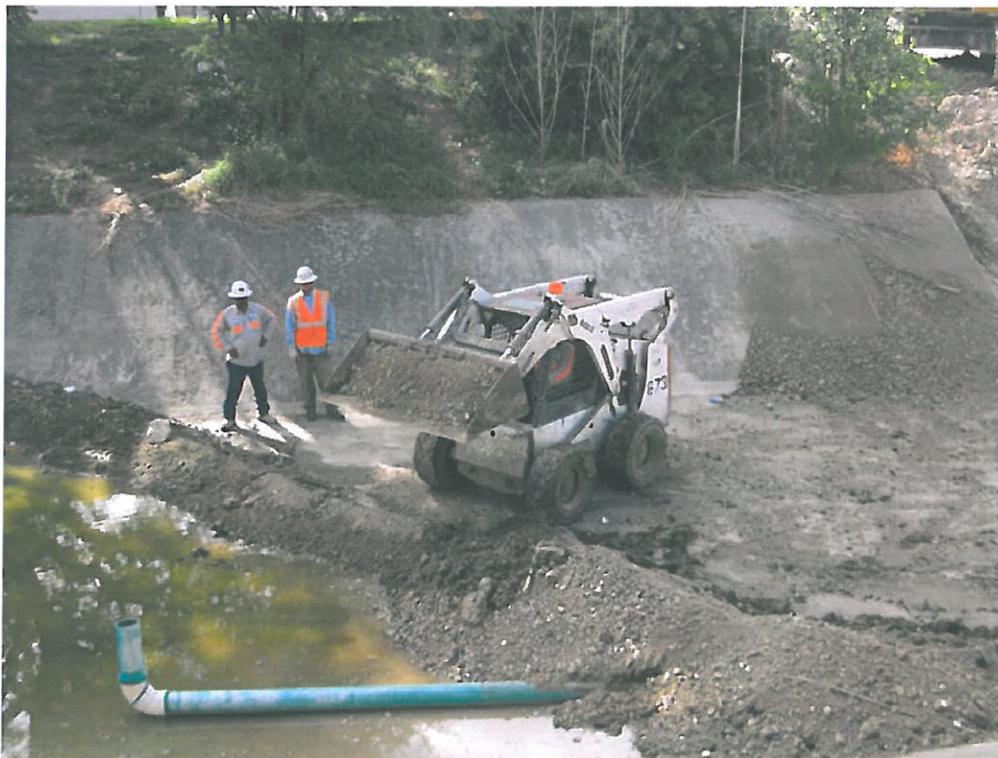
Excavation to work on the sewer line at the Millrace Bridge began on June 24, 2011, and went through June 27, 2011. The sewer line ran under the concrete-lined drainage channel, and workers encountered water immediately after removing the concrete (Figure 16). The water was pumped out so that the pipe could be reached. No artifacts or cultural features were observed, but the soil was inundated, and archeologists could not determine whether it was fill or intact soil.

Figure 16
Channel demolition at Millrace

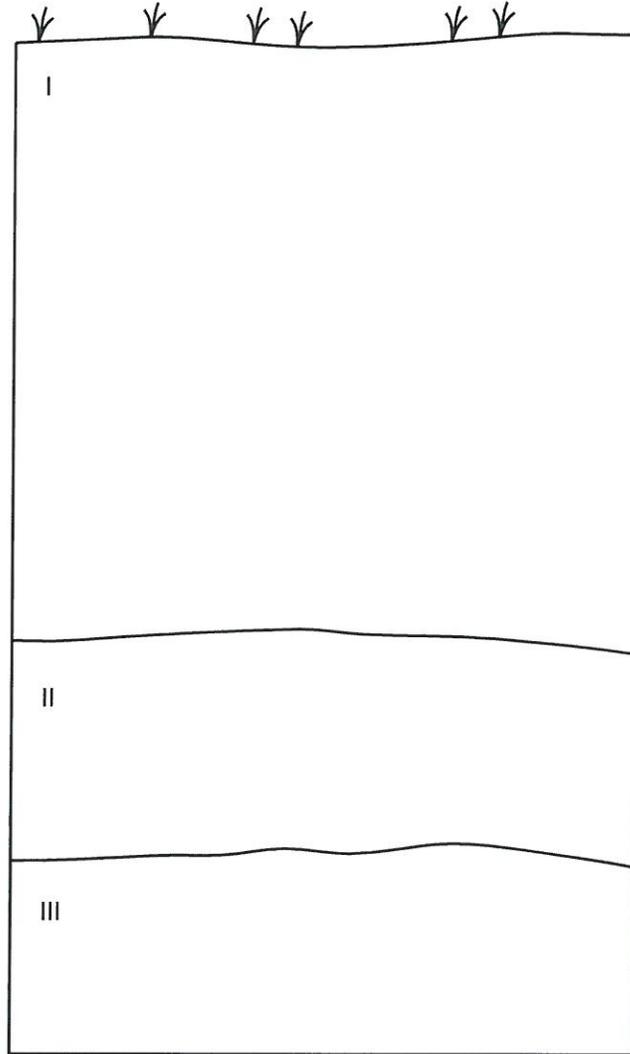
Figure 17

Soils in the second and third support holes mimicked the first (Figure 17). The second support hole contained burned rocks, 3 flakes (1 primary and 2 tertiary), a core, twisted metal, straw, and glass. The third support hole contained paper and clear glass. Two additional support holes excavated the following day showed a similar stratigraphy and contained no artifacts.

- I 0-80 cmbs; thickly bedded; 10YR 4/3 dark brown clay with many medium soft calcium carbonate nodules; very firm; clear smooth boundary.
- II 80-110 cmbs; 10YR 6/6 brownish yellow clay with many medium soft calcium carbonate nodules; very firm; clear smooth boundary
- III 110-140+ cmbs; 7.5YR 5/8 strong brown clay with many gravels; very firm; boundary unknown

MILLRACE BRIDGE SITE
TEMPORARY STRUCTURE
TRENCH PROFILE

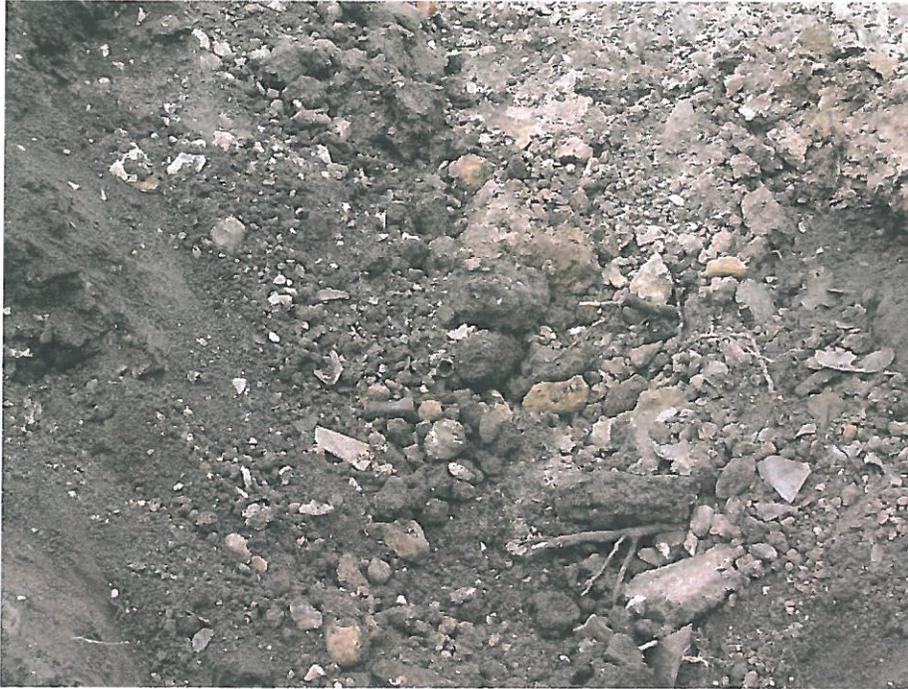
The Millrace Bridge demolition began on March 7, 2011, and lasted through June 20, 2011. While working on the southwestern side of the Millrace Bridge, archeologists observed a 5-x-5-m (18-x-18-ft) area that contained historic artifacts (Figure 18) including coke bottles, asbestos tiles, animal bone, whiteware, champagne bottles, half pint and 7-Up bottles, unmarked bricks, nails, and glass shards (colorless, green, aqua, yellow). Additional deposits included a horseshoe, two chert flakes, and D'Hanis brick fragments; soils were disturbed, and trash deposits extended approximately 1 m (3 ft) below ground surface. Atkins notified the COSA archeologist of these items, photographed the items (figures 19 and 20), and after coordination with the COSA archeologist, continued monitoring efforts.

Figure 18
Historic-age trash area

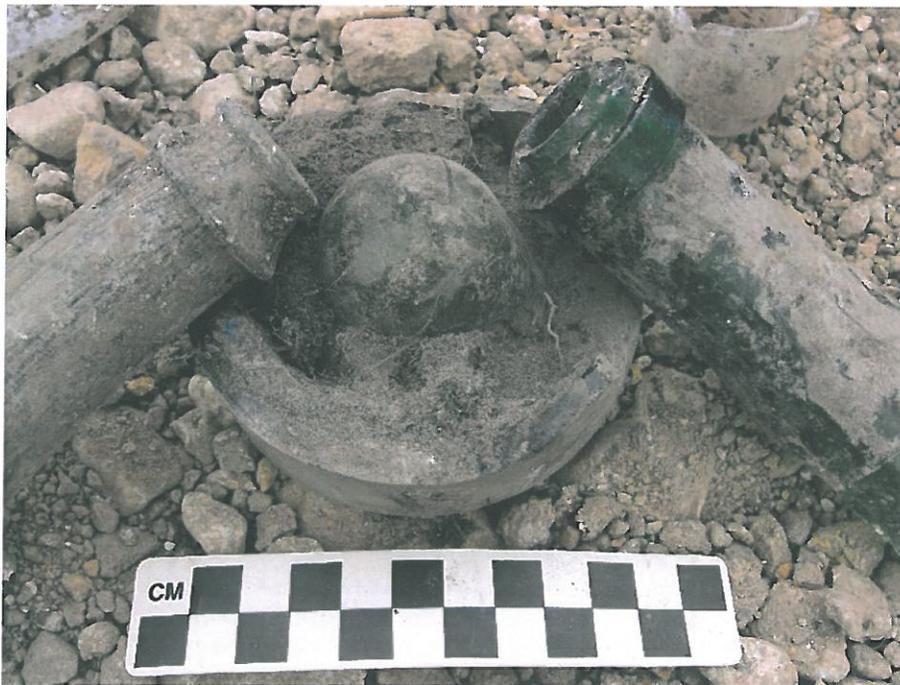
Figure 19
Champagne bottle fragments

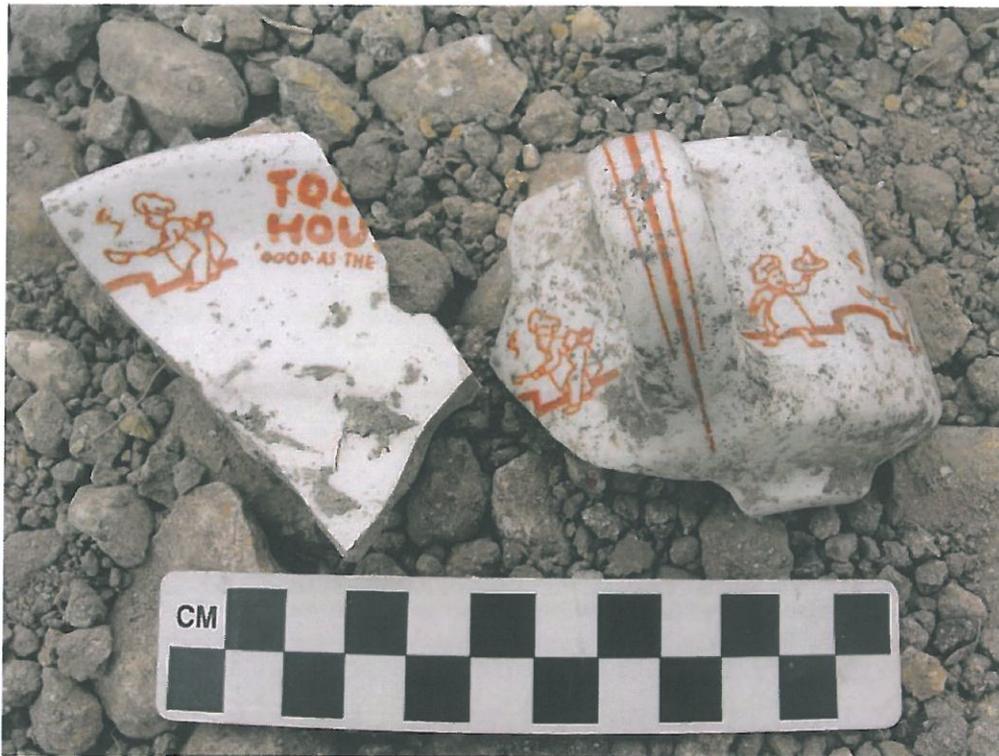
Figure 20
Ceramics from trash area

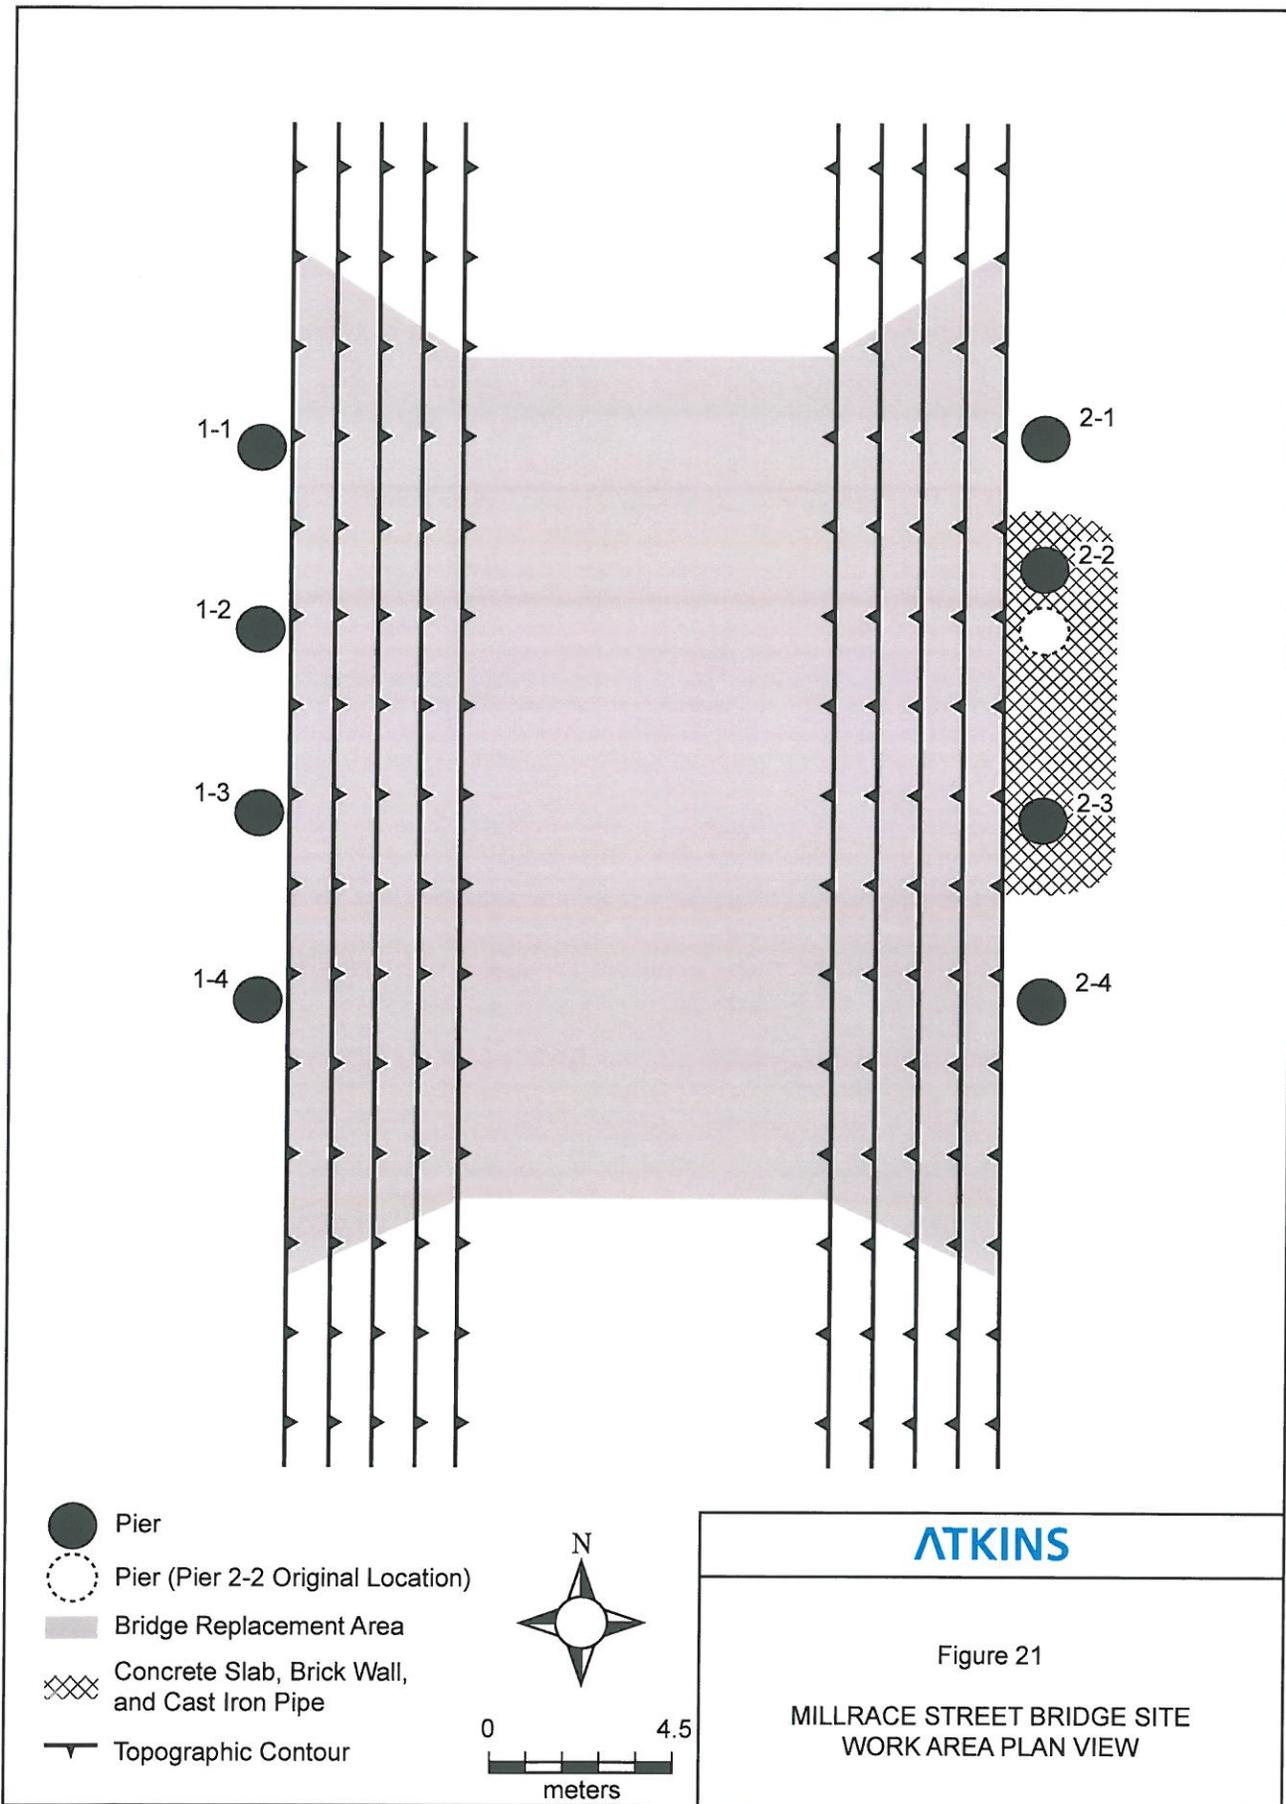
Eight bore holes measuring 1.2 m (4 ft) wide and 13 m (42 ft 6 inches) deep were placed in the Millrace crossing area in order to anchor the new bridge (Figure 21). These borings were completed from July 6, 2011, through July 19, 2011. Table 2 shows the materials that were observed in these holes.

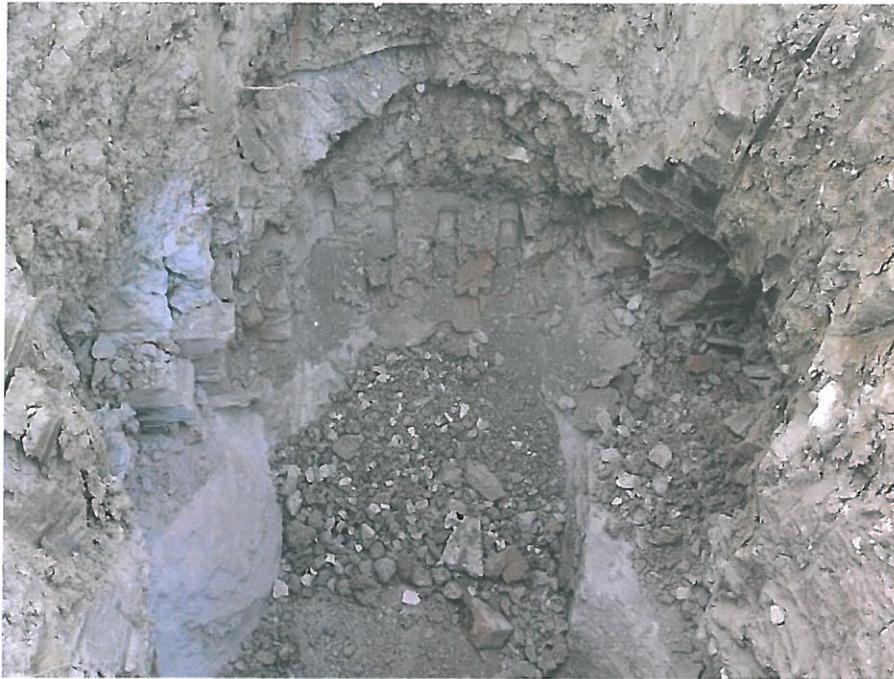
As Table 2 shows, layers of D'Hanis bricks, which date from 1905 to the present (Unknown n.d.), and rebar-reinforced concrete were present on the northeastern side of the existing bridge. Photographs and profiles of pier 2-2 (figures 22, 23, and 24) show this configuration.

Figure 22
Pier 2-2 Brick and concrete profile

The presence of the articulated brick layer underneath the concrete slab on the eastern side of the bridge, in addition to the articulated bricks observed at the northeastern corner of the bridge during demolition, suggests they may have been part of an earlier crossing structure. Although they were not articulated elsewhere, D'Hanis bricks were also noted at the southwestern corner of the bridge and at the center of the bridge, further suggesting there may have been an earlier structure at this location. A cast-iron pipe observed near the bottom of pier 2-2 further suggests an early-twentieth-century construction date; SAWS employees indicated this type of pipe was typically installed in the area between 1900 and 1915. Archival evidence confirms there was a pedestrian crossing structure at this location in the 1920s and likely a vehicular crossing structure present after 1940.

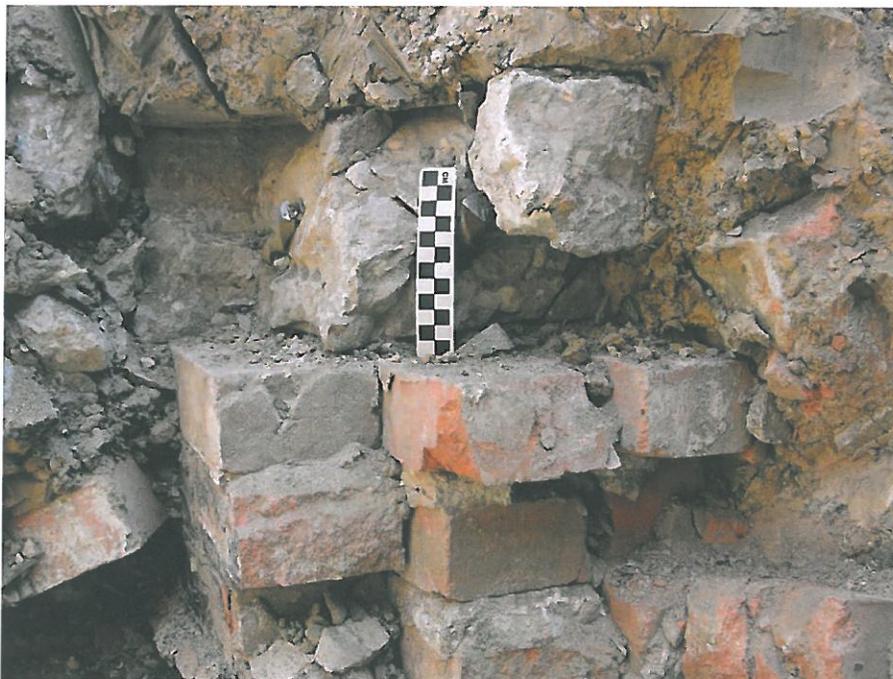
Figure 23
Detail view of brick in Pier 2-2

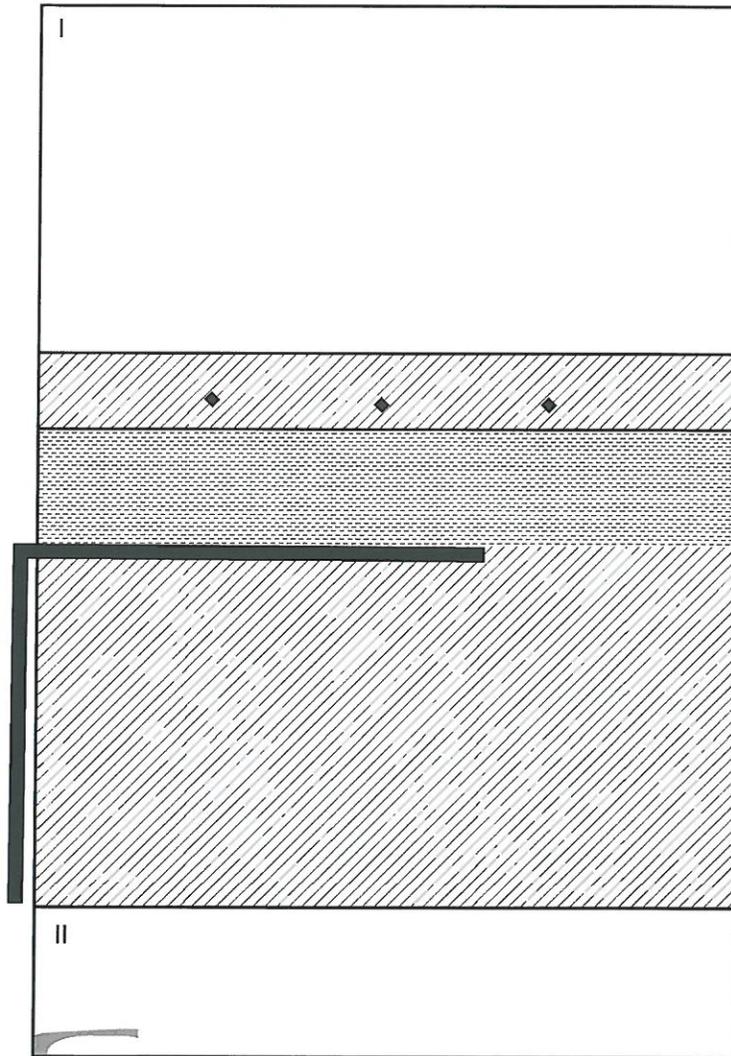
- I 0-90 cmbs; Black (10YR 2/1) clay; moderate coarse angular blocky structure; very firm; few fine roots; few fine pores; abrupt smooth boundary; Soil fill includes historic debris.
- II 130-170+ cmbs; Black (10YR 2/1) clay; moderate coarse angular blocky structure; very firm; few fine roots; few fine pores; common fine pressure faces; few calcium carbonate concretions; boundary unknown.

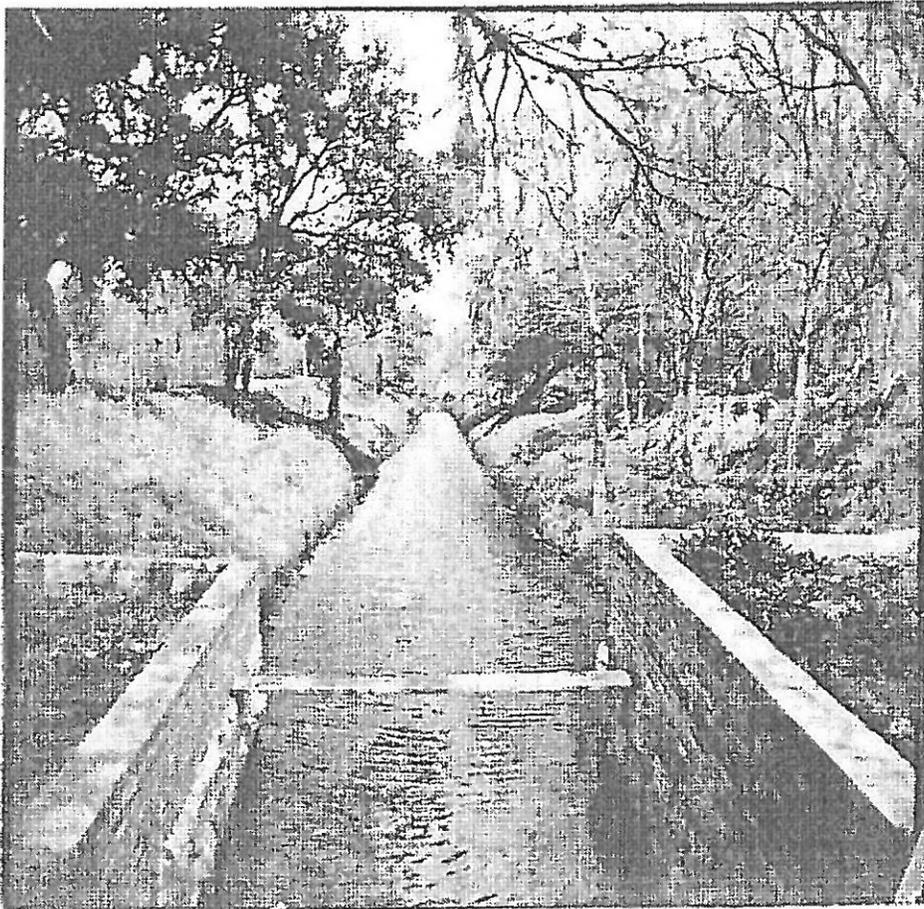
Figure 25

Water was channeled to the 1885 pump house through the open earthen channel shown in Figure 25. The channel began at the river in the northern part of Brackenridge Park near Tuleta Drive and ran in a straight course to the lower pump house. Though speculative due to the lack of late-nineteenth-century maps of the area, it is assumed that a small bridge or bridges would have been constructed across the channel near the pump house to provide access. It should also be noted that at this time, the river ran on the east side of the pump house (Figure 26), also necessitating a bridge. A bridge over the river at this location might have predated 1885.

Catalpa-Pershing Channel near the pump house.
