NON-ARCHEOLOGICAL HISTORIC-AGE RESOURCE
RECONNAISSANCE SURVEY REPORT
ROLAND AVENUE
BEXAR COUNTY, TEXAS

MAY 2010

HISTORIC RESOURCES RECONNAISSANCE SURVEY
ROLAND AVENUE AT SALADO CREEK
BEXAR COUNTY, TEXAS

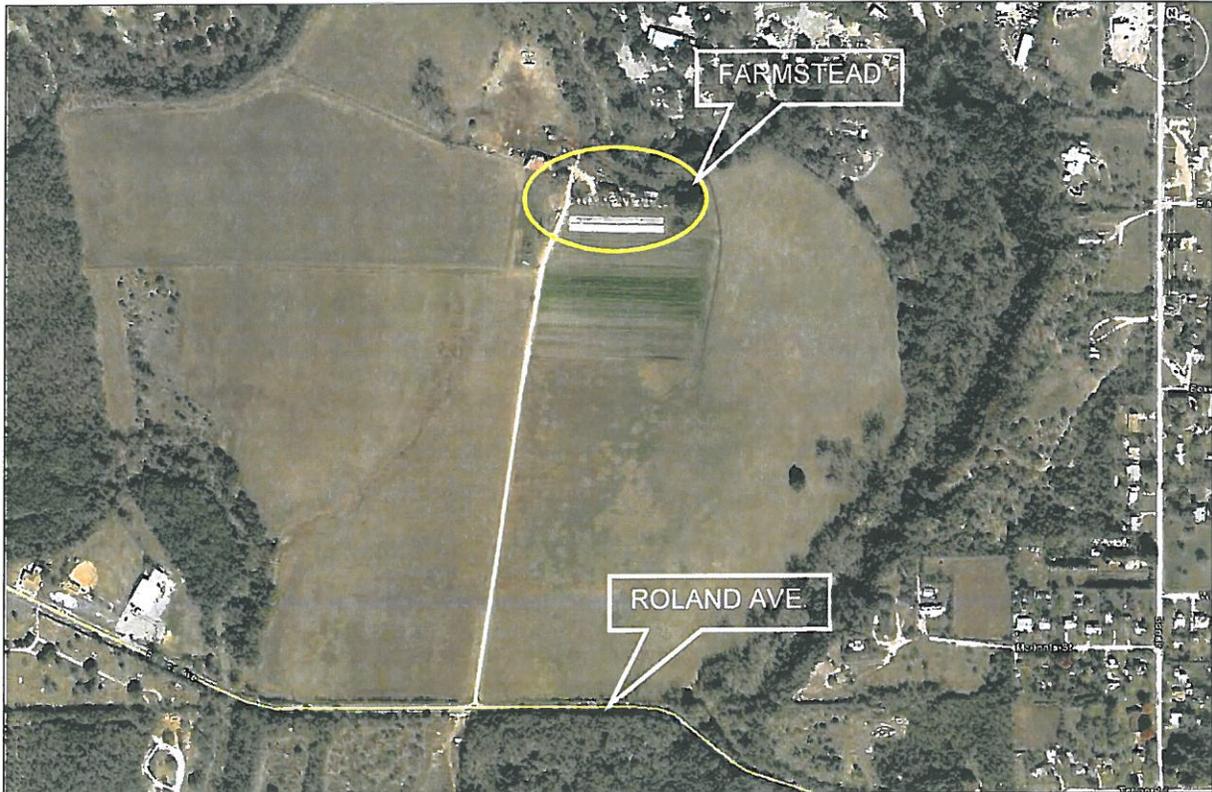
Figure 3. Granieri Farms. (Source: Google Earth)

Survey efforts identified one farmstead in the project APE, Map I.D. 3. Known as Granieri Farms, it is a complex consisting of a Ranch style main house (Map I.D. 3F), two secondary houses of indeterminate styling (Map I.D. 3D, 3E), a large gabled barn (Map I.D. 3A), corrals, and several smaller outbuildings that sits approximately 2,000 feet north of the Roland Avenue ROW (see **Figure 3** and photos 14-24, **Appendix C**).

The fields surrounding the farmstead are actively cultivated. According to information provided by the City of San Antonio Historic Preservation Office, Granieri Farms has existed in some form since 1925 with the family immigrating to the United States from Italy in the early twentieth century. Once supporting dairy cows, the farm now grows vegetable and other truck farming crops. Conversations with the owners via telephone confirmed the main house and the barn were of historic age, but the owners denied rights of entry to the property for historians to photograph the buildings or make any kind of analysis of their condition and appearance. Due to the distance from the roadway and lack of rights-of-entry, project historians were unable to get a close-up view of the farmstead or its component buildings. Available aerial photography and photographs taken from public right-of-way suggest the

buildings are relatively simple in architectural styling and detailing, with alterations including rear additions and possible replacement windows.

The Granieri Farm (Map I.D. #3) was unable to be fully evaluated due to rights-of-entry issues. Assuming for the purposes of determining effects under Section 106 that the property is eligible with all seven Aspects of Integrity intact, no buildings would be impacted by the proposed project and the required right-of-way from the farm's fields would be minimal. The proposed action would not sufficiently impact any of the Aspects of Integrity, and the property would still retain its ability to convey its significance. As such, project historians recommend that if the Granieri Farm were eligible, the proposed action would have **no adverse effect** on the property.

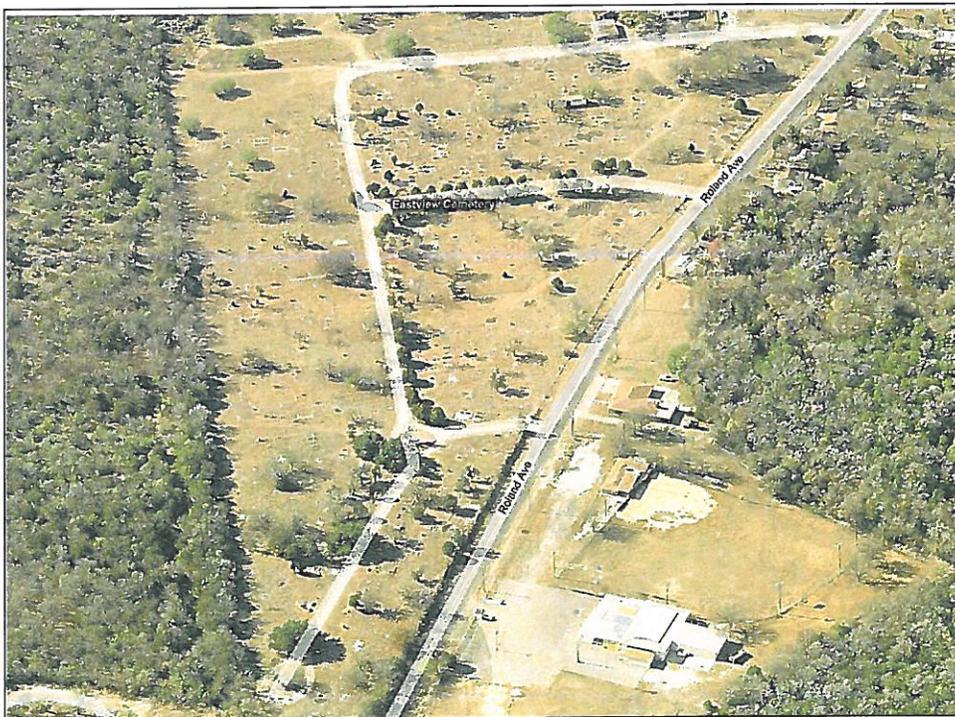
Photo 1: Aerial view of Eastview Cemetery facing west.

Map I.D. #: 1
Site Location: 3530 Roland Ave
UTM Coordinates: 14 555613, 3251562
Function/use: FUNERARY/ cemetery
Date: c. 1890/ 1923
Style/form: No Style/ NA
NRHP eligibility: Not eligible
Comments: Eastview Cemetery, historically African-American and still in active use. Contains a mix of modern and historic graves and headstones.

Although Eastview Cemetery has associations with the local African-American community under Criterion A, and nominal association with important historic persons under Criterion B, in order to be considered eligible for listing in the NRHP it must meet the requirements of Criterion Consideration D, as noted above. The cemetery is not of any great age, especially compared to the age of San Antonio itself, nor is it associated with specific important historic events. It is not noteworthy for its design, and its information potential appears to be no greater than any other cemetery. It does contain graves of known local persons, but Criteria Consideration D requires such graves to be of persons of transcendent importance. While both Rev. Sutton and Bellinger made their marks on San Antonio history, they did not rise to the level of significance required under the Criteria Consideration. As such, Eastview Cemetery does not meet the requirements of Criteria Consideration D and is therefore recommended **not eligible** for listing in the NRHP.

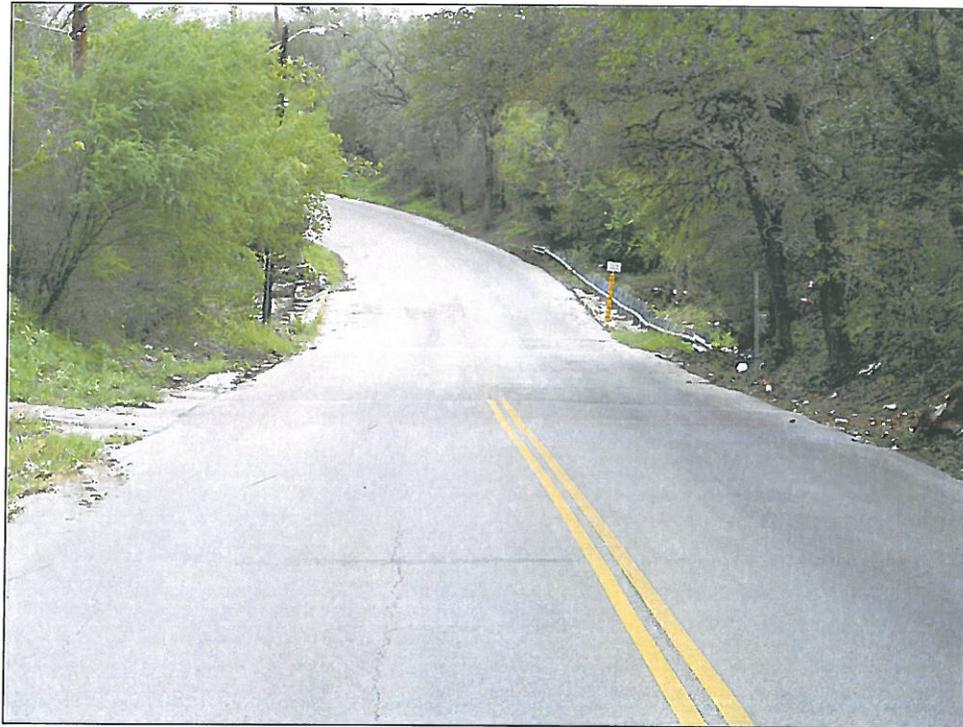
Photo 10: Culvert approach facing southeast.

Map I.D. #: 2
Site Location: Salado Creek branch west at Roland Avenue
UTM Coordinates: 14 555961, 3251403
Function/use: TRANSPORTATION/ culvert
Date: c. 1950
Style/form: No Style/ linear
NRHP eligibility: Not eligible
Comments: No NBI data available for site.

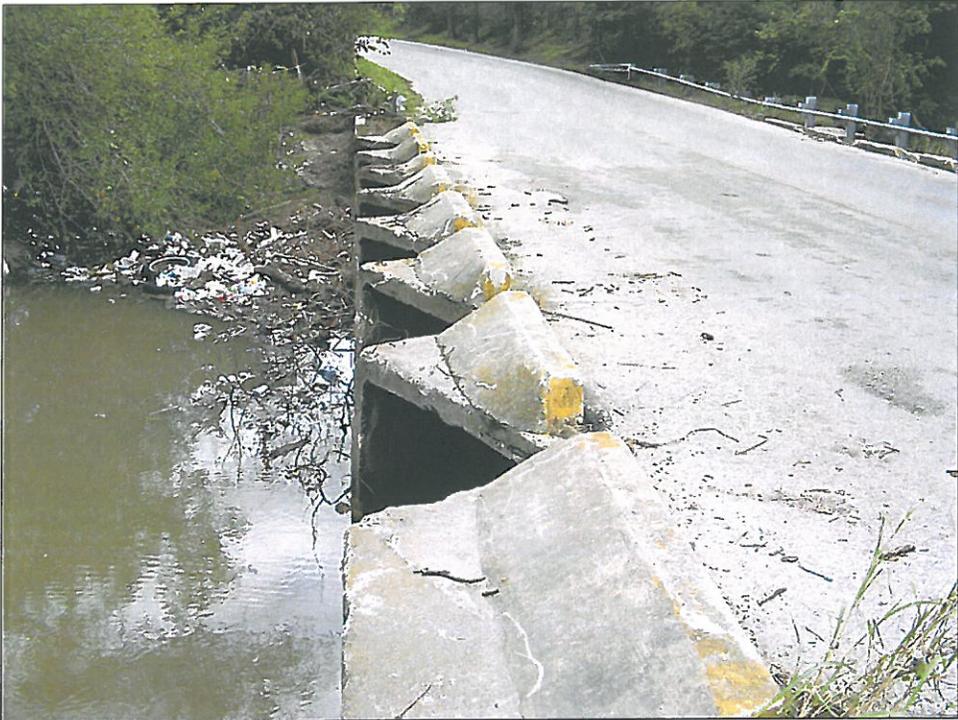
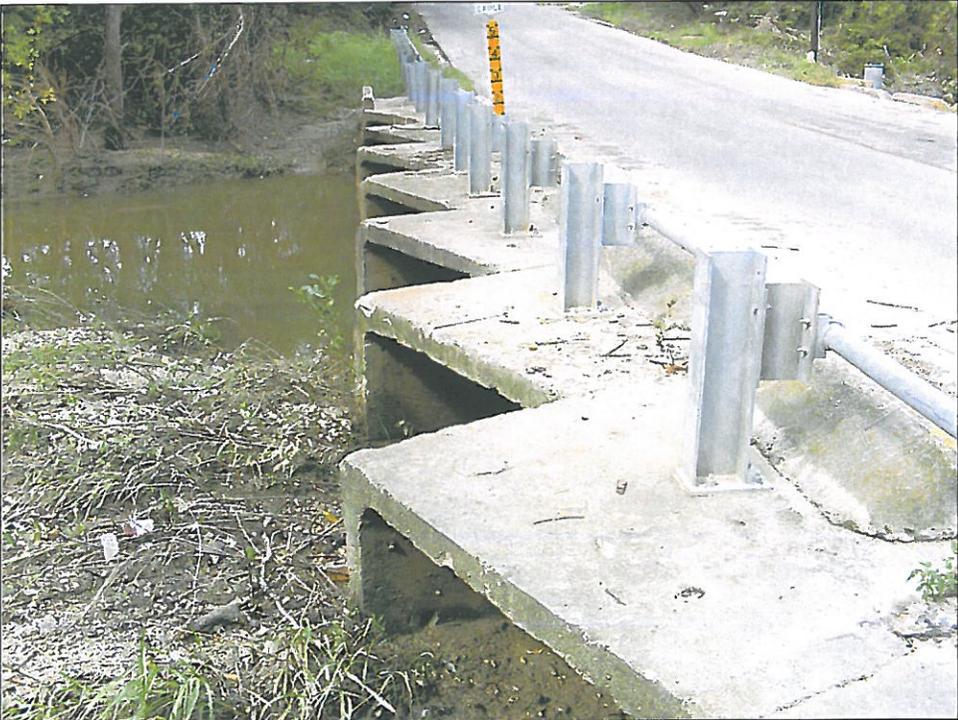
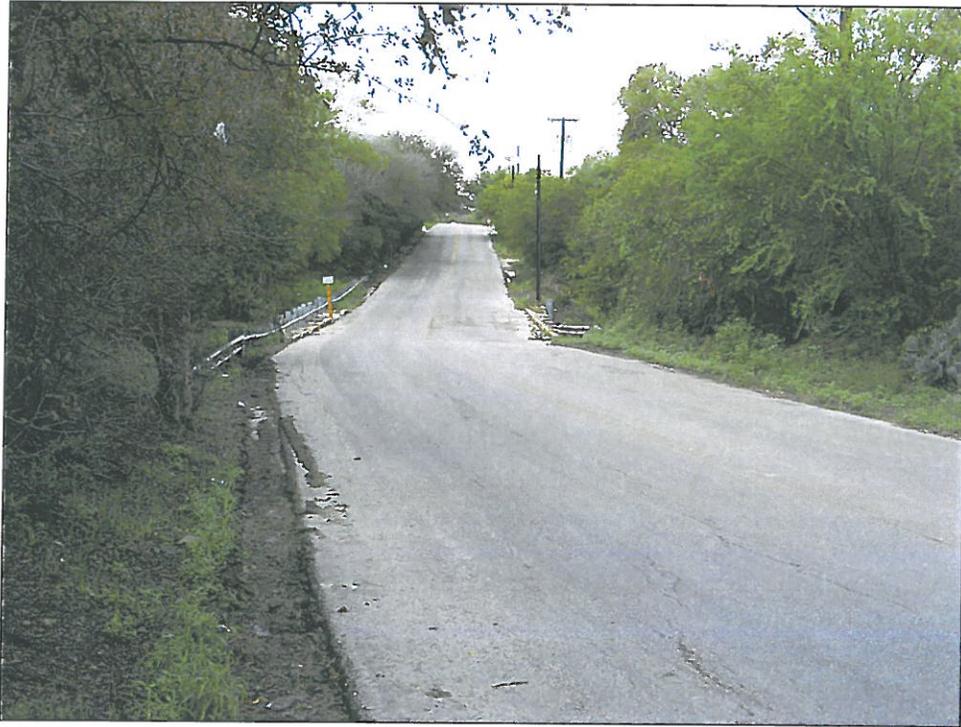
Photo 11: View facing southeast.

Photo 12: View facing northwest.

Photo 13: Culvert approach facing northwest.

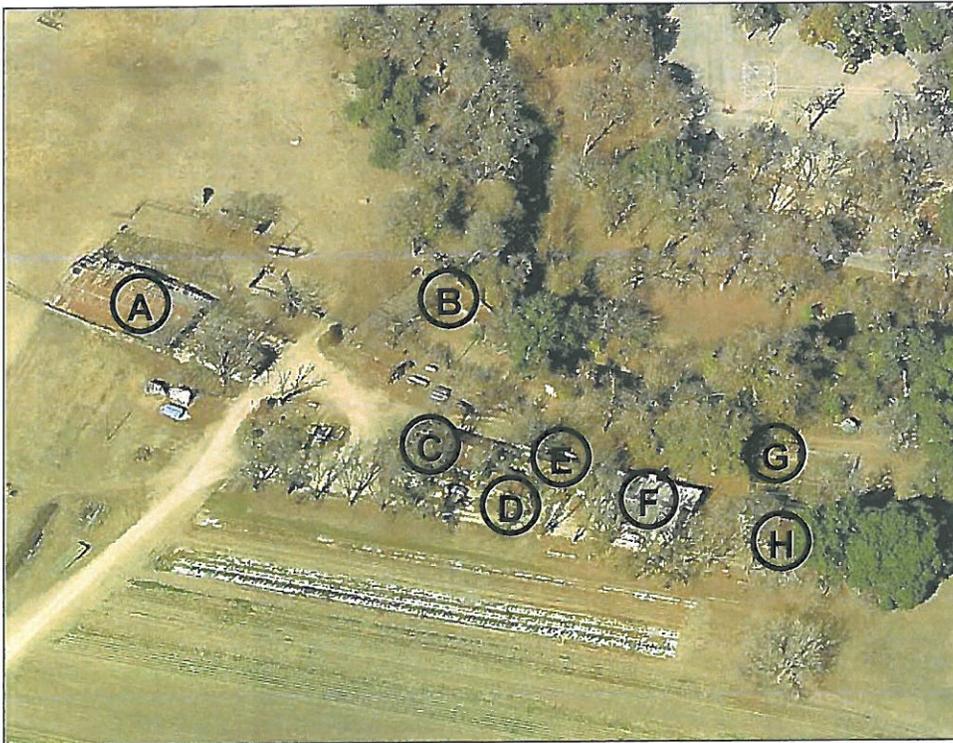
Photo 14: Aerial view facing north.

Map I.D. #: 3
Site Location: 3851 Roland Avenue
UTM Coordinates: 14 556263, 3251389
Function/use: AGRICULTURE/ farmstead
Date: c. 1925/1945
Style/form: No Style/ Various
NRHP eligibility: Not eligible
Comments: Known as "Granieri Farms". Visibility limited from public right-of-way. Rights of entry denied by owners.

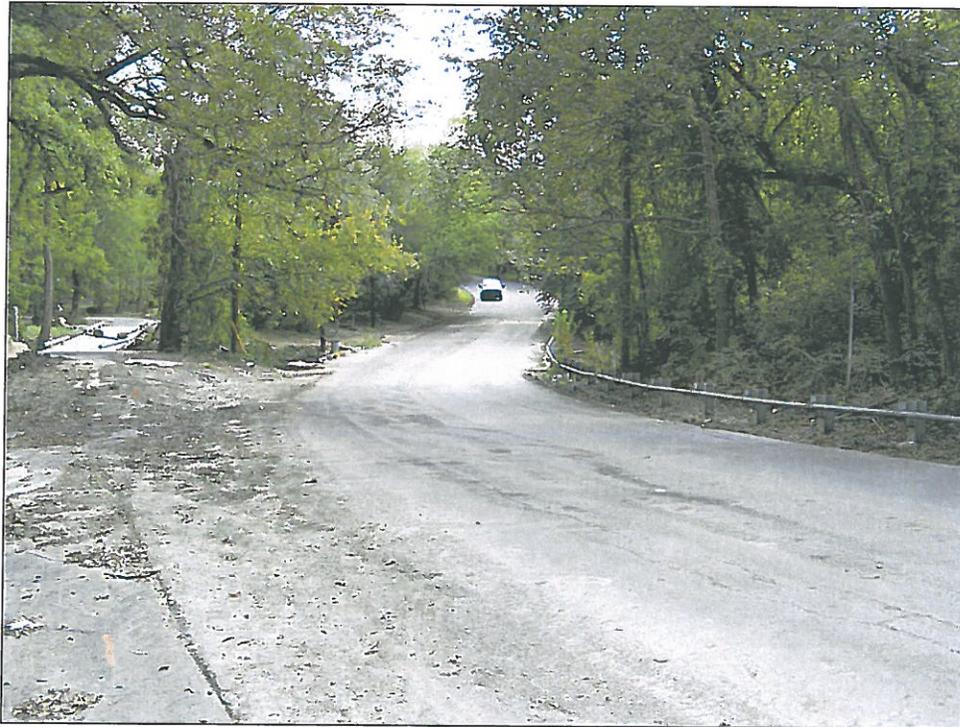
Photo 25: Culvert approach facing southeast.

Map I.D. #: 4
Site Location: Salado Creek branch east at Roland Avenue
UTM Coordinates: 14 556527, 3251354
Function/use: TRANSPORTATION/ culvert
Date: c. 1950
Style/form: No Style/ linear
NRHP eligibility: Not eligible
Comments: No NBI data available.

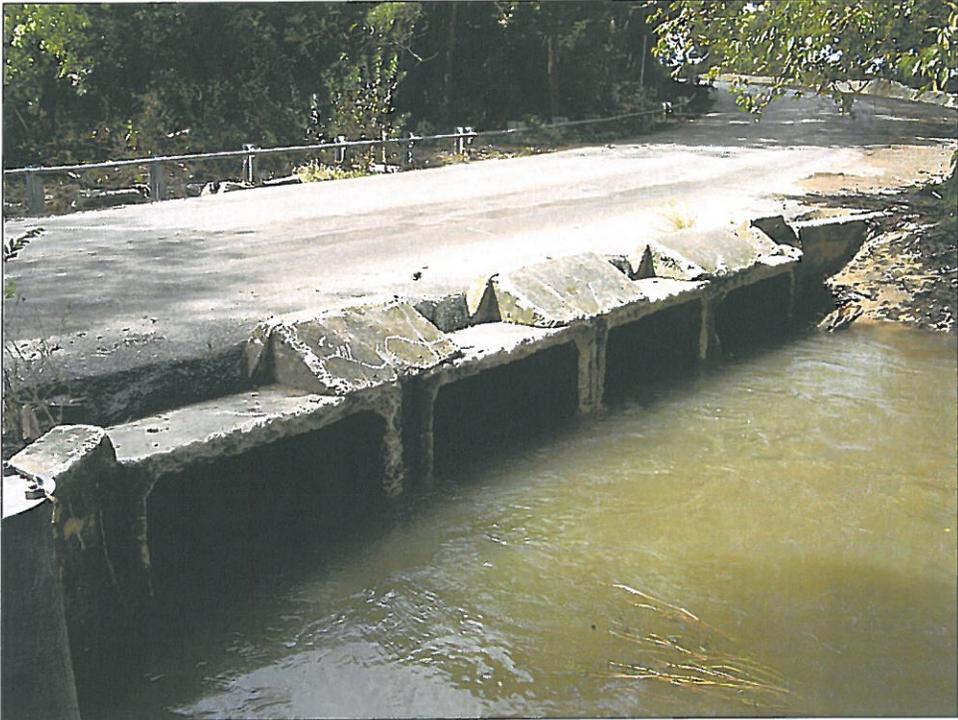
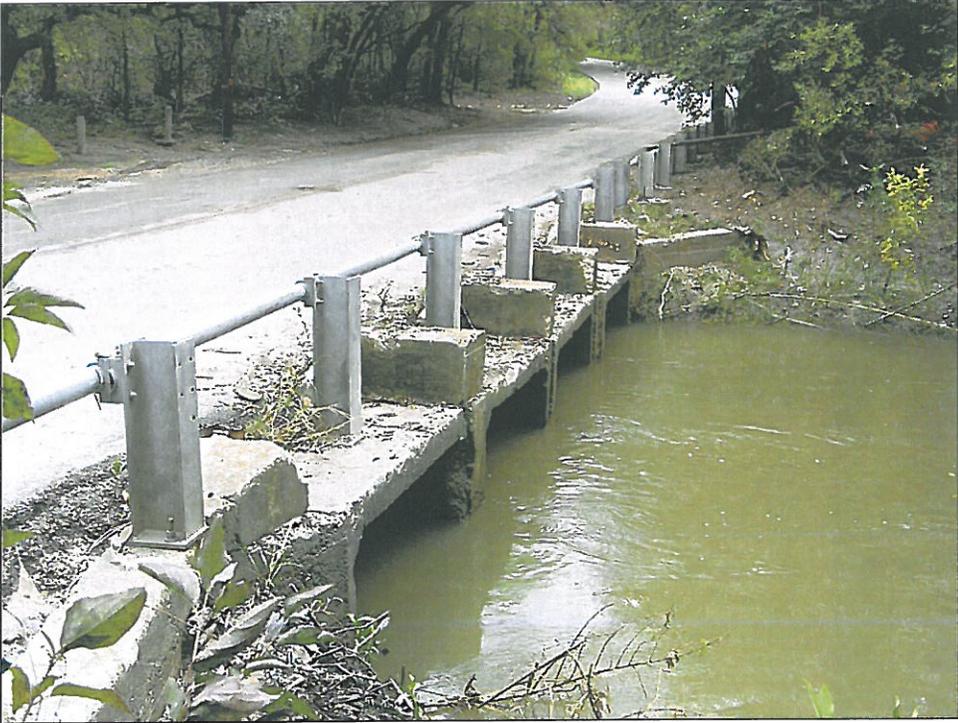
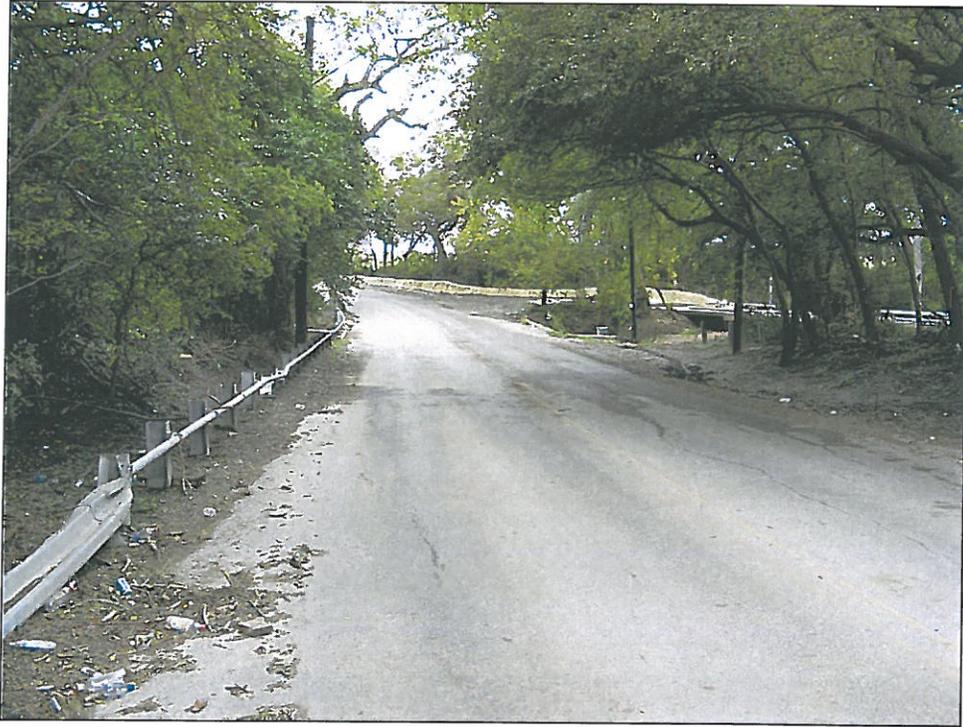
Photo 26: View facing northwest.

Photo 27: View facing southeast.

Photo 28: Culvert approach facing northwest.

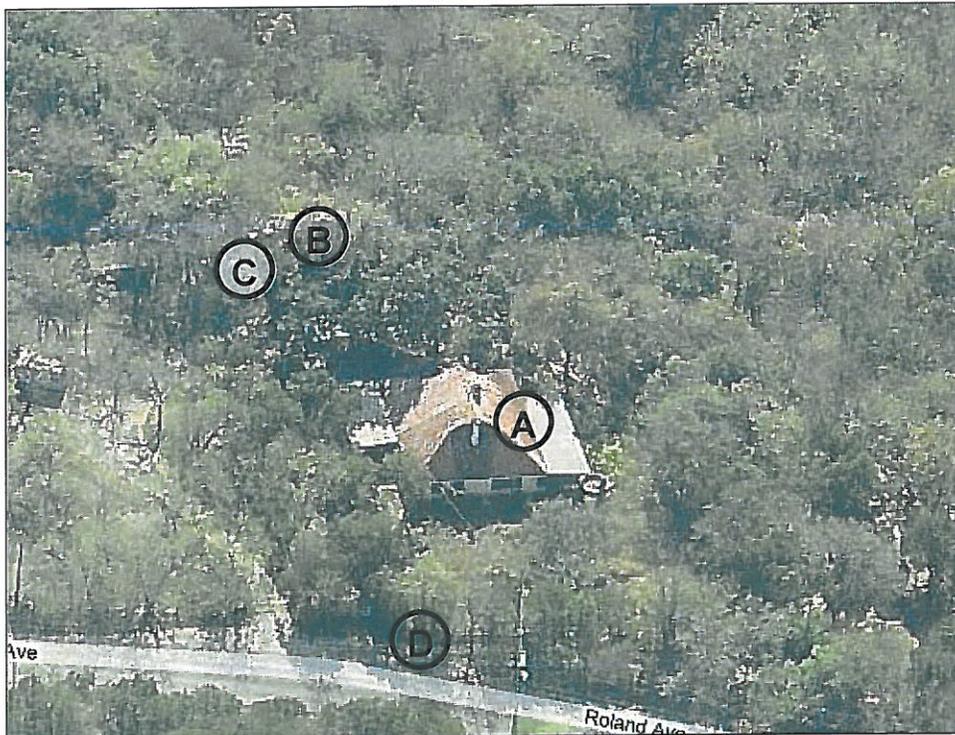
Photo 29: Aerial view facing south.

Two individual cottages or buildings with mixed architectural styling were identified in the project APE, both at Map I.D. 5. Map I.D. 5A is a large, one-and-one-half-story dwelling built in 1903¹⁹ of cast-in-place concrete with stucco siding, a mix of four-over-four-light wood-sash and modern aluminum frame windows, and replacement standing seam metal on a hipped gable roof. Two large additions (essentially sunrooms or enclosed patios) are on the east and west sides of the building, respectively (photos 33 and 34). The west addition hides prominent arches on the old exterior west wall of the house (photo 35). Part of the east side of the original building (the main body of the house) appears to have once been a separate detached building (likely a kitchen), but is now connected to the

Map I.D. #: 5
Site Location: No address
UTM Coordinates: 14 556778, 3251232
Function/use: DOMESTIC/ vacant
Date: 1903/ c. 1925
Style/form: Mixed/ Irregular hipped roof
NRHP eligibility: Eligible, C
Comments: Multiple side and rear additions, some replacement windows, replacement roof. Property eligible under Criterion C in the area of Architecture for its rare method of construction.

Consequently, this property is recommended as eligible for NRHP listing under Criterion C at the local level of significance for Architecture for method of construction. Although the property has undergone numerous changes, sufficient integrity of location, design, setting, materials, workmanship, feeling, and association remain to convey significance. The contributing resources include the main dwelling, the secondary dwelling, and the stone gateposts. The NRHP boundary coincides with the existing fence defining the yard surrounding the primary and secondary dwelling.

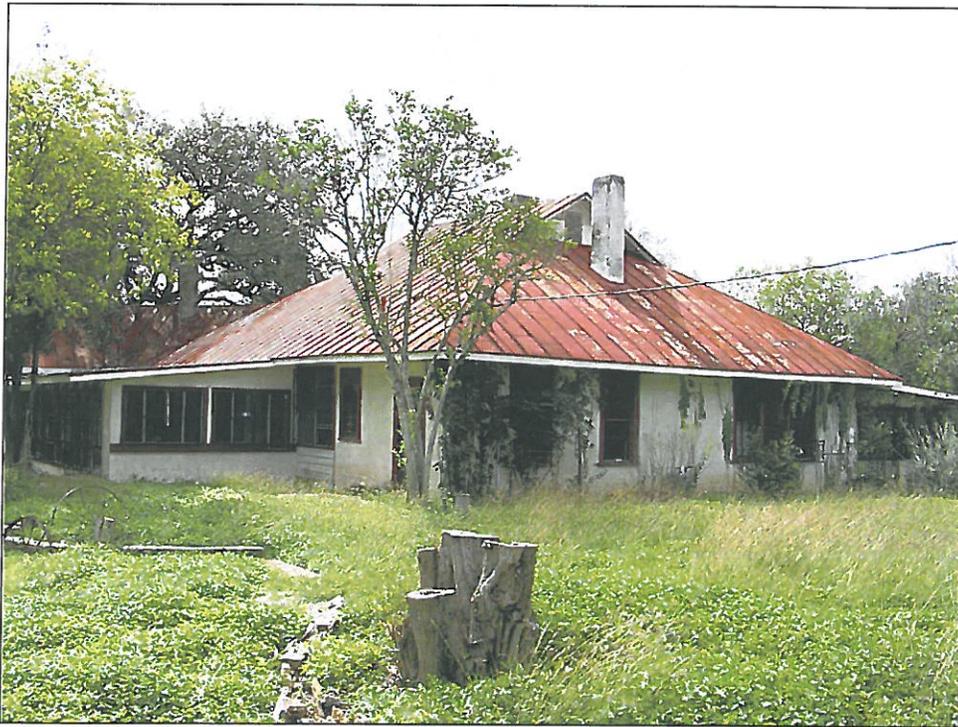
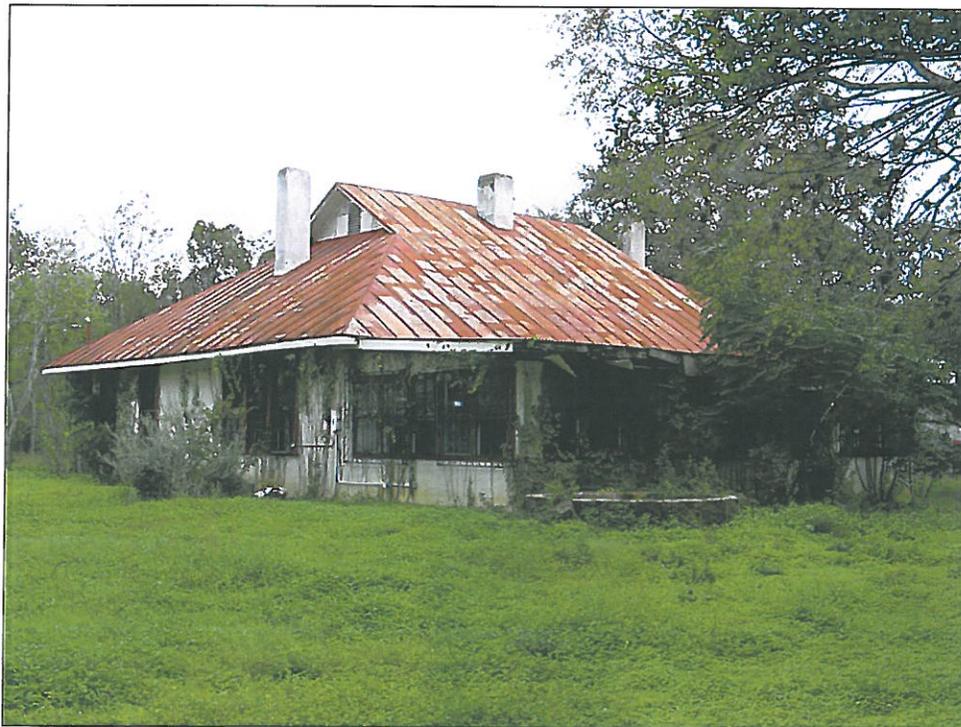
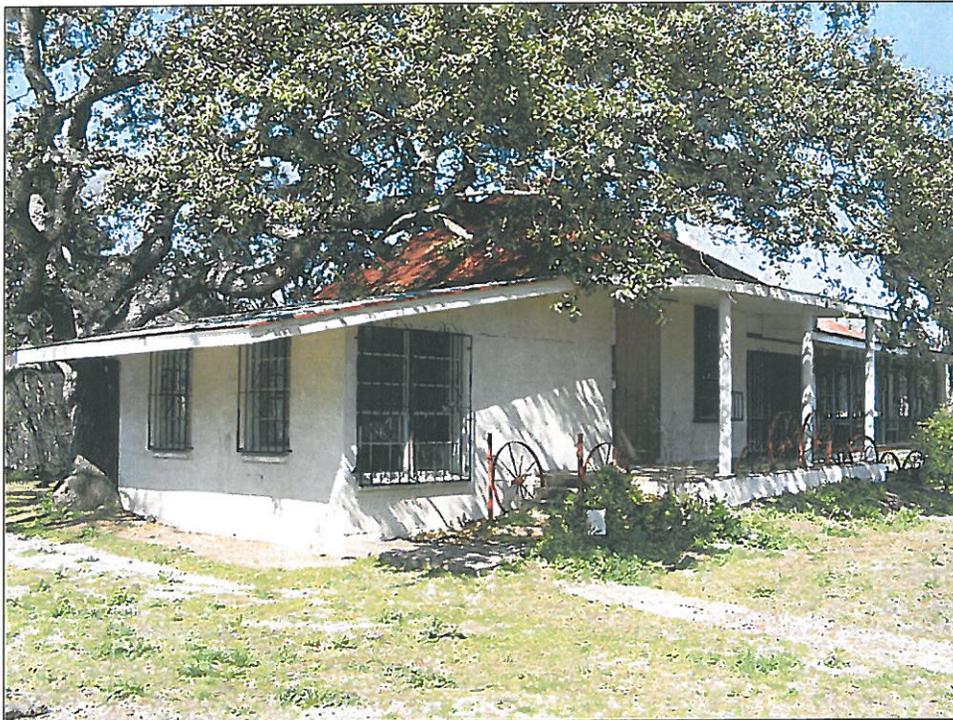
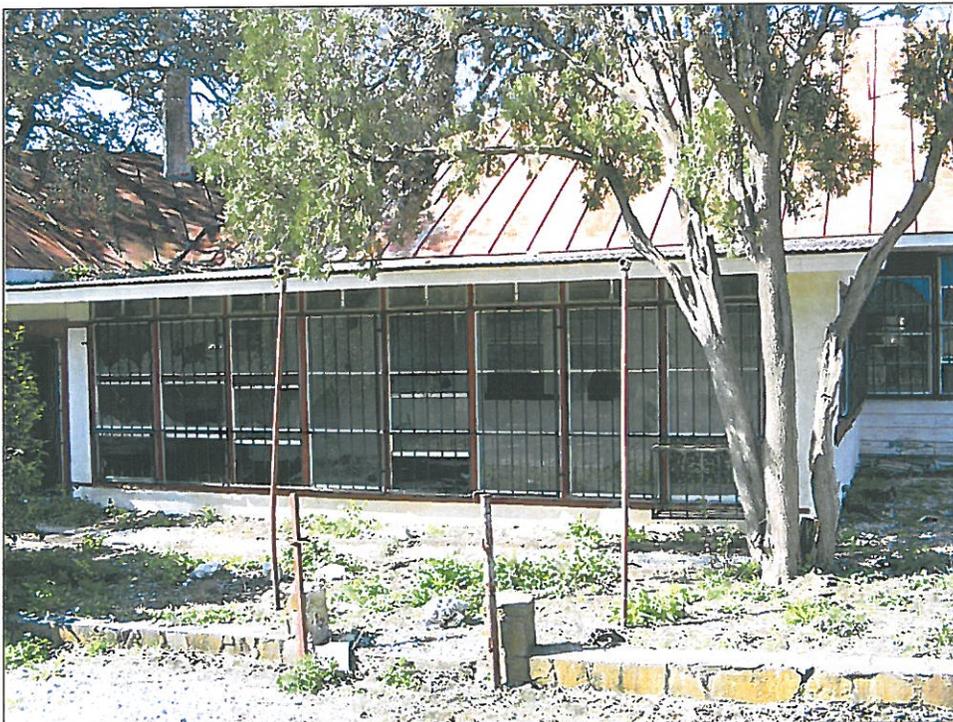
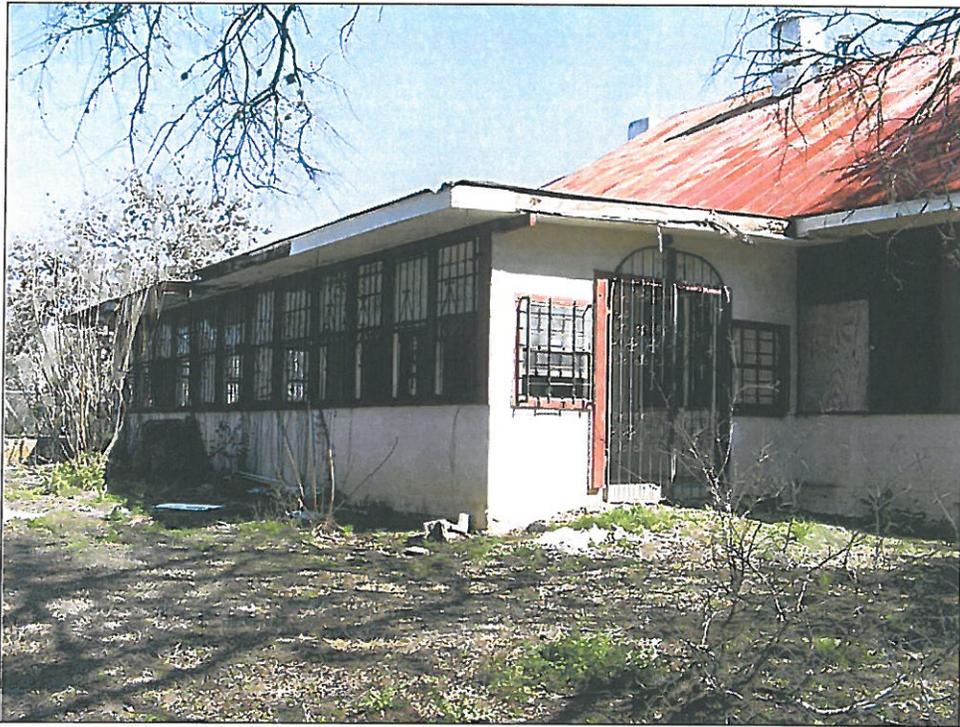
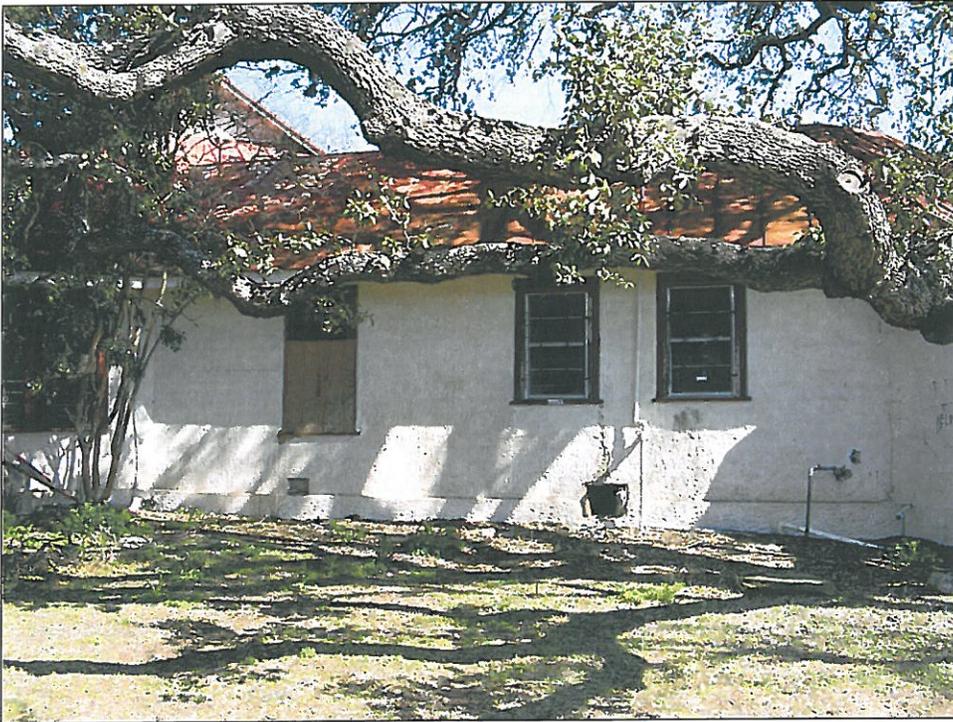
Map I.D. #5A

Photo 30: View facing southwest.

Photo 31: View facing southeast.

Photo 32: View facing northwest.

Photo 33: View facing west.

Photo 34: View facing northeast.

Photo 36: View facing north.

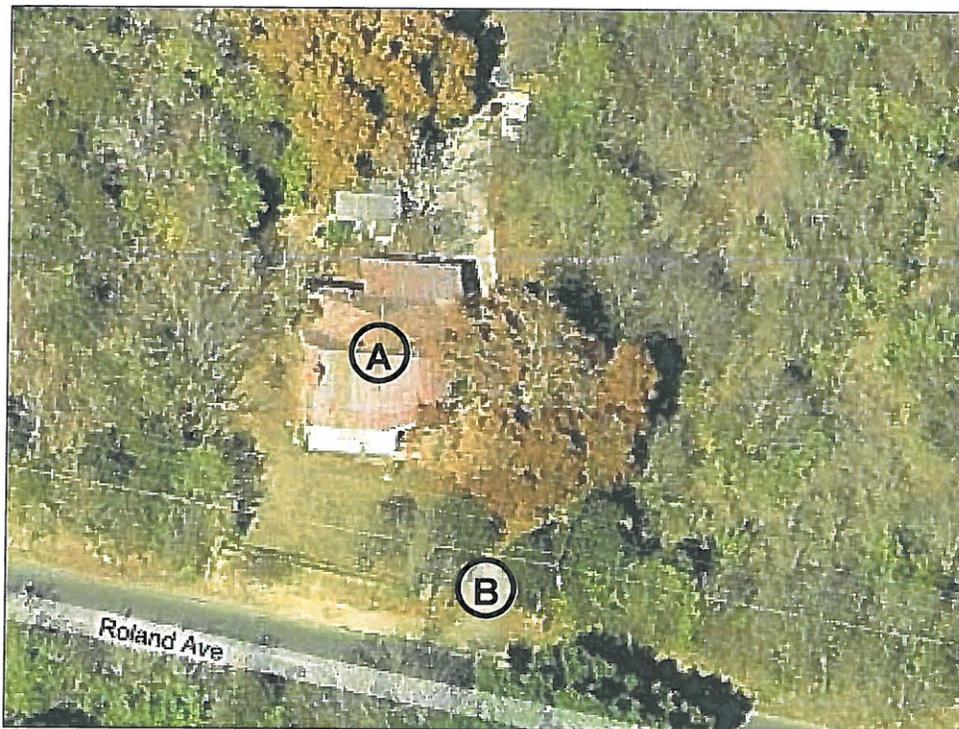
Photo 43: Aerial view facing north.

Survey efforts identified one Craftsman-influenced bungalow in the project area, Map I.D. 6. This 1930 single-story, wood-frame building features horizontal wood siding, replacement metal frame windows, and a replacement standing seam metal on a clipped gable roof (photos 43-47). The house has a small inset porch supported by replacement column faced with stone and topped with decorative iron work. The house has a large rear addition which has been badly damaged by fire.¹⁶ The chain link entry gate is supported by two large stone gate posts with short curving walls. The property is presently vacant. It has no known association with significant historic events, trends, or persons under Criteria A and B. Although a decent example of bungalow architecture in the area and thus marginally significant under Criterion C, the addition, window and porch changes, and substantial fire damage impact integrity of design, materials, workmanship, and feeling to a degree that it is unable to convey its significance. As such, the property is recommended **not eligible** for listing in the NRHP.

Map I.D. #: 6
Site Location: 4131 Roland Ave
UTM Coordinates: 14 556873, 3251231
Function/use: DOMESTIC/ vacant
Date: c. 1930
Style/form: Craftsman-influenced/ gabled roof
NRHP eligibility: Not eligible
Comments: Replacement windows, porch posts, and roofing; severe fire damage to rear of building.

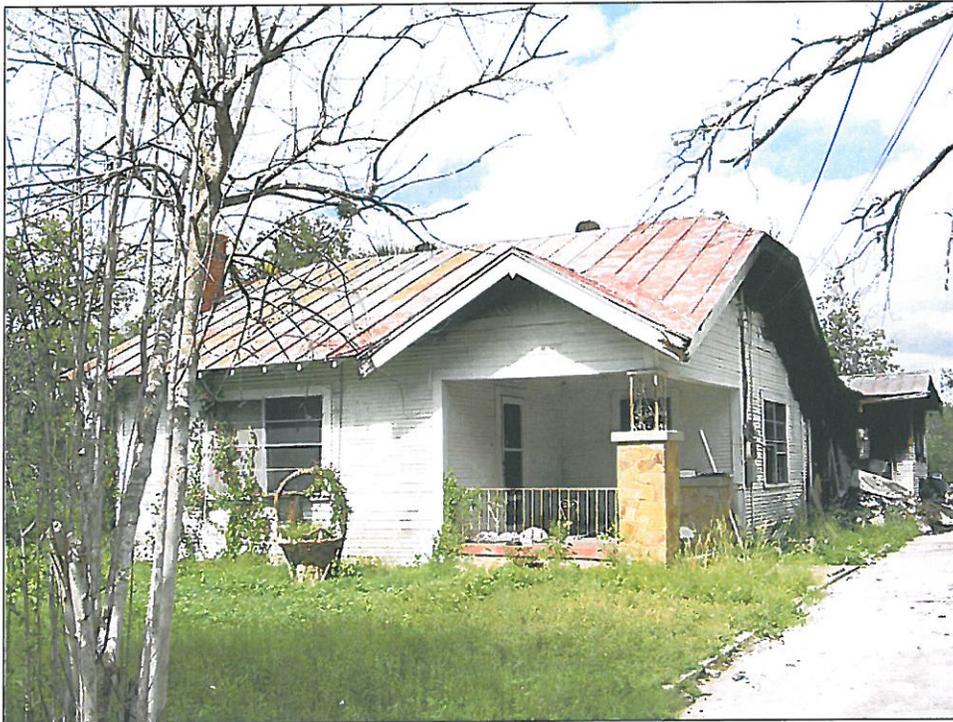
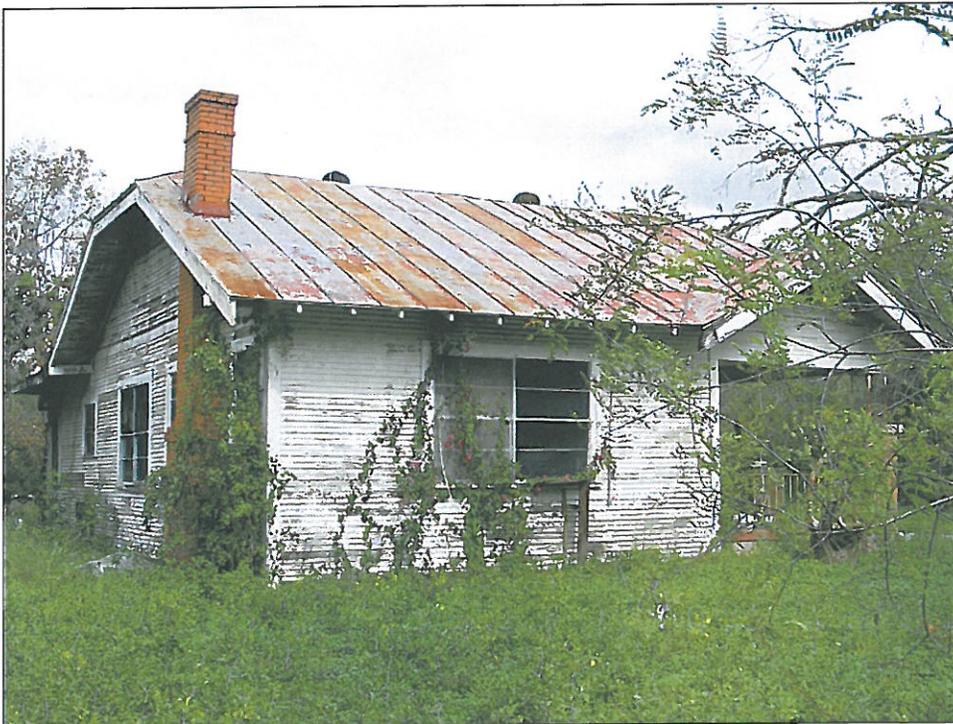
Map I.D. #6A

Photo 44: View facing northwest.

Photo 45: View facing northeast.

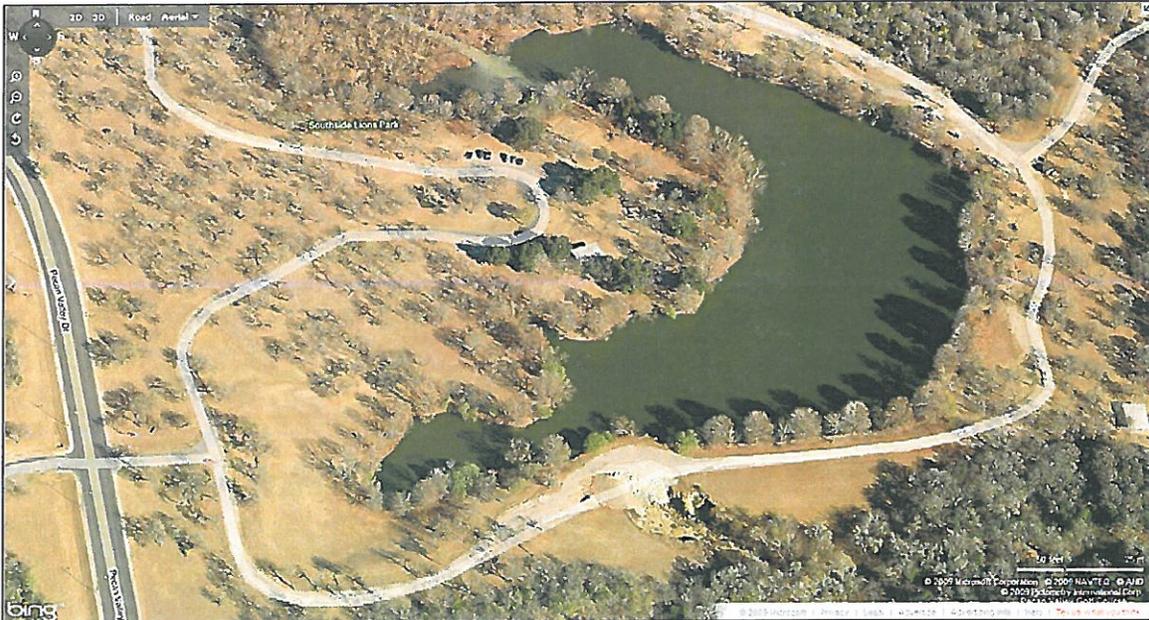
Photo 48: Aerial view of East Side Lions Park, facing north. Source: Microsoft Bing.

Map I.D. #: 7
Site Location: Pecan Valley Drive
UTM Coordinates: 14 555424, 3250921
Function/use: RECREATION/ park
Date: 1944/ 1953/ 1964
Style/form: No Style/ NA
NRHP eligibility: Not eligible
Comments: East Side Lions Park. Most amenities built in the 1960s and later.
