**Intensive Archaeological Pedestrian Survey and
Construction Monitoring of the VFW Boulevard
Drainage Improvements Project, Segment I,
San Antonio, Bexar County, Texas**

San Antonio River Improvements Series: Volume 1

Texas Antiquities Permit No. 5957

Prepared by:
Center for Archaeological Research
The University of Texas at San Antonio
One UTSA Circle
San Antonio, Texas 78249
Archaeological Report, No. 422

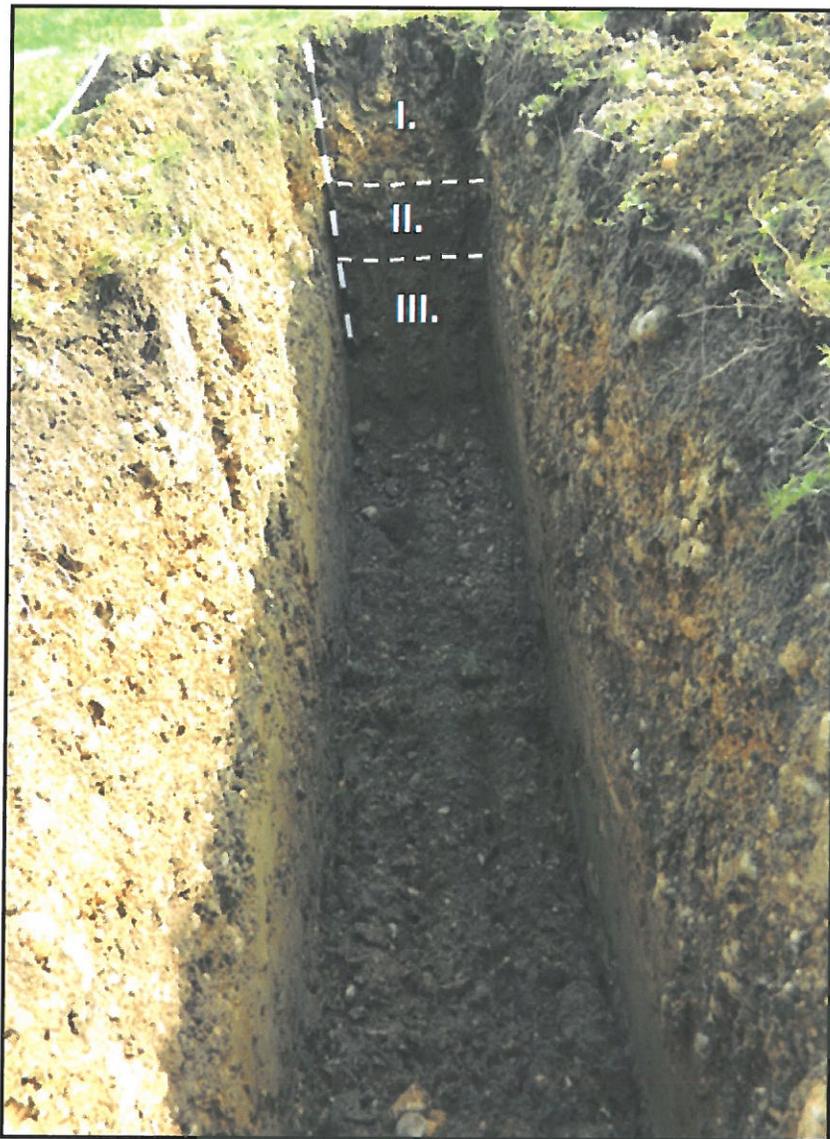
Figure 5-2. *BHT 1 trench profile. Note multiple artificial fill layers.*

BHT 1 (550817E, 3248957N, UTM:NAD83) was 6 m (19.7 ft.) in length and located at the northeast end of the proposed easement, approximately 165 m (541 ft.) southwest of the current San Antonio River alignment. Based on pre-channelization aerial photographs (see Figure 3-6), this trench would have been situated on the east bank of the original river channel inside a meander loop. This trench revealed three distinct layers of construction fill material to an excavated depth of 200 cm (78.7 in.; Figures 5-2, 5-3). No cultural materials were found in BHT 1. Given the depth of fill material and 1959 aerial photographs showing extensive construction impacts and re-contouring of the area, excavation of BHT 1 was terminated since the probability of locating intact archaeological deposits was considered very low.

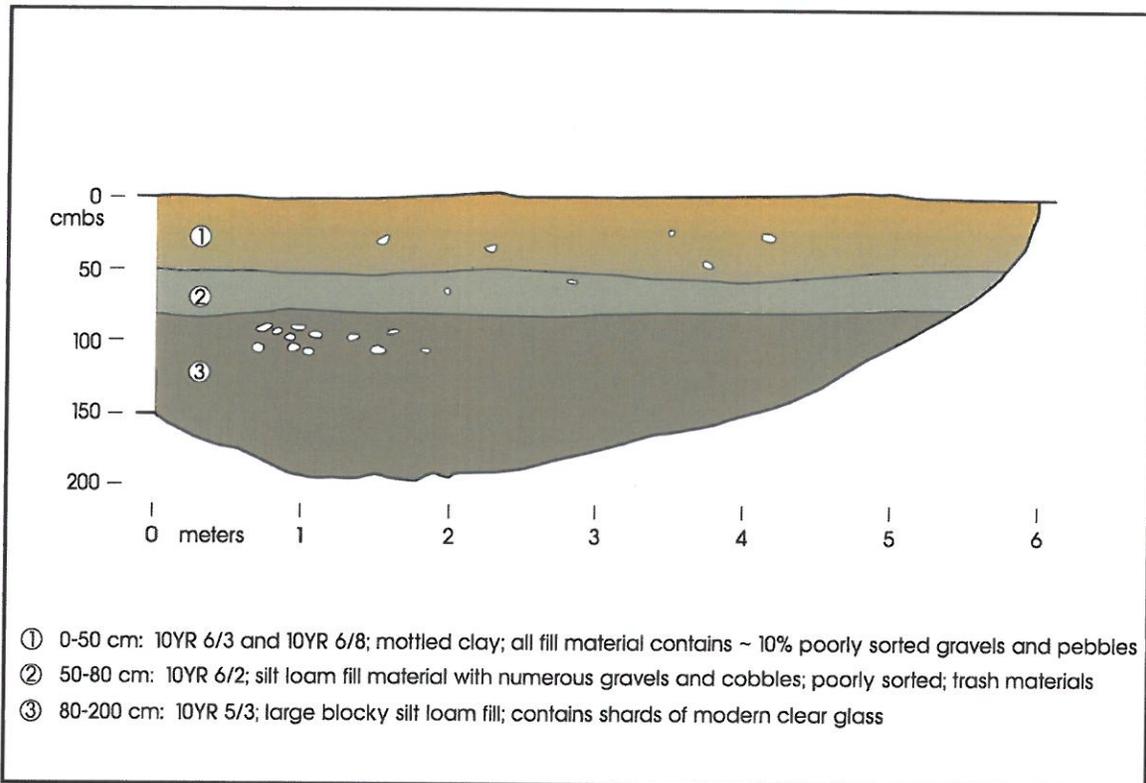
Figure 5-3. Profile drawing of BHT 1, southeast wall. Each zone indicates a separate layer of artificial construction fill.

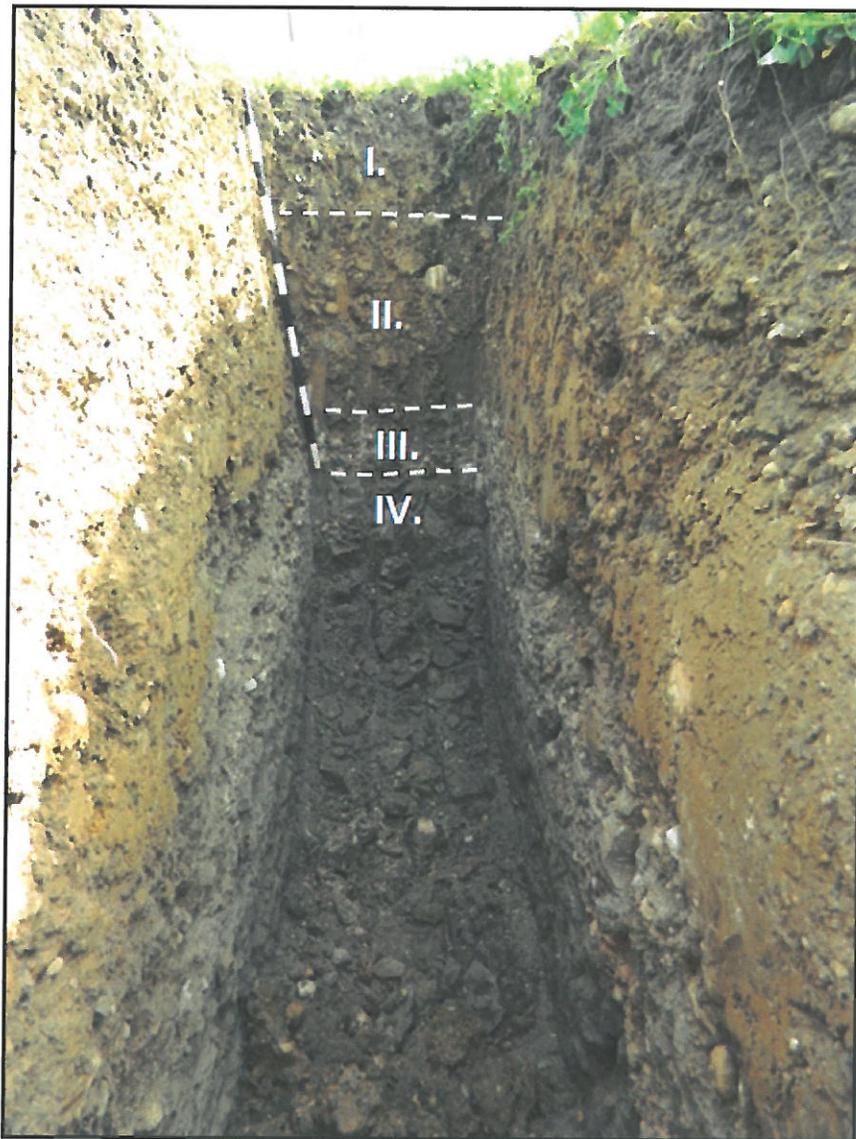
Figure 5-4. *BHT 2 trench profile.*

BHT 2 (550793E, 3248941N, UTM:NAD83) was 5.5 m (18 ft.) in length and located approximately 200 m (656 ft.) southwest of the current San Antonio River alignment and 35 m (114.8 ft.) from BHT 1. This trench would have also been situated on the east bank of the original river channel inside a meander loop. Similar to BHT 1, BHT 2 revealed four distinct layers of construction fill material to an excavated depth of 170 cm (67 in.; Figures 5-4, 5-5). No cultural materials were found in BHT 2. Given the depth of fill material and 1959 aerial photographs showing extensive construction impacts and re-contouring of the area, excavation of BHT 2 was terminated since the probability of locating intact archaeological deposits was considered very low.

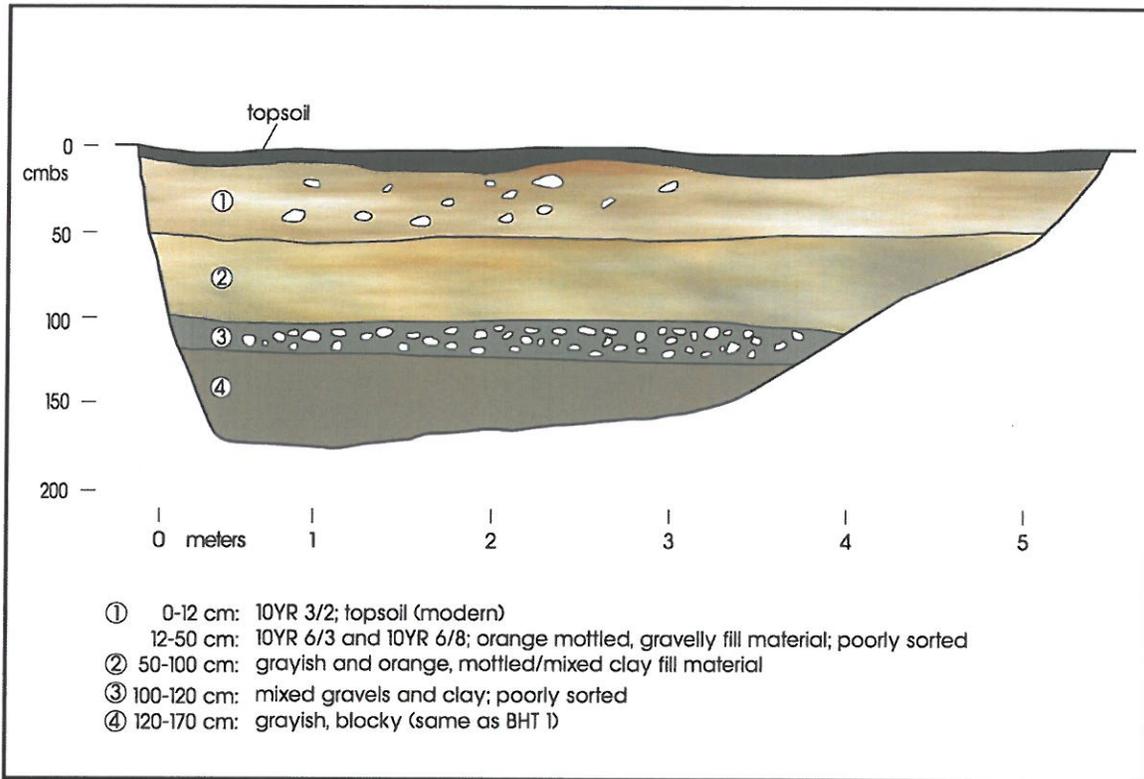
Figure 5-5. Profile drawing of BHT 2, southeast wall. Each zone indicates a separate layer of artificial construction fill.

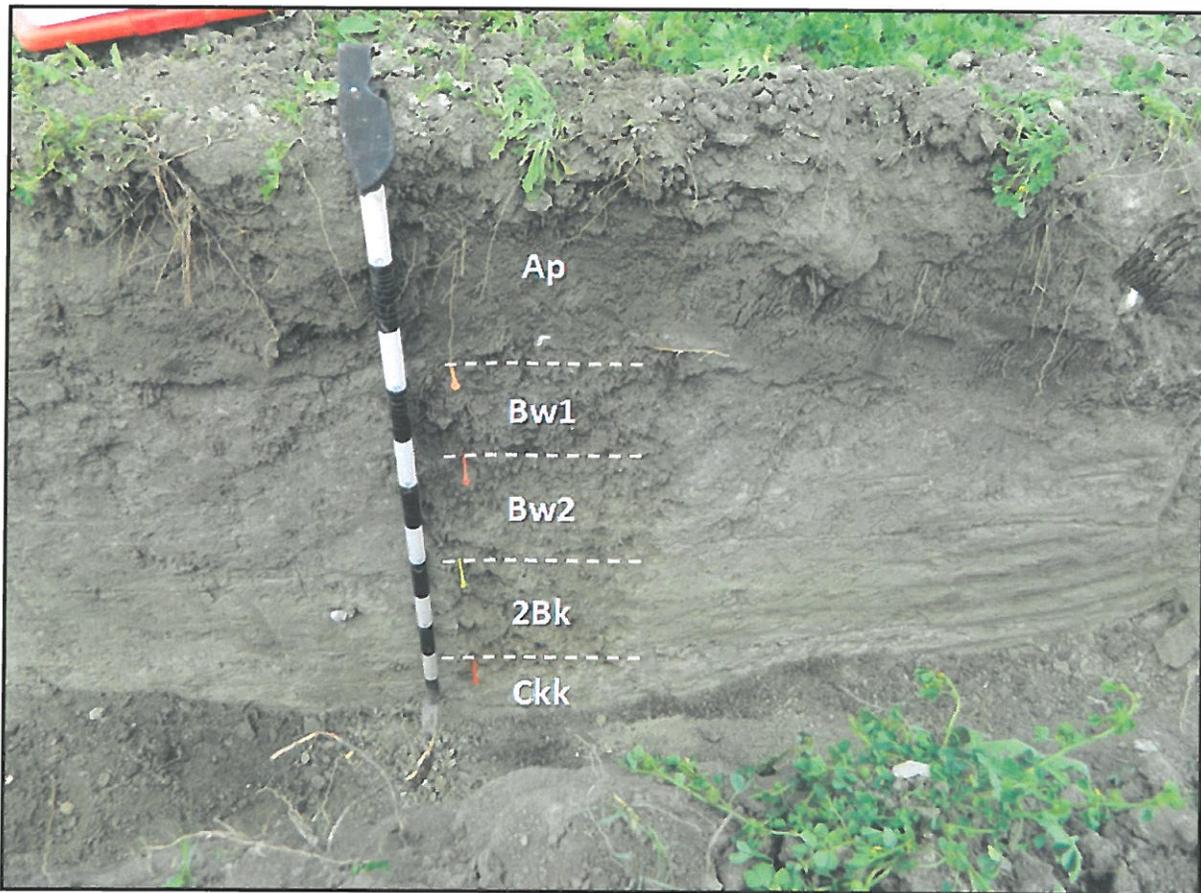
Figure 5-6. *BHT 3 soil profile. An erosional unconformity exists between the Bw2 and 2Bk horizons.*

BHT 3 (550754E, 3248914N, UTM:NAD83) was 5 m (16.4 ft.) in length and located 245 m (803.8 ft.) southwest of the current San Antonio River alignment and 45 m (147.6 ft.) from BHT 2. BHT 3 revealed an Ap-Bw1-Bw2-Bk-Ck horizon sequence to an excavated depth of 220 cm (86.6 in.; Figures 5-6, 5-7). Soil texture ranged from silty clay loam in the Ap horizon to silt loam in the lower horizons. Very fine, faint threads of secondary (pedogenic) calcium carbonate filaments were observed throughout the Bk horizon, and the Ck horizon exhibited massive structure and appears to consist entirely of extremely friable and powdery calcareous silt, which has not been cemented. No cultural materials were found in BHT 3.

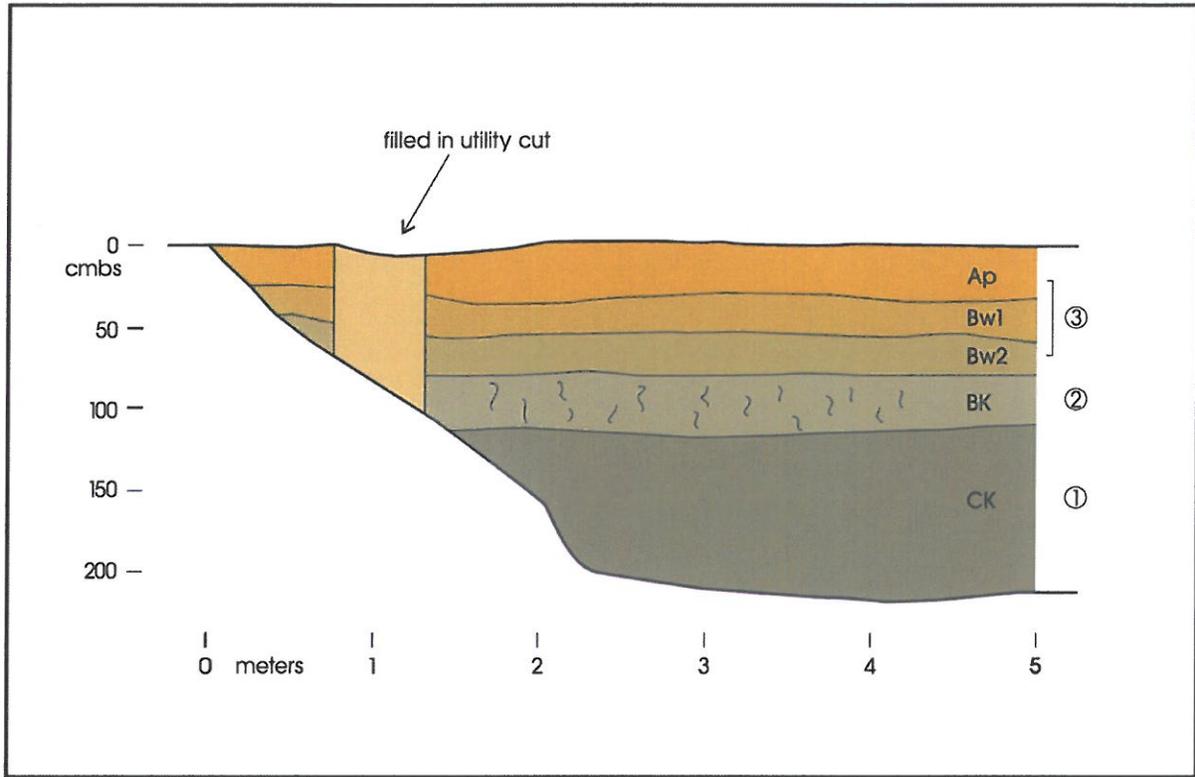
Figure 5-7. Profile drawing of BHT 3, northwest wall.

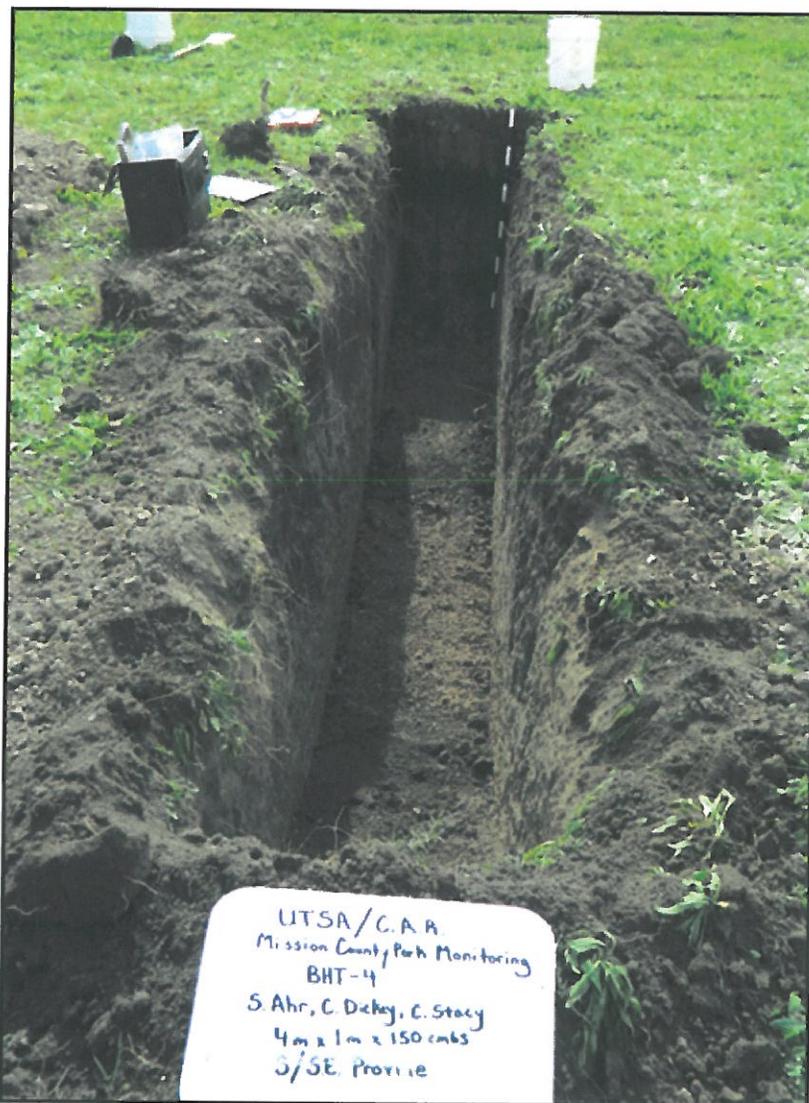
Figure 5-8. Overview of BHT 4, facing northeast.

BHT 4 (550728E, 3248895N, UTM:NAD83) was 5.5 m (18 ft.) in length and was located 275 m (902.2 ft.) southwest of the current San Antonio River alignment and 30 m (98.4 ft.) from BHT 3. BHT 4 revealed an A-Bw-2Bk-2Btk horizon sequence to a depth of 150 cmbs (59 in.; Figures 5-8, 5-9). Soil texture ranged from silty clay loam to silt loam, with weak fine granular and weak moderate subangular blocky ped structure in the A and Bw horizons, which grade to moderate coarse angular blocky structure in the Bt and Btk horizons. *Rabdotus* snails and fragments are present throughout all B horizons, and a few pieces of fire-cracked rock (FCR) less than 5 cm (2 in.) in diameter are present within the uppermost portion of the Bw horizon. The lower boundary of the A horizon is abrupt and wavy, which suggests perhaps the upper solum is a more recent addition of deposits, following erosion and truncation of a portion of the Bw horizon.

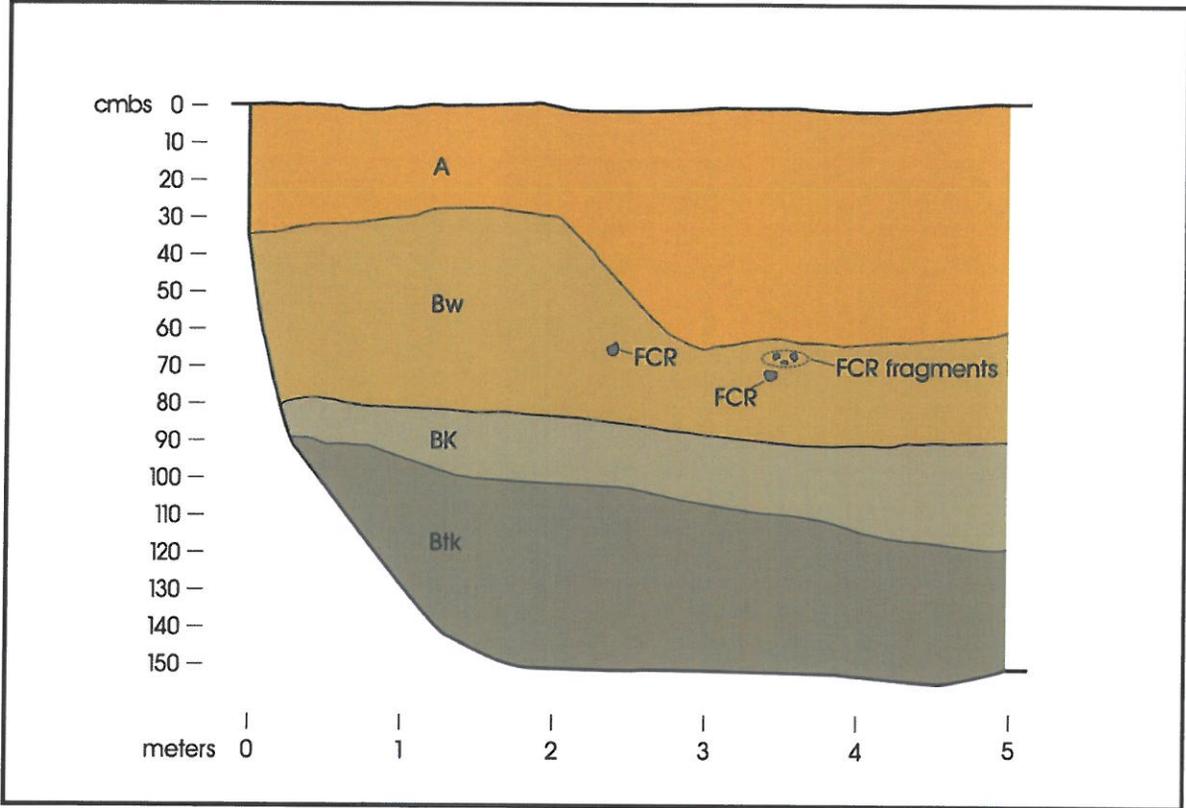
Figure 5-9. Profile drawing of BHT 4, southeast wall.

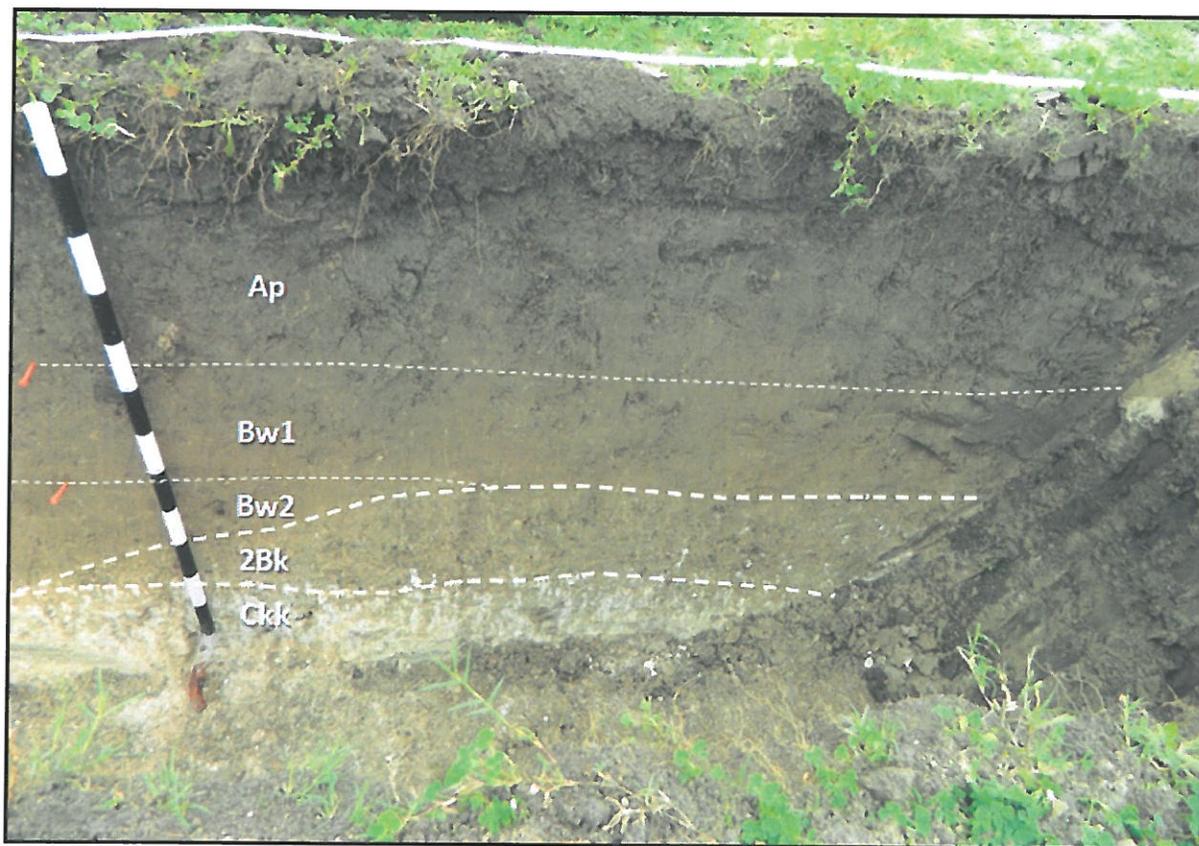
Figure 5-10. BHT 5 soil profile. Heavy dashed line indicates lithologic break, while thin dashed line indicates soil horizon boundary.

BHT 5 (550703E, 3248881N, UTM:NAD83) was 6 m (19.7 ft.) in length and was located 300 m (984 ft.) southwest of the current San Antonio River channel and 25 m (82 ft.) from BHT 4. BHT 5 exhibits an A-Bw1-Bw2-Bk-Ckk horizon sequence to an investigated depth of 150 cmbs (59.1 in.; Figures 5-10, 5-11). Soil texture included clay loam in the upper A and Bw horizons, transitioning into silty clay loam in the lower Bk and Ckk horizons. Very few faint secondary carbonate filaments were observed within the Bk horizon, potentially indicating a moderate amount of leaching through the soil. The Bk horizon also contains a modest amount of *Rabdotus* snails and snail shell fragments. In the southwest part of the trench, a good portion of the Bk horizon appears to have been eroded/scoured, resulting in the strongly undulating horizon boundaries observed in previous investigations. Below 120 cmbs (47.2 in.), a grayish-white silty loam deposit was encountered (Ckk horizon), which consists of approximately 75% caliche, in which 75% of the soil fabric is plugged with fine grained pedogenic carbonate, equivalent to stage III carbonate morphogenetic stages (Gile et al., 1966). No cultural materials were observed within BHT 5.

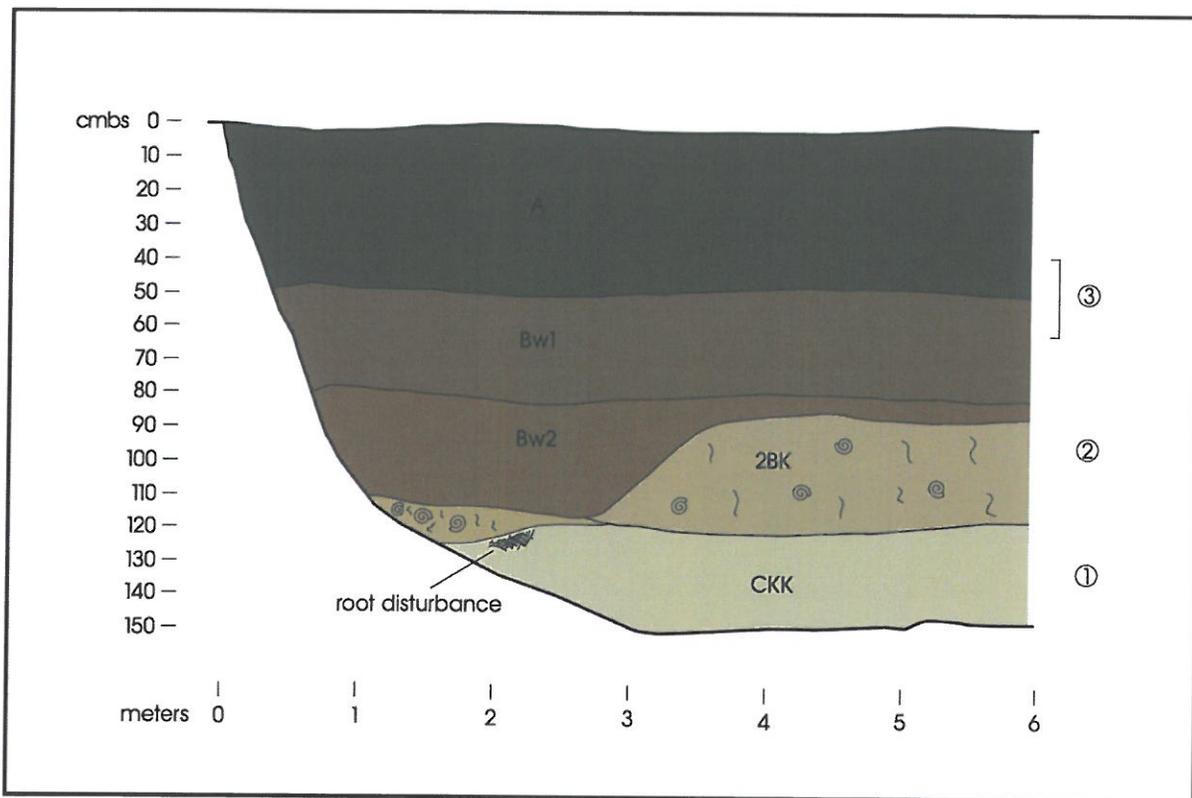
Figure 5-11. Profile drawing of BHT 5, northwest wall.

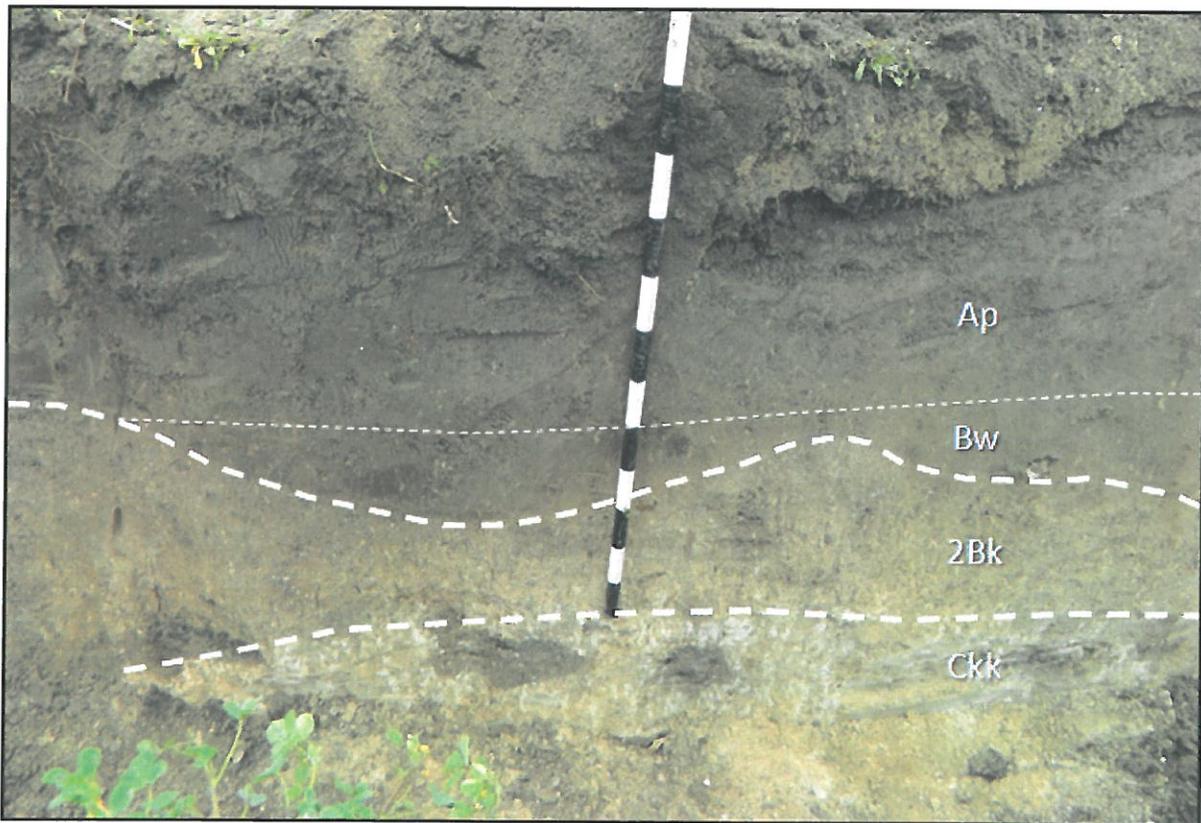
Figure 5-12. *BHT 6 soil profile. Note the abrupt and undulating upper boundary of the 2Bk horizon, indicative of scouring. The upper Ap and Bw horizons were deposited sometime after this erosional event. Heavy dashed line indicates lithologic break, while thin dashed line indicates soil horizon boundary.*

BHT 6 (550669E, 3248862N, UTM:NAD83) was 11 m (36 ft.) in length and was located approximately 345 m (1,132 ft.) southwest of the current channel alignment and 45 m (147.6 ft.) from BHT 5. BHT 6 exhibits an A-Bw-Bk-Ckk soil horizon sequence to an investigated depth of 150 cmbs (59 in.; Figures 5-12, 5-13). The 60-cm (23.6-in.) thick A horizon consists of 10YR 3/2 clay loam and grades gradually into a 60-cm (23.6-in.) thick Bw horizon, which appears to unconformably overlie a Ckk horizon beginning at 120 cmbs (47.2 in.). At the northwest part of BHT 6, the lower boundary of the A horizon is abrupt and wavy, and it appears to be a distinct deposit that is unconformably resting upon a much older, scoured and eroded Bk horizon. A couple of lithic flakes were identified in situ within the top portion within the Bk horizon, as well as a burned clay (daub) feature (Figure 5-14).

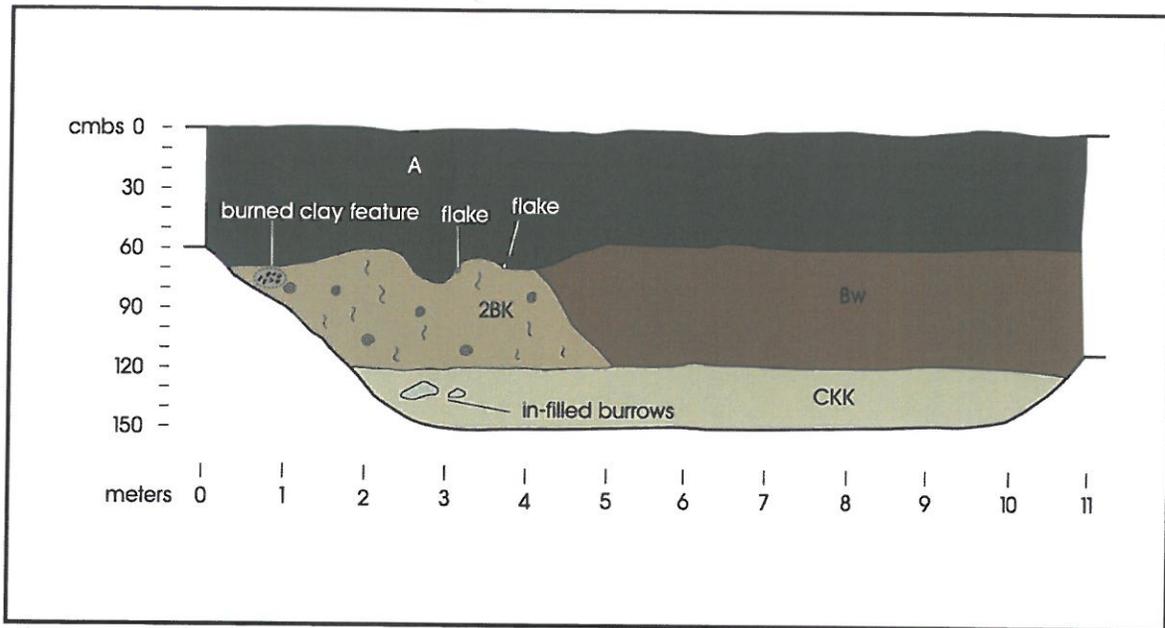
Figure 5-13. Profile drawing of BHT 6, southeast wall.

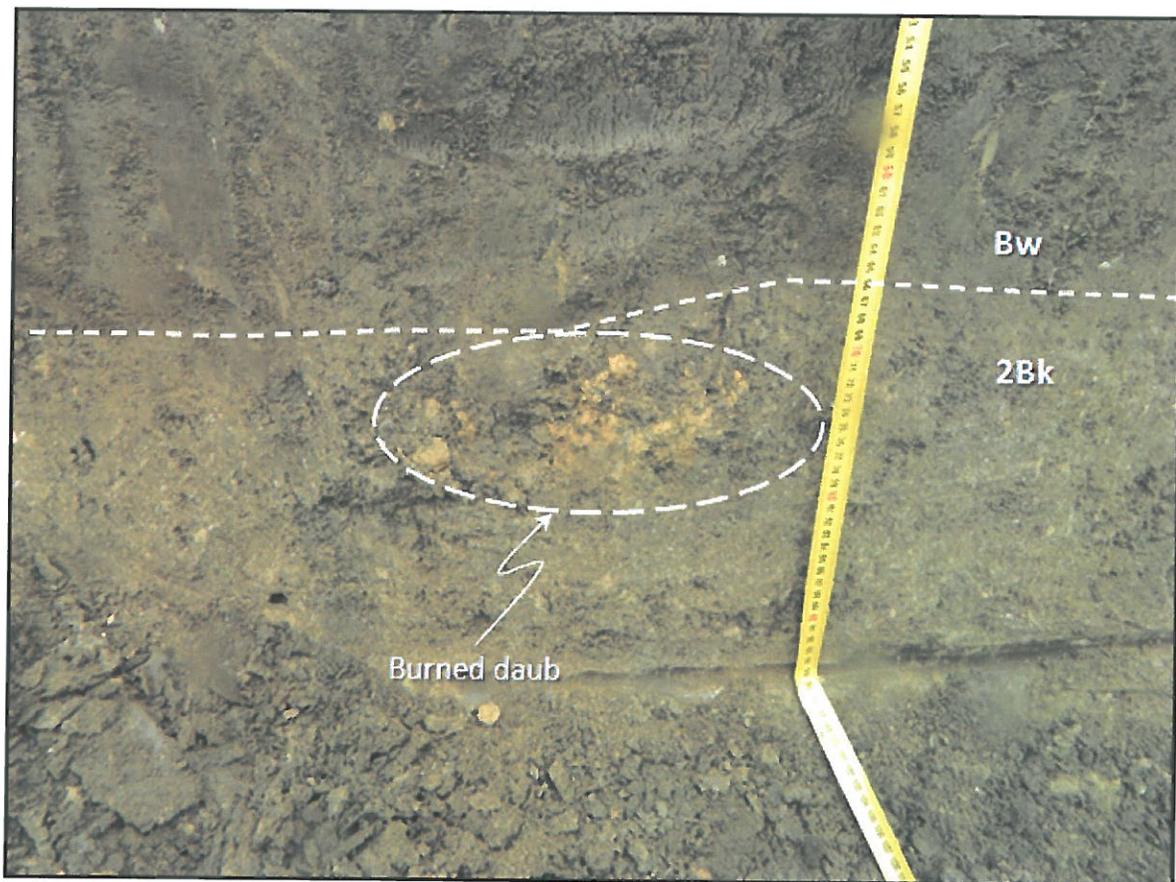
Figure 5-14. Burned daub concentration identified in BHT 6, between 70-80 cmbs (27.6-31.5 in.), within 2Bk horizon of alluvial-stratigraphic Unit II.

The burned daub feature was located between 70 and 80 cmbs (27.6 and 31.5 in.) and measured approximately 20 cm (7.9 in.) in diameter. It is located within the upper 10 cm (3.9 in) of the Bk horizon, which is located at the northeast portion of BHT 6. The uppermost part and the southwestern portion of the Bk horizon appear to have been truncated by erosion, scour, or mechanical impacts.

It is interesting to note that the small concentration of burned, reddish-orange daub identified in BHT 6 at 41BX1917 appears to be the same as that previously documented at site 41BX1920, which was associated with clusters of charred plant materials and charcoal. A piece of charcoal associated with the fragment of daub exposed in a trench wall at 41BX1920 returned a 2σ date range of cal BP 3450-3360, which would date to the early part of the Late Archaic Period (DiVito and Oksanen 2012). Another piece of charcoal from a basin-shaped pit feature containing burnt daub at 41BX1920 yielded a 2σ date range of cal BP 4230-3990 (DiVito and Oksanen 2012).

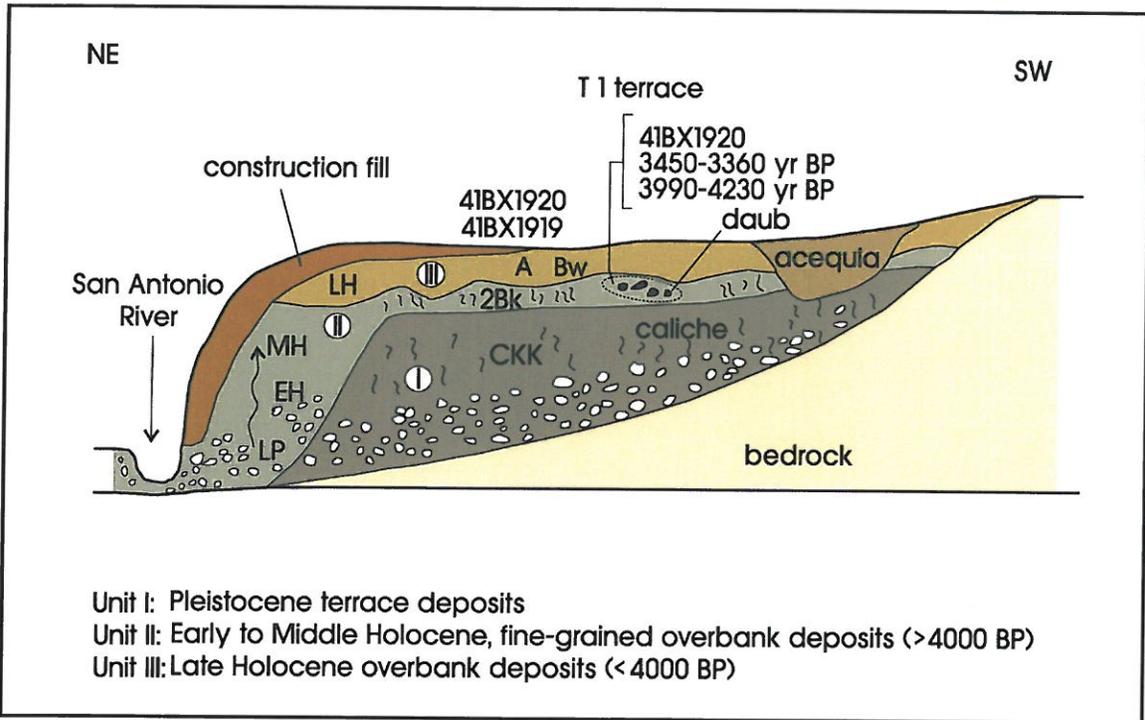
Figure 6-1. Generalized alluvial-stratigraphic cross-section for Mission County Park, Bexar County, Texas, illustrating major alluvial units. LP=Late Pleistocene; EH=Early Holocene; MH=Middle Holocene; LH=Late Holocene.

The APE is situated entirely within the T-1 terrace on the west bank of the current river channel. This terrace is represented on *Geologic Atlas of Texas* maps as fluvial terrace deposits of late Pleistocene age that occur mostly above flood levels along entrenched streams. This T-1 terrace lies stratigraphically below and post-dates the extensively distributed Uvalde gravel deposits (e.g., Pliocene) located to the east of the study area. Based on previous investigations of other areas of the San Antonio River Improvements Project (SARIP), the T-1 terrace deposits rest unconformably upon Eocene-age Wilcox and Midway Group deposits. The depth of this lower contact below the terrace tread has previously been measured to 7 m (23 ft.) in other investigated areas along the Mission Reach project (DiVito and Oksanen 2012). The T-1 terrace is underlain by three lithologically-distinct alluvial fills, designated from oldest to youngest as Units I through III (Figure 6-1).

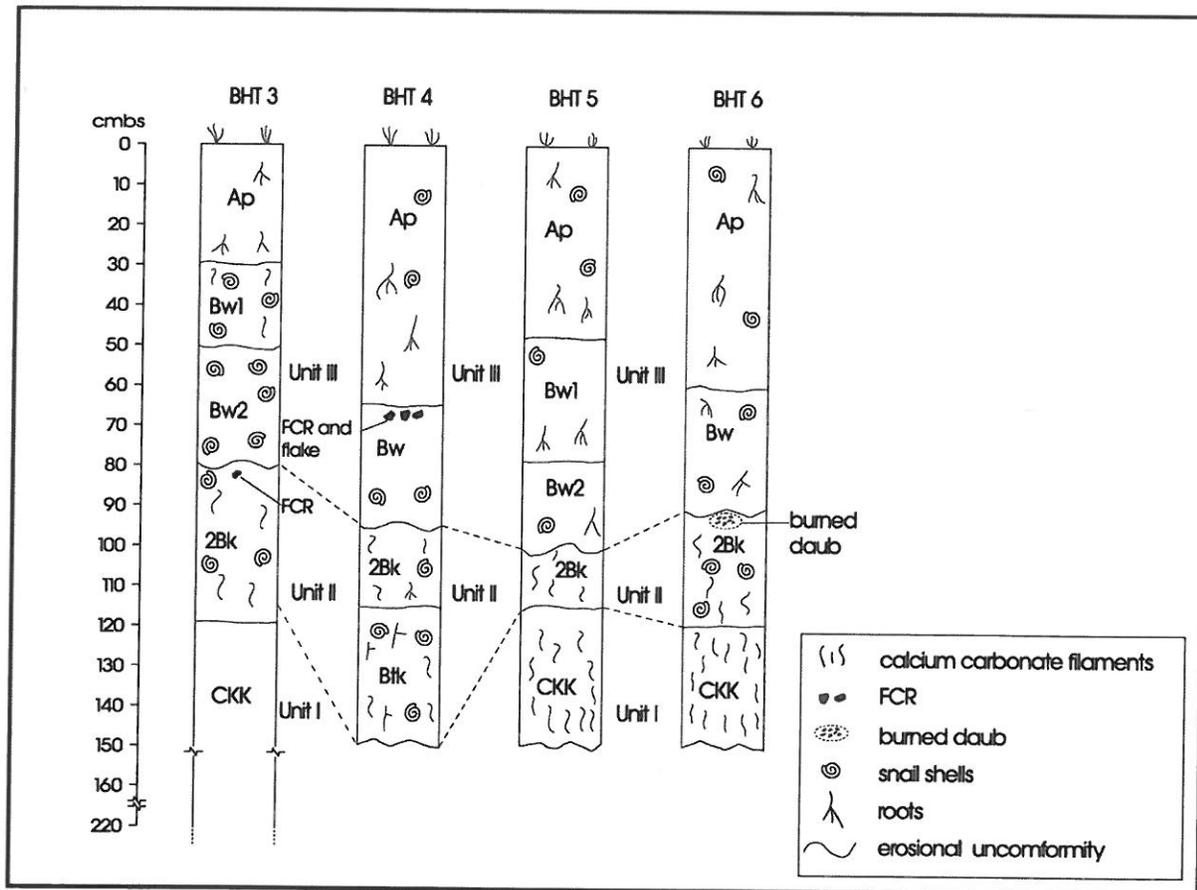
Figure 6-2. Soil-stratigraphic columns for BHTs 3 through 6. BHTs 1 and 2 are comprised entirely of fill material and are not illustrated.

Unit I comprises the lower portions of the terrace fill and is presumed to be Pleistocene in age. The lower part of Unit I was not directly observed during the current project, but during previous investigations and construction monitoring in several other nearby portions of the San Antonio River, thick, laterally and vertically accreted gravelly beds were observed, along with thick, coarse sandy interbeds. The coarse bedload deposits fine upward into vertical accretion facies of sands, silts, and loams. The uppermost part of Unit I is comprised of extremely friable and powdery Ckk horizon exhibiting massive structure, which appears to consist entirely of calcareous silt. This upper chalky portion of Unit I was identified in BHTs 3, 5, and 6 during the current study (Figure 6-2).

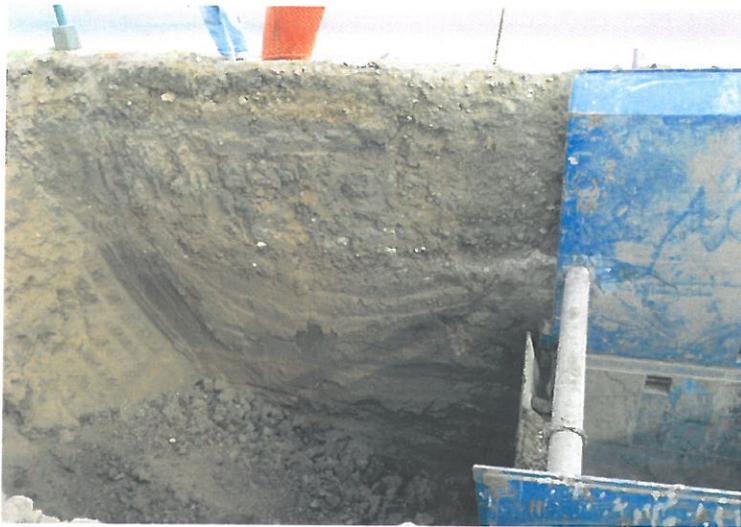
Figure 7-2 North wall profile exposed before moving the shoring unit.

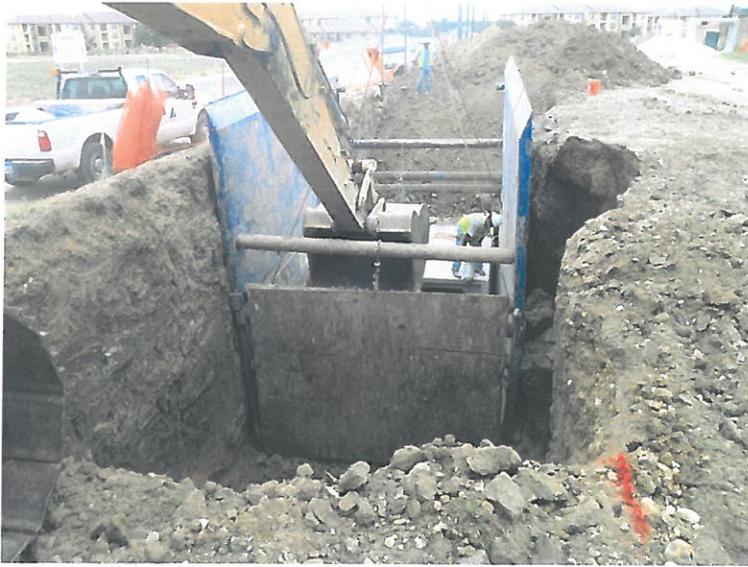
Figure 7-3 *Excavator moving the exterior drainage pipe shoring unit.*

The trenching and pipe installation was conducted by Zachry Construction Contractors using a 345D CAT Excavator which removed soil to an average depth of 15-feet. The trench was 14 ½-feet wide. Along an approximate 20-foot section of the trench paralleling VFW Boulevard, bucket-loads of matrix were removed from the western edge of the trench and placed on the ground next to the trench. After the monitor's inspection of the backdirt, a bulldozer was used to scoop up the matrix and deposit it into a larger pile which was also situated to the south on the Mission County Park grounds. The Excavator was then repositioned and the steel-plated wall-shoring unit was moved into place (Figure 7-2). Following these procedures, a commercial-grade crane lowered each 9-x-11-foot cement drainage pipe section into the trench while workers connected each section to previously laid segments (Figure 7-3 and 7-4). A large gravel bucket was next filled and lowered into the trench and its contents poured around the newly laid pipe. Finally, the temporarily stored top soil was used to top-off the trench to the original ground surface.

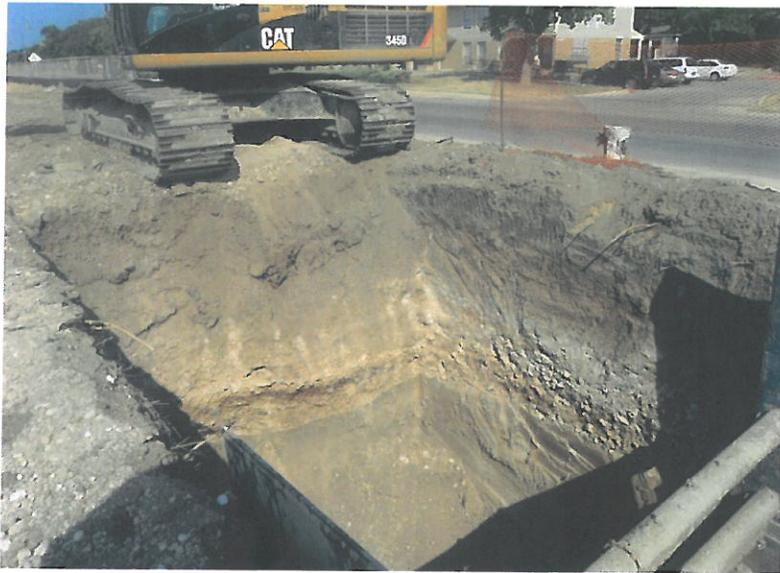
Figure 7-5 Increase of river gravels noted within 5-8 meters east of 41BX1917.

During actual monitoring of the trench from east of the old riverbed meander going approximately 130 meters to the west, much evidence of soil disturbance was noted. Observation of small portions of the north wall of the trench revealed areas of fill-gravels and evidence of changing riverbed locations which contained some historic artifacts. Pieces of old construction materials, bottle glass, white earthenware, rusted metal, sewer pipe fragments, mussel shell, and animal bone were retrieved from the Excavator bucket and backdirt. As the trenching progressed westward, at approximately 60 meters from the starting point and past an area where a previous water pipe was encountered and removed, an increase of river gravel was noted in the north wall profile (Figure 7-5).
