THE ALAMO CENOTAPH

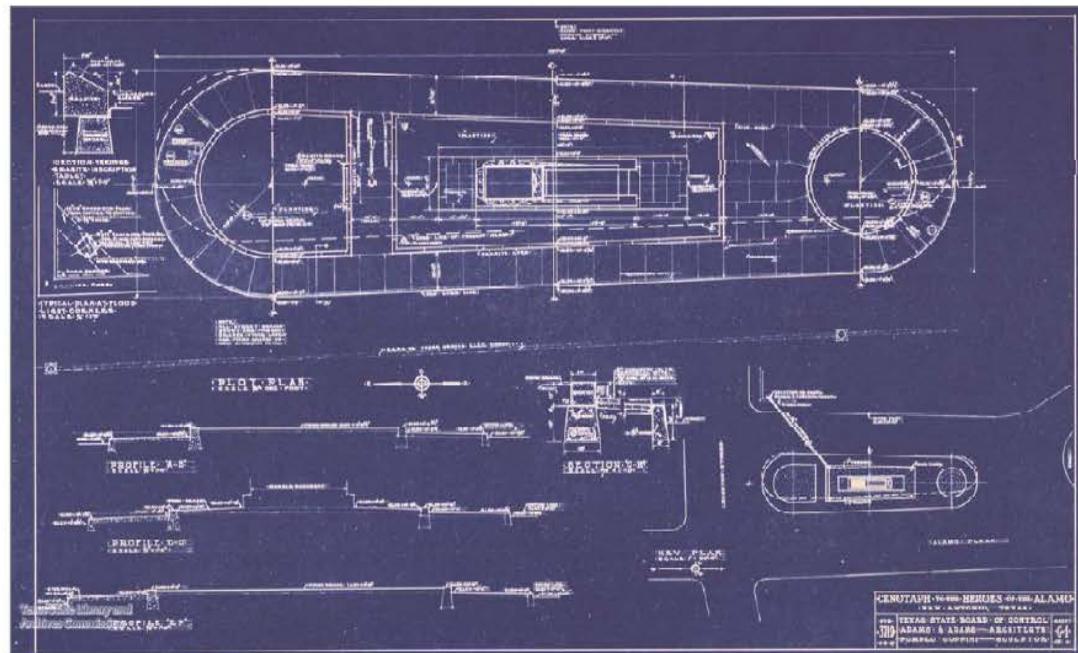
Figure 8 - 32: 1937 Plan Drawing of the Alamo Cenotaph by Architect Adams & Adams, Designed and Executed by the Sculptor Pompeo Coppini. [Blueprints and Drawings Collection, Archives and Information Services Division, Texas State Library and Archives Commission]

The Cenotaph was constructed in 1937-1939. While there are available drawings of the proposed design [Figure 8 - 32 and Figure 8 - 33], it is not known whether the structure was constructed as shown in the drawings.

It appears that the records of several WPA projects are in Ft. Worth, TX. The Master Plan recommends the following:

- a. Visit the collection to confirm that all documents regarding any work by the WPA associated with the Alamo have been copied and are available for future researchers.
- b. Visit with any entities, such as contractors, installers, etc. who are still in business to determine as to whether there are any documents, photos, etc. taken during the construction of the Cenotaph.
- c. Reach out to the public to solicit any photographs taken during construction.
