**LETTER REPORT ON ARCHIVAL AND ARCHITECTURAL RESEARCH FOR  
BUILDINGS LOCATED ON THE CROWNRIDGE PROPERTY,  
SAN ANTONIO, TEXAS**

By Mindy L. Bonine

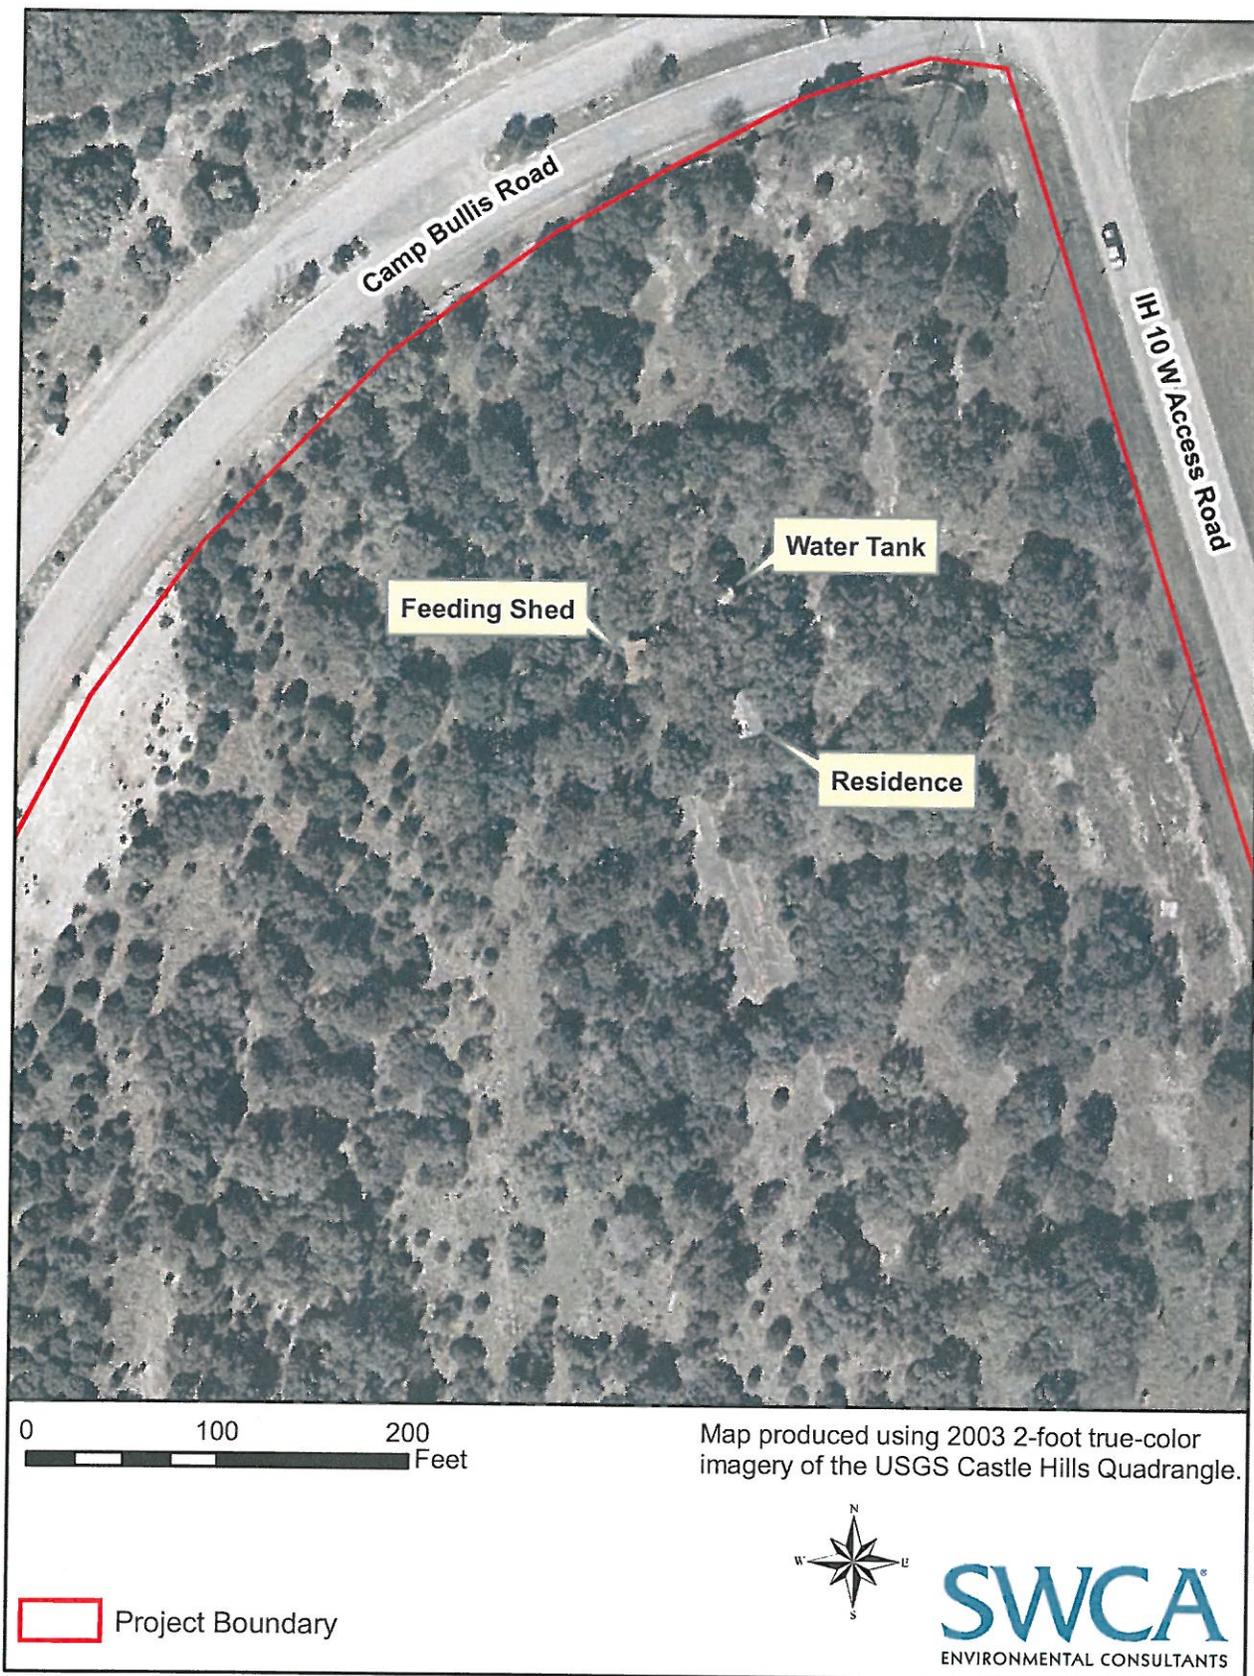
No NRHP properties, SALs, OTHMs, RTHLs, cemeteries, or local neighborhood surveys were found to be present in or near the Crownridge property. According to the Bexar Appraisal District, the property does not contain any recorded improvements, and it is listed as undeveloped land (Bexar County 2005). However, an aerial photograph dating to 1959 and used by the Soil Conservation Service in the compilation of the soil maps, shows one standing structure at the same location as the existing standing structures today (Taylor et al. 1962). One possible standing structure was plotted on the Castle Hills 7.5-minute USGS topographic map dating to 1992, but the location is plotted approximately 70 m to the east of the existing complex of buildings, at the edge of the IH 10 frontage road. The most accurate aerial photograph of the complex as it stands today is a 2002 photo of the area, which can be found on the City of San Antonio's GIS Mapping Application (Figure 2). The roofs of the main residence, feeding shed, and water tank can all be seen.

Figure 2. Aerial photo of project area, note roofs of residence, feeding shed, and water tank.
