9 Preservation Briefs

Technical Preservation Services

The Repair of Historic Wooden Windows

John H. Myers

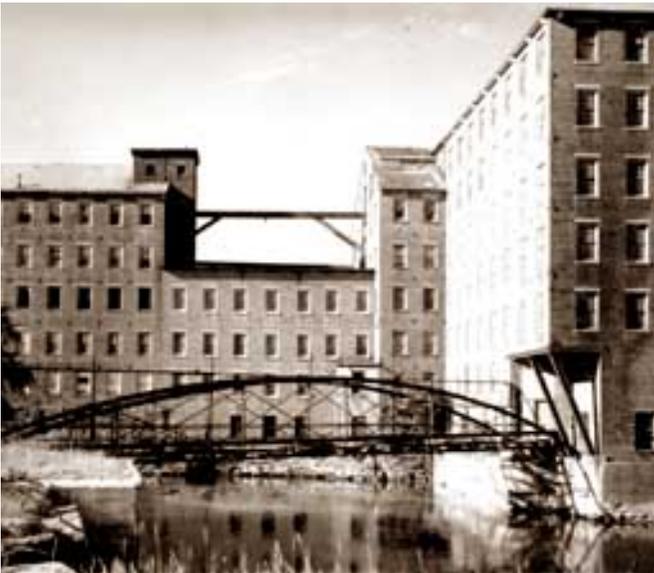
Windows are frequently important visual focal points, especially on simple facades such as this mill building. Replacement of the multi-pane windows with larger panes could dramatically alter the appearance of the building. Photo: NPS files.

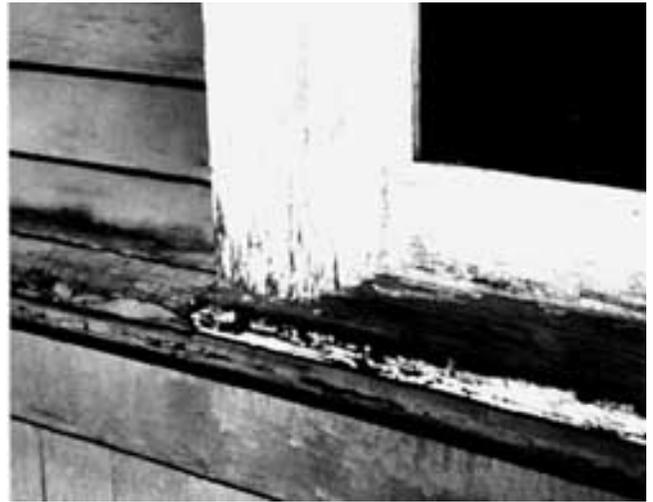
Deterioration of poorly maintained windows usually begins on horizontal surfaces and at joints, where water can collect and saturate the wood. Photo: NPS files.

Each window should be examined for operational soundness beginning with the lower portions of the frame and sash. Exterior rainwater and interior condensation can flow downward along the window, entering and collecting at points where the flow is blocked. The sill, joints between the sill and jamb, corners of the bottom rails and muntin joints are typical points where water collects and deterioration begins. The operation of the window (continuous opening and closing over the years and seasonal temperature changes) weakens the joints, causing movement and slight separation. This process makes the joints more vulnerable to water which is readily absorbed into the endgrain of the wood. If severe deterioration exists in these areas, it will usually be apparent on visual inspection, but other less severely deteriorated areas of the wood may be tested by two traditional methods using a small ice pick.

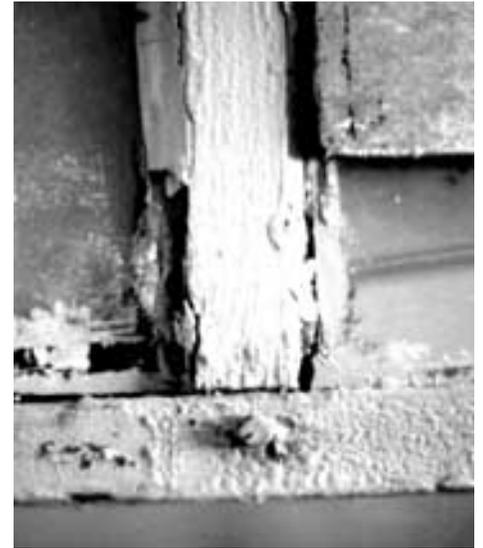
This historic double-hung window has many layers of paint, some cracked and missing putty, slight separation at the joints, broken sash cords, and one cracked pane. Photo: NPS files.

The operations just discussed summarize the efforts necessary to restore a window with minor deterioration to "like new" condition. The techniques can be applied by an unskilled person with minimal training and experience. To demonstrate the practicality of this approach, and photograph it, a Technical Preservation Services staff member repaired a wooden double-hung, two over two window which had been in service over ninety years. The wood was structurally sound but the window had one broken pane, many layers of paint, broken sash cords and inadequate, worn-out weatherstripping. The staff member found that the frame could be stripped of paint and the sash removed quite easily. Paint, putty

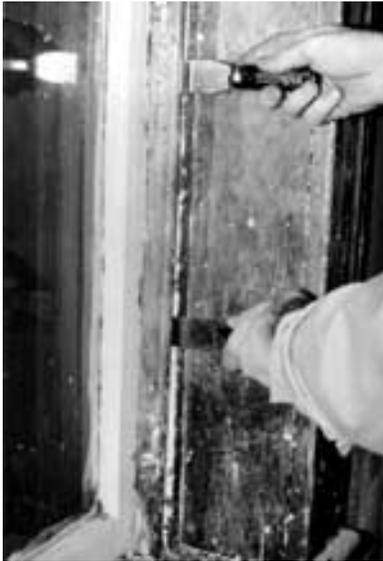
After removing paint from the seam between the interior stop and the jamb, the stop can be pried out and gradually worked loose using a pair of putty knives as shown. Photo: NPS files.

to remove the paint from the interior stop and the parting bead, particularly along the seam where these stops meet the jamb. This can be accomplished by running a utility knife along the length of the seam, breaking the paint bond. It will then be much easier to remove the stop, the parting bead and the sash. The interior stop may be initially loosened from the sash side to avoid visible scarring of the wood and then gradually pried loose using a pair of putty knives, working up and down the stop in small increments. With the stop removed, the lower or interior sash may be withdrawn. The sash cords should be detached from the sides of the sash and their ends may be pinned with a nail or tied in a knot to prevent them from falling into the weight pocket.

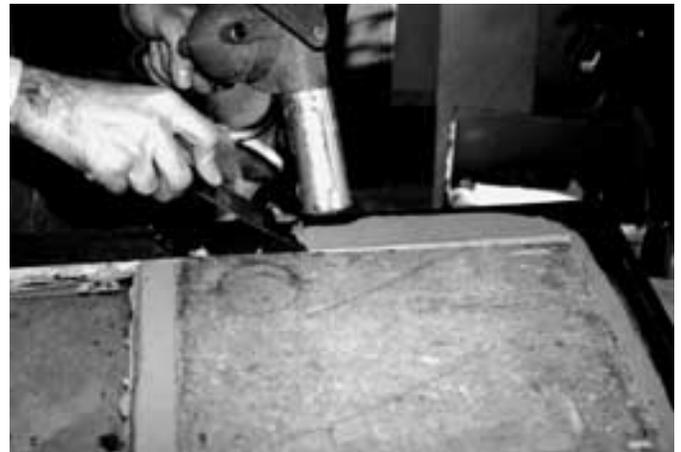
Sash can be removed and repaired in a convenient work area. Paint is being removed from this sash with a hot air gun. Photo: NPS files.

The sash can be stripped of paint using appropriate techniques, but if any heat treatment is used, the glass should be removed or protected from the sudden temperature change which can cause breakage. An overlay of aluminum foil on gypsum board or asbestos can protect the glass from such rapid temperature change. It is important to protect the glass because it may be historic and often adds character to the window. Deteriorated putty should be removed manually, taking care not to damage the wood along the rabbet. If the glass is to be removed, the glazing points which hold the glass in place can be extracted and the panes numbered and removed for cleaning and reuse in the same openings. With the glass panes out, the remaining putty can be removed and the sash can be sanded, patched, and primed with a preservative primer. Hardened putty in the rabbets may be softened by heating with a soldering iron at the point of removal. Putty remaining on the glass may be softened by soaking the panes in linseed oil, and then removed with less risk of breaking the glass. Before reinstalling the glass, a bead of glazing compound or linseed oil putty should be laid around the rabbet to cushion and seal the glass. Glazing compound should only be used on wood which has been brushed with linseed oil and primed with an oil based primer or paint. The pane is then pressed into place and the glazing points are pushed into the wood around the perimeter of the pane.

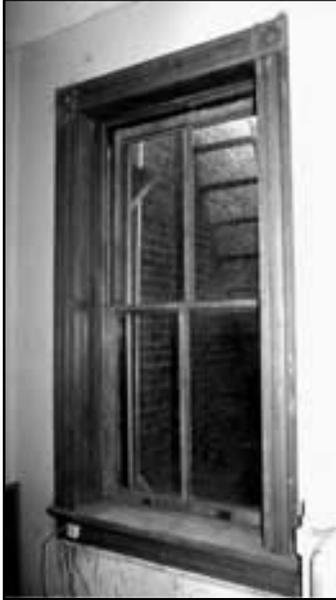
Following the relatively simple repairs, the window is weathertight, like new in appearance, and serviceable for many years to come. Photo: NPS files.

and glass removal required about one hour for each sash, and the reglazing of both sash was accomplished in about one hour. Weatherstripping of the sash and frame, replacement of the sash cords and reinstallation of the sash, parting bead, and stop required an hour and a half. These times refer only to individual operations; the entire process took several days due to the drying and curing times for putty, primer, and paint, however, work on other window units could have been in progress during these lag times.

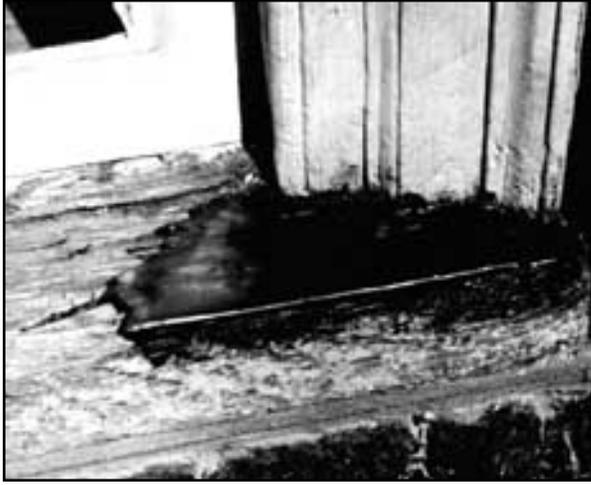
This illustrates a two-part epoxy patching compound used to fill the surface of a weathered sill and rebuild the missing edge. When the epoxy cures, it can be sanded smooth and painted to achieve a durable and waterproof repair. Photo: NPS files.

The surface of the consolidated wood can then be filled with a semirigid epoxy patching compound, sanded and painted. Epoxy patching compounds can be used to build up missing sections or decayed ends of members. Profiles can be duplicated using hand molds, which are created by pressing a ball of patching compound over a sound section of the profile which has been rubbed with butcher's wax. This can be a very efficient technique where there are many typical repairs to be done. The process has been widely used and proven in marine applications; and proprietary products are available at hardware and marine supply stores. Although epoxy materials may be comparatively expensive, they hold the promise of being among the most durable and long lasting materials available for wood repair. More information on epoxies can be found in the publication "Epoxies for Wood Repairs in Historic Buildings," cited in the bibliography.
