# Intensive Archaeological Survey of the Hemisfair Martinez Street Surface Parking Lot Project and a Segment of the Acequia del Alamo/Acequia Madre (41BX8), San Antonio, Bexar County, Texas

Antiquities Permit No. 7511  
Principal Investigator:  
Mary Jo Galindo, Ph.D., RPA

Report Authors:  
Mary Jo Galindo, Ph.D., RPA;  
Katie Hill, M.A.; and Jacob I. Sullivan, B.S.

January 2017

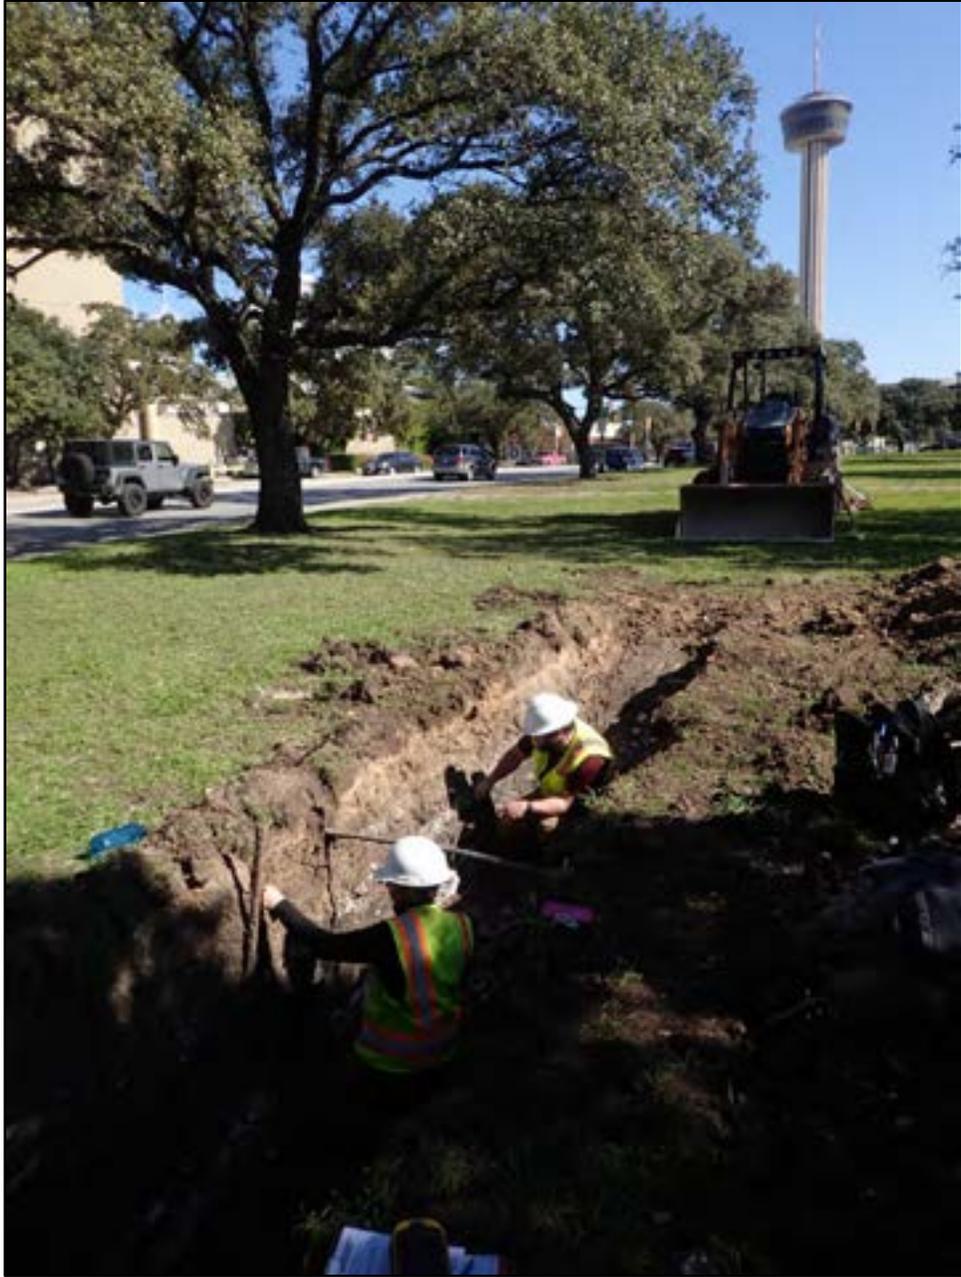
Figure 2: Overview of the project area and Backhoe Trench 1, facing northeast.

The project area consists of a roughly rectangular, grass-covered area with mature pine and oak trees along the perimeter (Figures 2 and 3). It is maximally 81 feet (ft) (25 meters [m]) north to south and 365 ft (111 m) east to west, for a total area of 0.64 acre (0.26 hectare [ha]). Bounded by East César E. Chávez Boulevard and Martinez Street to the north and south, respectively, and to the east and west by South Presa and South Alamo Streets, the project area is about 0.56 mile (0.90 kilometer [km]) northwest of the intersection of East César E. Chávez Boulevard and Interstate Highway 37.

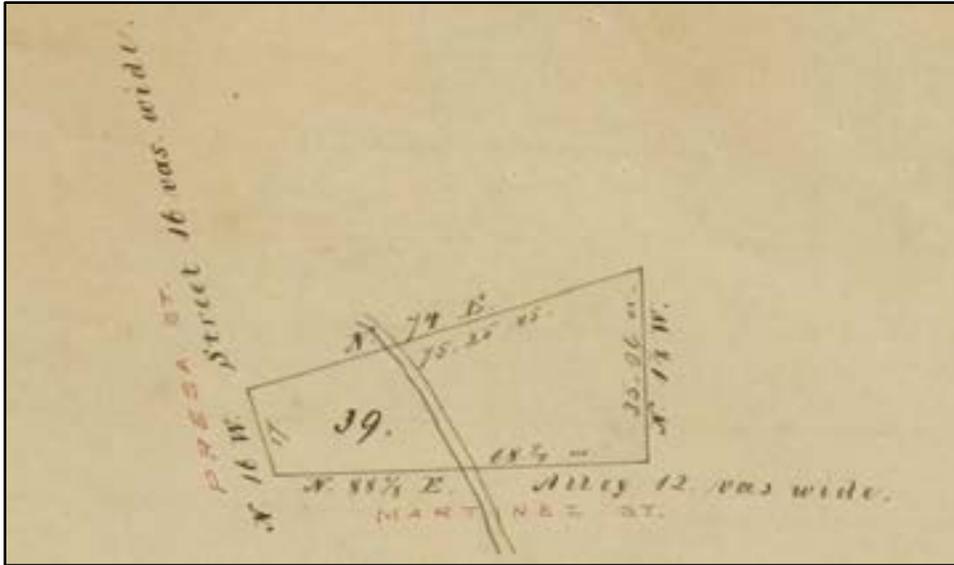
Figure 8. Plat and field notes by R. E. Clements indicating a ditch traverses Lot 39 of Old/New City Block 901, which is within the project area near the corner of South Presa and Martinez Streets (Subdivision, Civil Engineer, Survey Book 1:191, August 10, 1853).

According to one historian, the Acequia del Alamo was expanded during the 1860s by adding a branch that reached backward at Martinez Street towards Garden Street (present-day South St. Mary's Street) (Corner 1890:45). While Corner (1890) dates the construction of this branch to the 1860s, it was already depicted on maps by 1853 (see Figure 8), and even by 1850 (discussed below). This branch crossed the Acequia Pajalache (also called Concepción Acequia) at Garden Street via a *cano*, or hollowed cypress log, before rejoining the (unchannelized) river (Corner 1890:45). As mentioned, prior to channelization a prominent bend in the San Antonio River was approximately 514 ft (157 m) west of the project area, and this is where the acequia branch would have rejoined the river immediately after crossing the Acequia Pajalache (see Figure 10). Corner's (1890) description also matches the depiction of an acequia path that crosses the project area on maps that are on file with the SA-OHP (see Figure 9). Cox (2005:30) describes a similar canoa crossing of the Acequias del Alamo and Pajalache near the present-day intersection of South St. Mary's and South Alamo Streets, before it was formalized with a stone aqueduct in the mid-1800s.

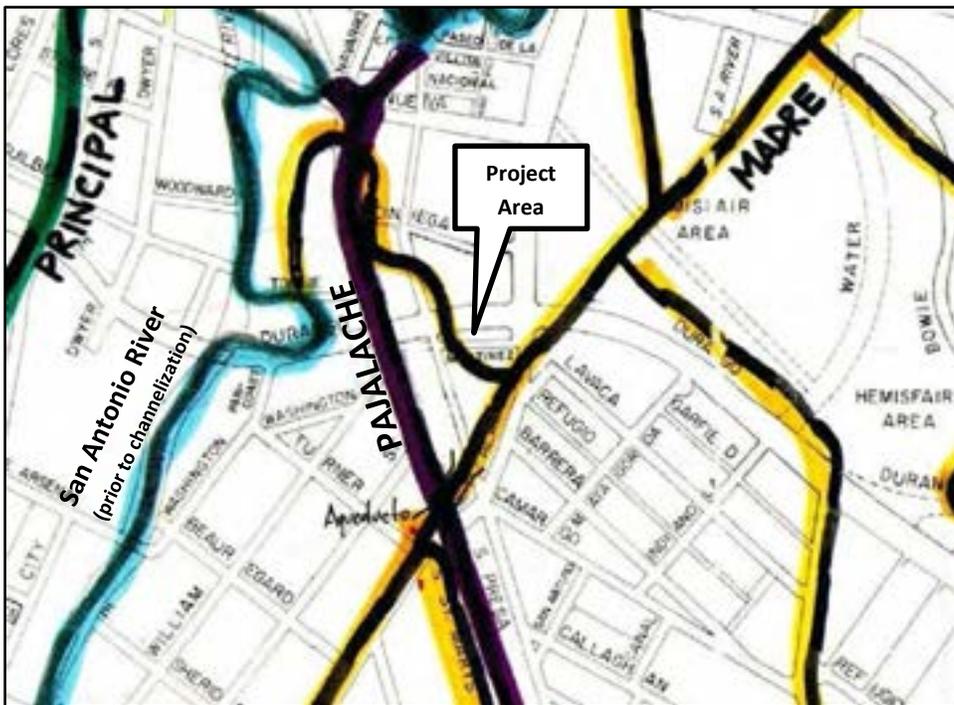
Figure 9. Project area on a portion of an acequia map that is on file with the SA-OHP.

As discussed in the background review results section of this report, the Acequia del Alamo was expanded at some point before 1850 by adding a branch that reached backward at Martinez Street towards Garden Street (present-day South St. Mary’s Street) (Corner 1890:45). This branch crossed the Acequia Pajalache at Garden Street via a *canoas*, or hollowed cypress log, before rejoining the (unchannelized) San Antonio River about 514 ft (157 m) west of the project area (Corner 1890:45). Corner’s (1890) description matches the depiction of the project area in acequia maps on file with the SA-OHP, an 1883 map, and plat maps in the COSA archives (see Figures 9, 10, 11, and 12).

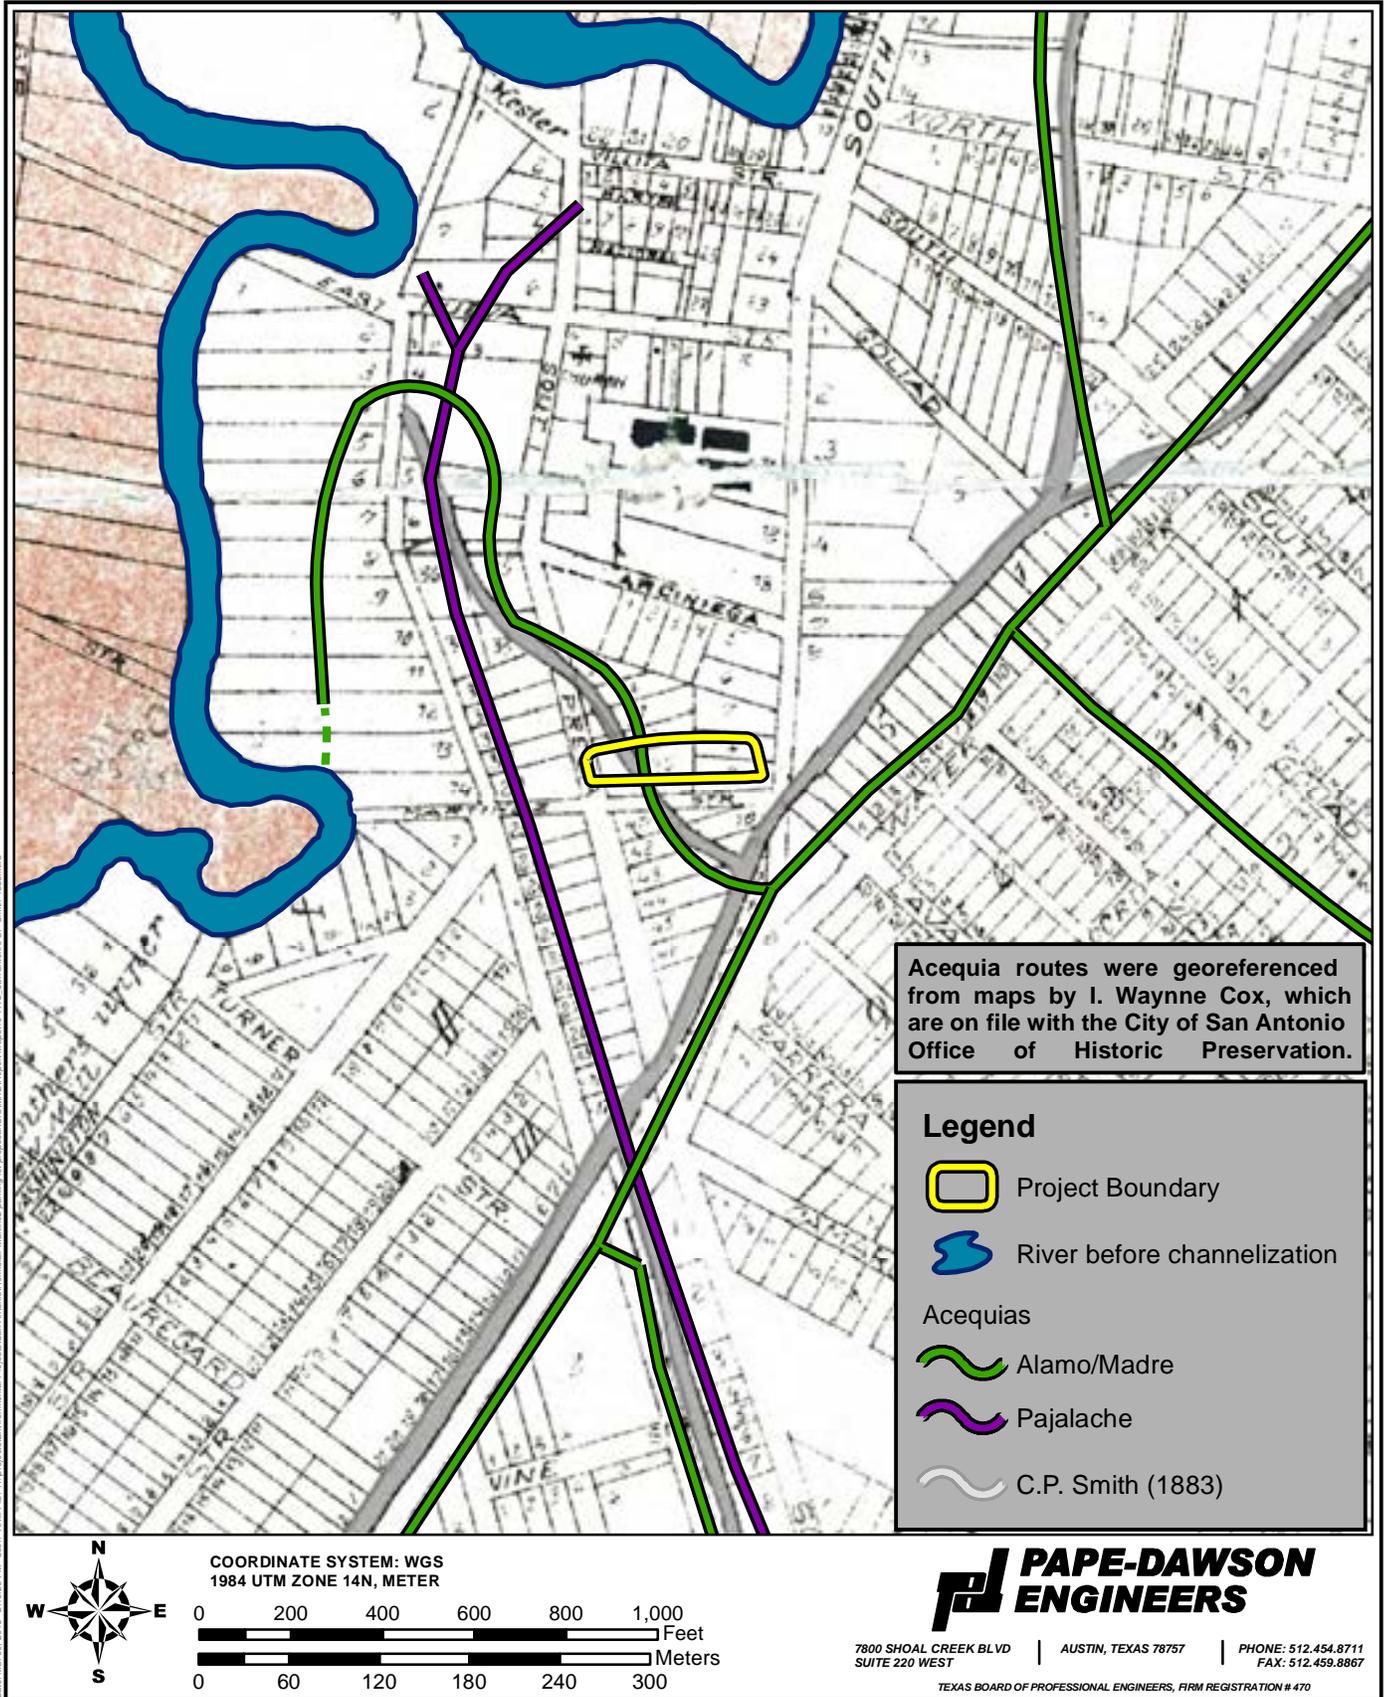
Figure 10. 1883 C.P. Smith map of San Antonio (Foster et al. 2006)

A review of 15 Texas Historic Overlay maps from 1767 to 1953 determined that structures were depicted within the subject property on these historic-age maps (Foster et al. 2006). Specifically, an 1868 map of San Antonio by an unknown artist, an 1883 map of San Antonio by C. P. Smith, and a 1912 San Antonio Officials map depict an acequia segment traversing the western half of the project area (see Figure 10) (Foster et al. 2006). According to the 1912 map, the entire block that includes the project area was once agricultural land owned by Vicente Micheli. A house is depicted on the corner of South Presa

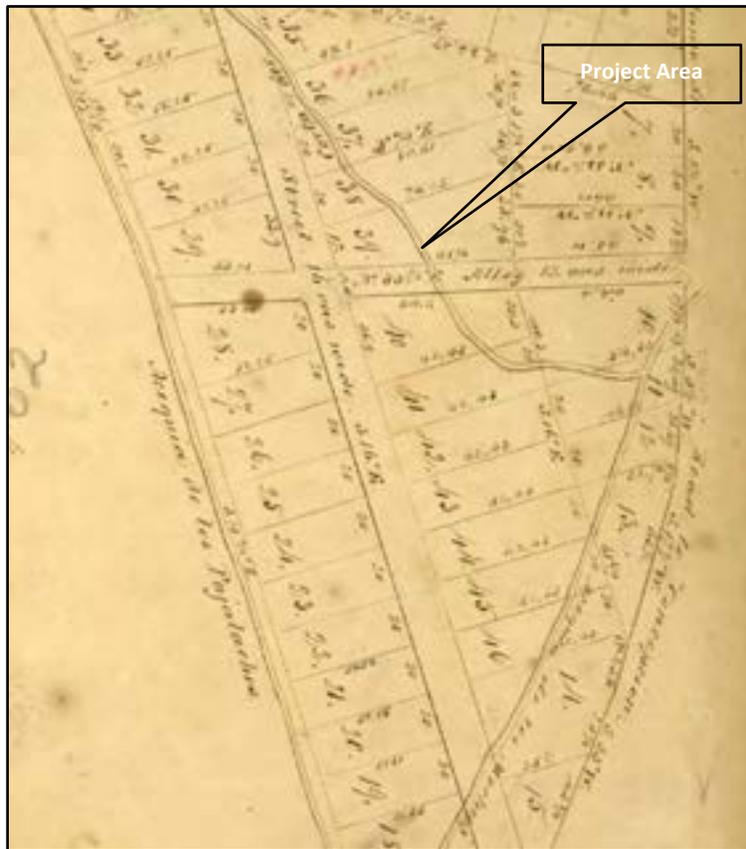
**Figure 11: Plat map by F. Giraud of an acequia branch crossing the project area (Subdivision, Civil Engineer, Survey Book 1:134, February 14, 1850).**

Two other historic depictions of this acequia branch were located in the COSA archives (Figures 11 and 12), supplying more evidence that it was intended as a branch of the Acequia del Alamo. As mentioned, the first plat map is from 1850—a decade before Corner (1890) said the branch was constructed. Labeled, “Cortador,” or short-cut, the acequia branch separates from the Acequia del Alamo (labeled “Acequia de los Mochos”) at Lot 11 of New City Block (NCB) 901, catches the corner of Lot 10 before traversing Lots 40 and 41, and crossing Martinez Street. It then traverses Lots 35 through 39 of NCB 903 before crossing Presa Street. The current project area is within Lot 39. The branch’s termination at either the Acequia Pajalache or the San Antonio River was not depicted. The second plat map is dated 1880 and it depicts NCB 903, which is across Martinez Street and south of the project area. The Acequia del Alamo is labeled, “Alamo Ditch,” while the channel that traverses the project area is labeled, “Branch Ditch.” It follows much the same path as in the 1850 map, originating in Lot 11 and crossing Lots 10, 41, and 40 before crossing Martinez Street and entering the project area.

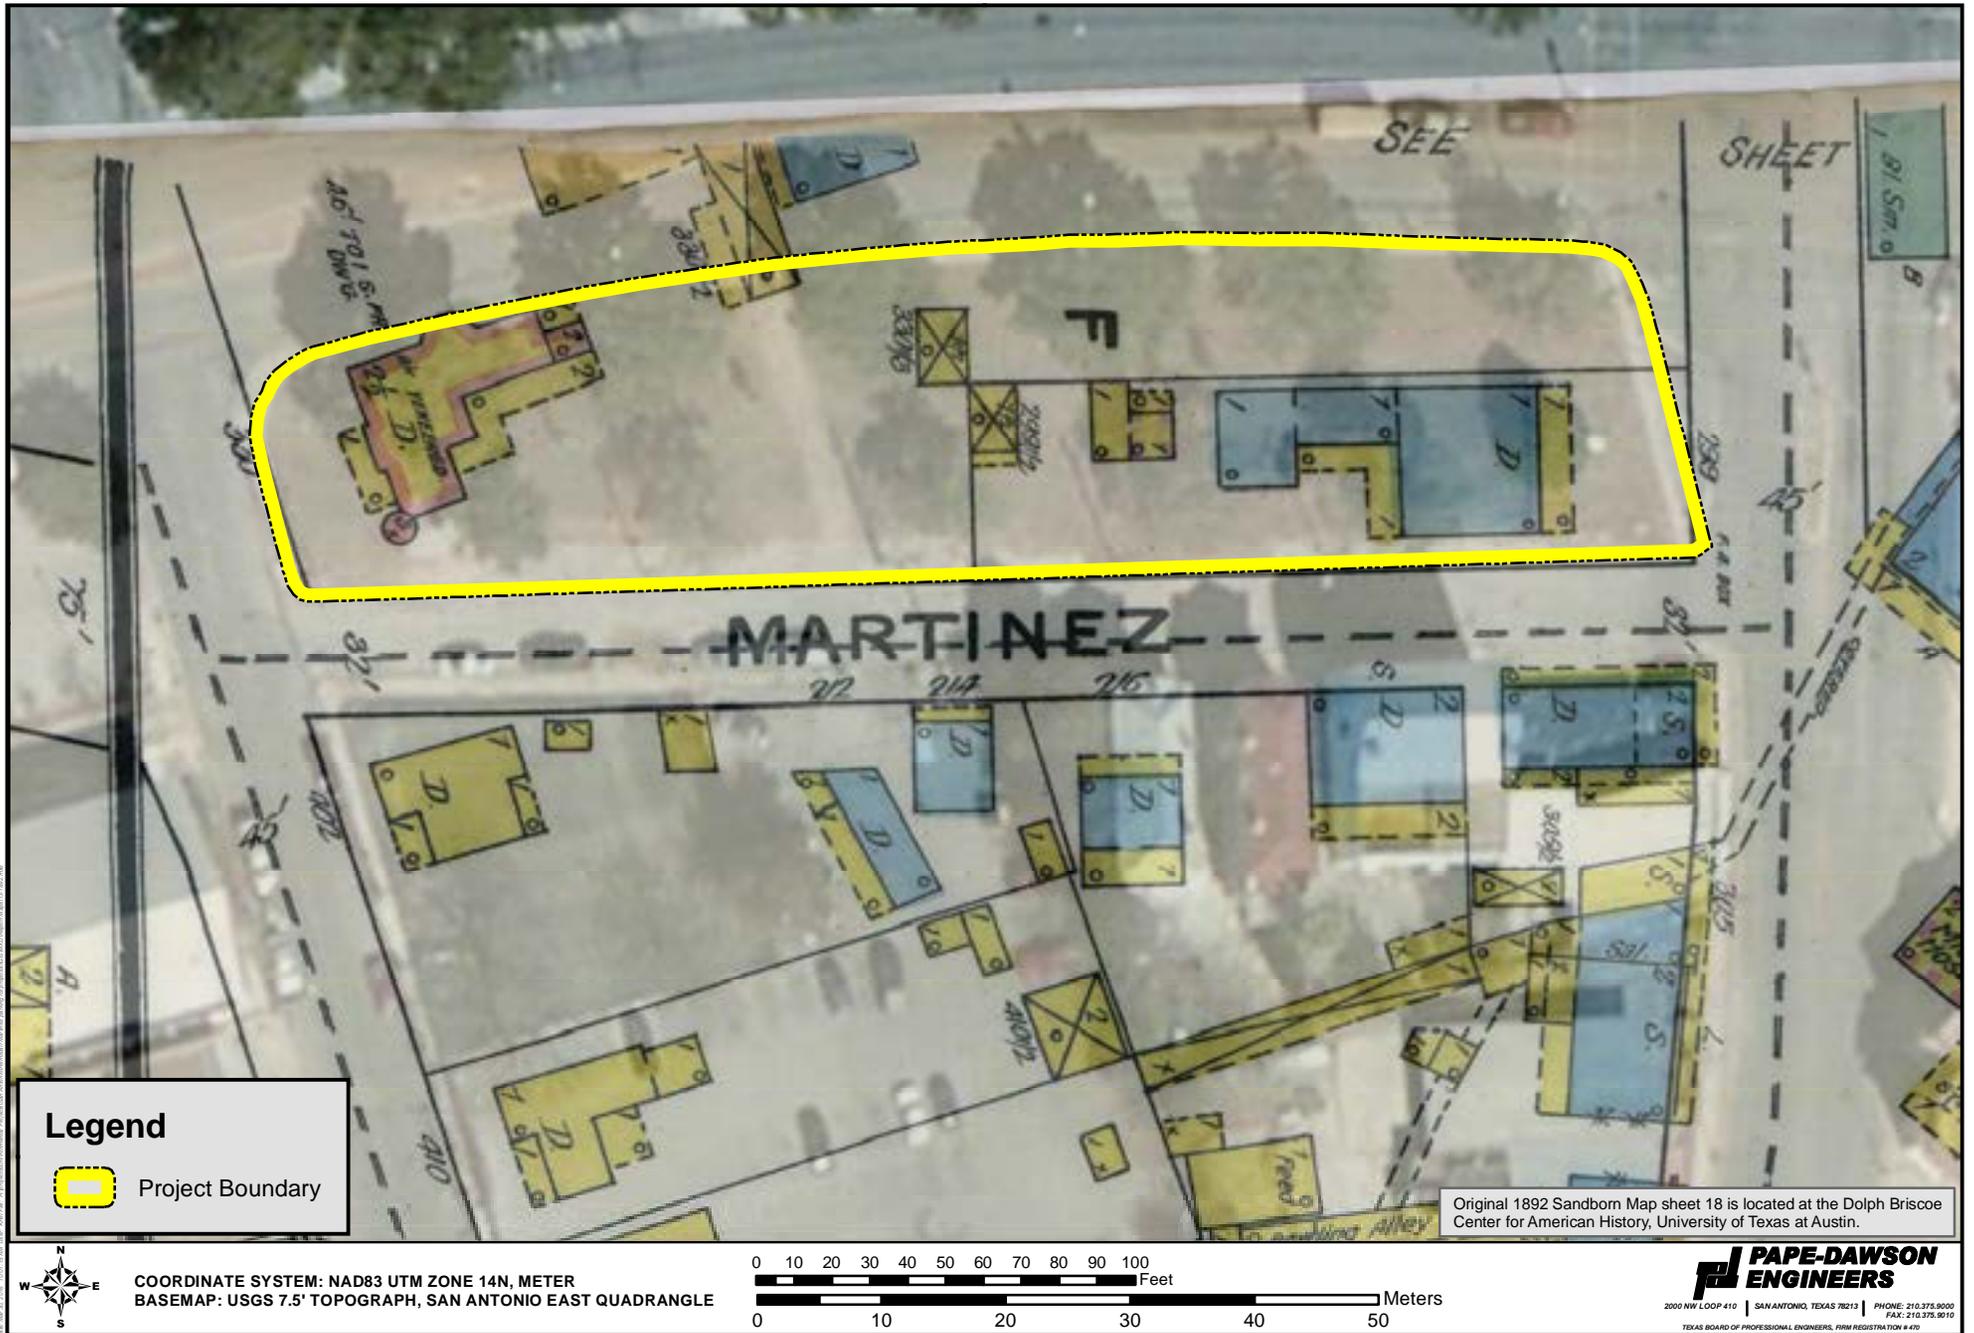
Figure 13 : 1892 Sanborn Map with Project Boundary

The 1888 Sanborn maps do not extend coverage to the project area; however, the 1892 Sanborn (Sheet 18) illustrates two homes within the project area, one facing South Presa Street and the other facing South Alamo Street (Figure 13). The home at 330 South Presa Street is a 2-1/2-story frame structure with brick veneer and a slate or tin roof. A 3-story turret is depicted at the southwest corner with a shingled roof. There was a 1-story porch facing South Presa Street and another at the dwelling's northeastern corner. A stately home, it has an extensive L-shaped, 2-story porch along the southern side and a bay window facing north. The home was built on two lots and another residence with attached stables is northeast of the main dwelling, labeled 330-1/2 South Presa Street. A portion of 330-1/2's stable and porch extends into the project area. (The location of the remainder of the 330-1/2 South Presa Street dwelling would now be within the right-of-way of East César E. Chávez Boulevard.) A small frame stable with a slate or tin roof is labeled 330-1/3 South Presa Street at the eastern end of the lot and within the current project area.

The 1892 Sanborn (Sheet 18) also illustrates a residence at 299 South Alamo Street that is a 1-story stone building with a slate or tin roof. A 1-story porch spans the length of the structure, facing east to South Alamo Street. A second L-shaped porch is nestled amidst the house's three main rooms and faces Martinez Street to the south. Behind the house is a small frame building with brick nogging (masonry used to fill the spaces between frame studs) and a slate or tin roof. Its small porch faces north. A separate address for this building is not indicated; however, at the back corner of the lot is a small frame stable with an address of 299-1/2 South Alamo Street. The stable has a slate or tin roof and its porch faces south to Martinez Street. Its northwestern corner is depicted adjacent to the southeastern corner of the stable at 330-1/3 South Presa Street.

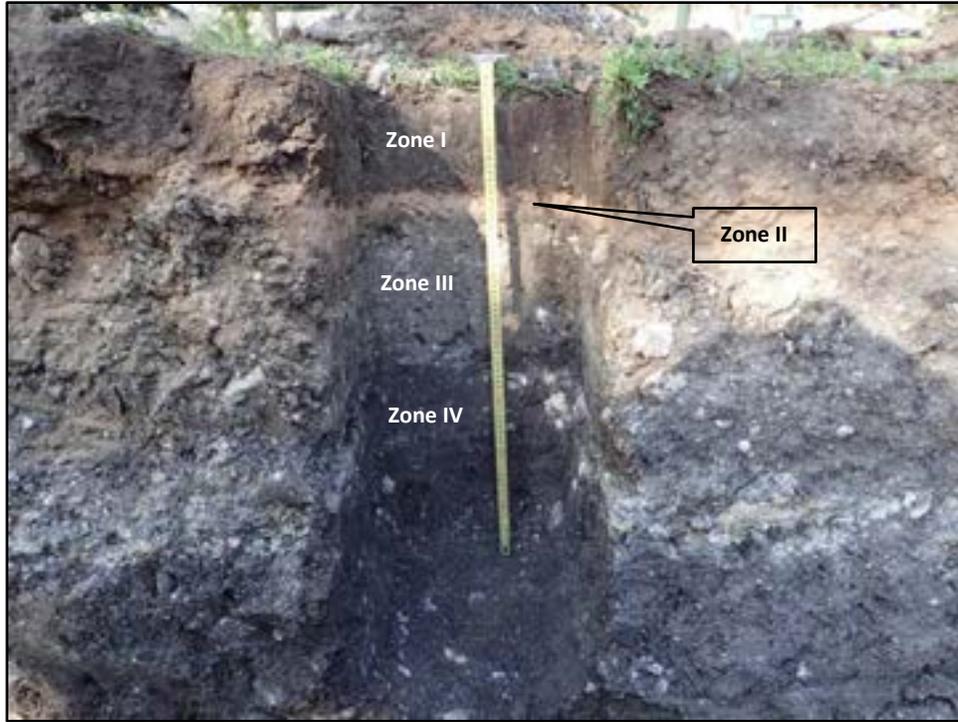
Figure 16: Strata identified in BHT 1 (Column Sample A), facing north. Not pictured is Zone V, bedrock.

The investigations encountered brown (10YR4/3) loam and yellowish brown (10YR5/6) sand fill in the top 5.91 to 9.84 inches (15 to 25 cm) below surface in all trenches. These were designated Zones I and II, respectively (Figure 16). Zone III varied in thickness between 9.84 to 19.69 inches (25 to 50 cm), and consisted of a dark gray brown (10YR4/2) to light yellowish brown (10YR6/4) clay with limestone pebbles and cobbles ranging in diameter from 0.39 to 3.94 inches (1 to 10 cm). The matrix in Zone III exhibited about 20 to 50 percent mottling with very pale brown (10YR7/4) sandy clay. Besides root and rootlet inclusions, undiagnostic yellow and red bricks and brick fragments were noted in Zone III of all BHTs. All of these bricks were isolated, and while some had mortar attached, no brick features were encountered. The short exterior sides of the red bricks were consistently discolored with a black material that proved to be tar. Although no maker's mark was stamped into them, these red bricks were in manufacture during the 1890s (Kay Hindes personal communication 2016) and were apparently used as paving stones. One specimen from BHT 2 retained a layer of asphalt attached to it (Figure 17). Zone IV varied in each trench. In BHT 1, Zone IV was a very dark brown (10YR2/2) clay that appeared to be intact. Zone V was white (10YR8/1) limestone bedrock, which was evident in all trenches.

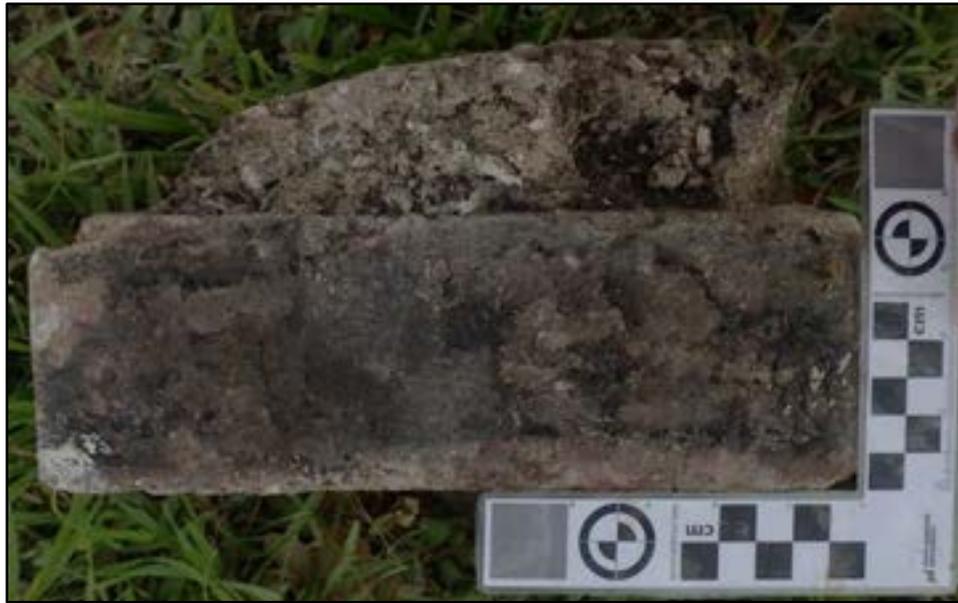
Figure 17: Circa 1890s red brick paver with asphalt layer attached.

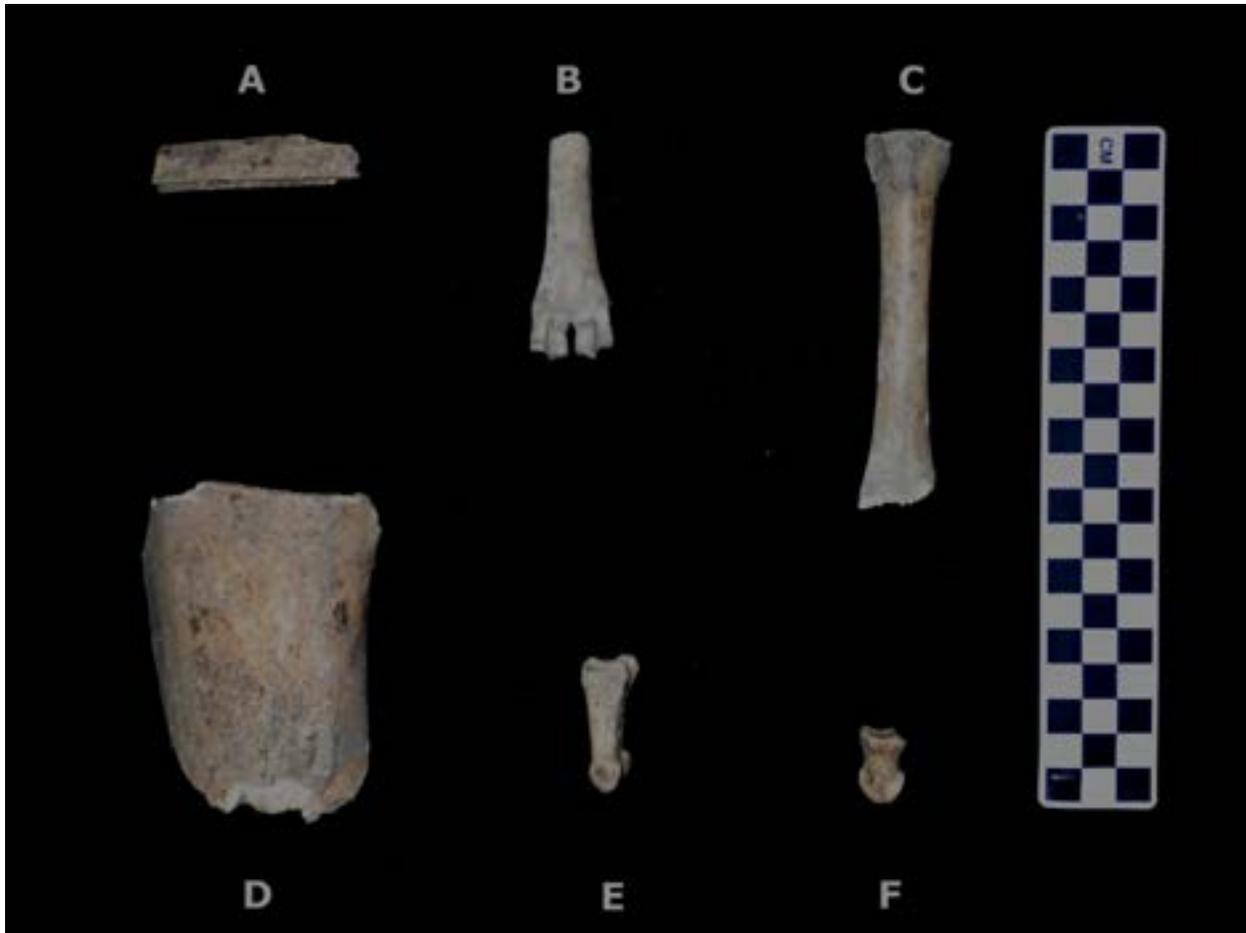
Figure 18: Animal bone sample from the BHT 1 back dirt pile. A) Large mammal rib fragment cut lengthwise; B) Left metapodia (distal end and partial shaft) of an adult sheep or goat; C) Left metacarpal (proximal end and partial shaft) of an adult sheep or goat; D) Large mammal (probably cow) femur shaft fragment with cut mark; E) First phalanx of an adult sheep or goat; F) Second phalanx of an adult sheep or goat.

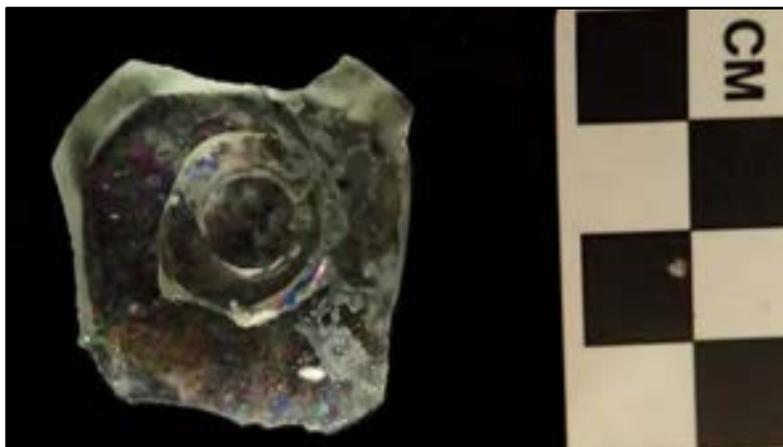
Figure 19. Glass bottle base fragment with an open pontil scar from BHT 1 column sample.

Based on the amount of cultural material noted during the BHT 1 excavation, an 11.81-by-11.81-inch (30-by-30-cm) column sample was excavated along the northern wall in 3.94-inch (10-cm) layers. Artifacts encountered in the BHT 1 column sample include a square nail in Zone III (11.81-15.75 inches [30-40 cm] below surface), an aqua glass bottle base fragment with an open pontil scar at the interface between Zones III and IV (11.81-19.69 inches [30-50 cm] below surface) (Figure 19), an undecorated

ceramic whiteware sherd in Zone IV (19.69-23.62 inches [50-60 cm] below surface), and charcoal from Zone IV (23.62-27.56 inches [60-70 cm] below surface). These artifacts were collected, but with the exception of the glass bottle base fragment with the open pontil scar, they will be discarded in consultation with the THC.

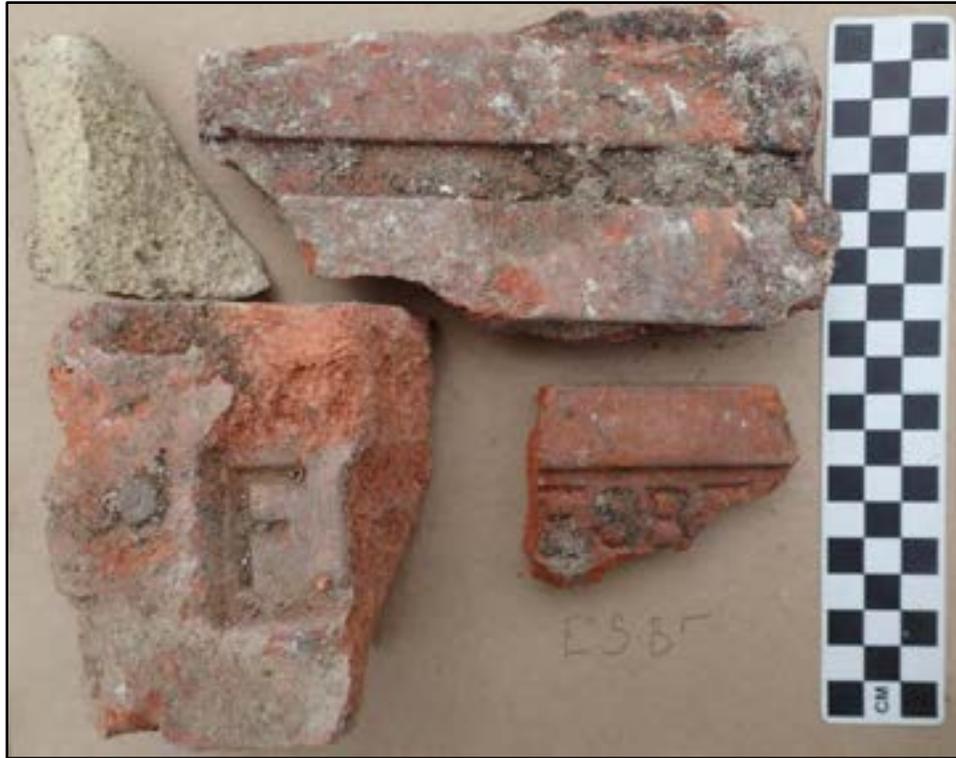
**Figure 20. A representative sample of artifacts encountered in BHT 3.**

BHT 3 was excavated near the rear property line between the former residences at 442 South Presa Street and 523 South Alamo Street. An undecorated whiteware rim sherd, clear and green bottle glass shards, and window pane fragments were noted in Zones III and IV. Fragments of a Ferris-brand red brick, yellow brick, red tile, and a red brick with a partial maker's mark (...ESB...) were noted in the back dirt pile of BHT 3 (Figure 20).

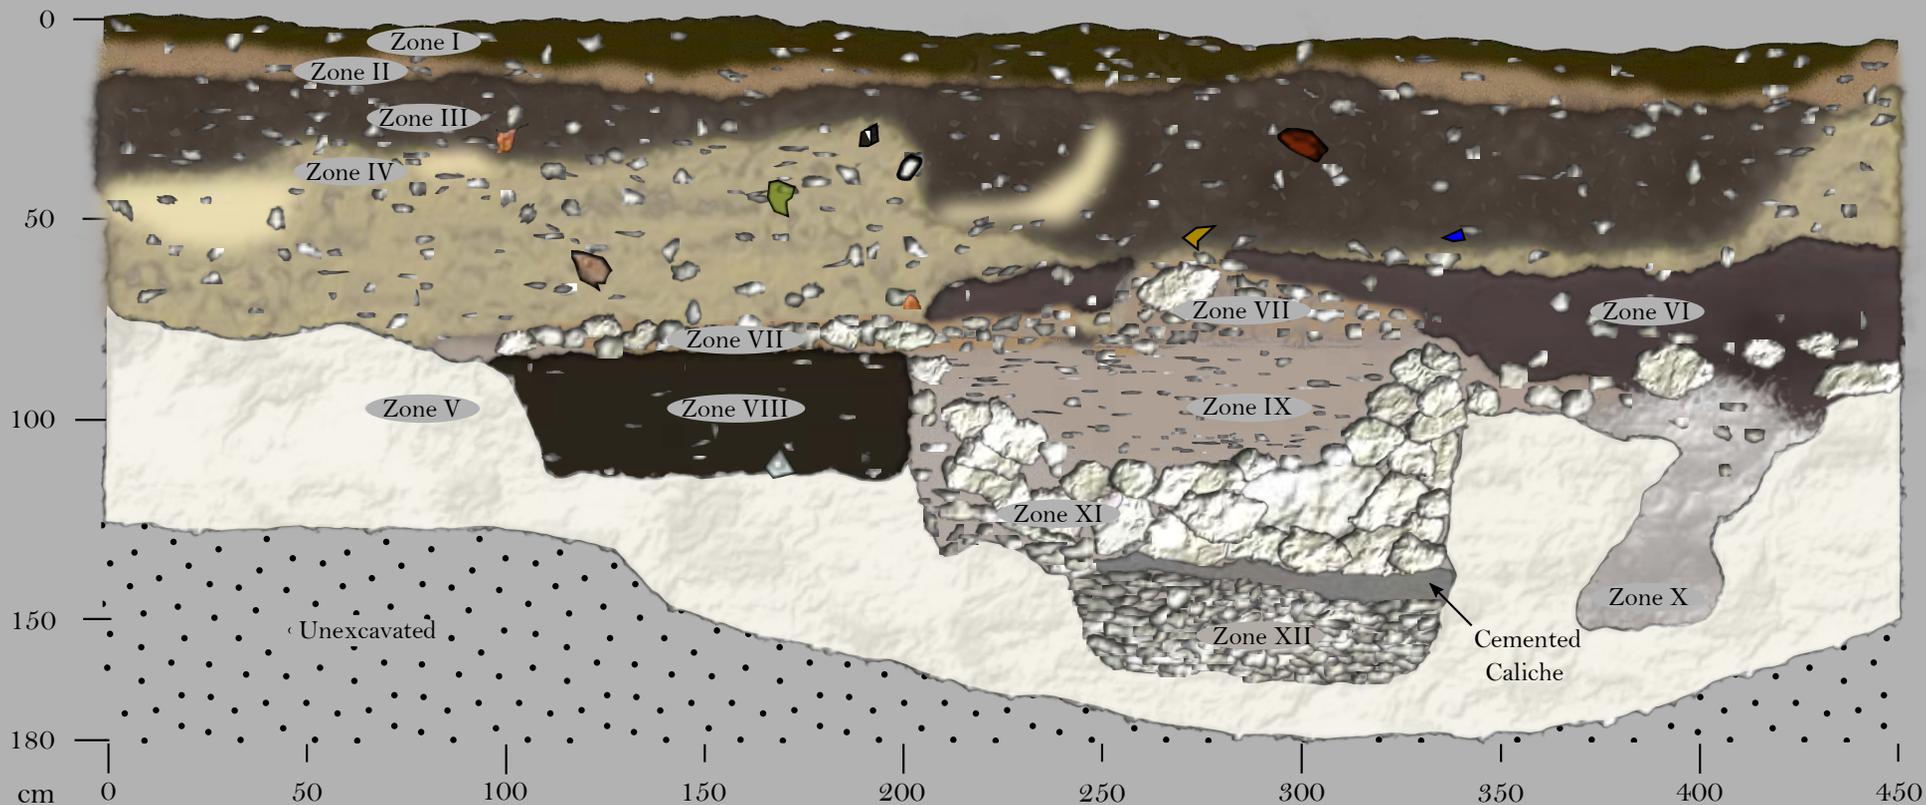
Figure 22: BHT 2 South Wall Profile

A five-stage construction sequence is discernible in the south wall profile, although some details of the following description are necessarily tentative. The deepest channel (5.25 ft [1.60 m] below current ground surface) appears to be the initial excavation into the bedrock that was about 3.3 ft (1 m) wide and 27.6 inches (70 cm) deep (see Figure 23, CS 1). The lower 9.8 inches (25 cm) of CS 1 was later filled with uniform-sized gravel and capped with a caliche-based cement or plaster. Zone XII may represent a location where the raw material for the cement was obtained; the resulting hole would have been filled with excess gravel. Whether this filling and capping was related to CS 1 or a subsequent use stage is not clear. At some point the channel was widened to 7.9 ft (2.4 m) with a depth of 11.8 inches (30 cm) and probably raised about 7.9 inches (20 cm) with larger (3.9- to 13.8-inch [10- to 35-cm] diameter) limestone cobbles (see Figure 23, CS 2). This wider CS 2 was then narrowed to 4.6 ft (1.4 m) by adding fill (see Figure 23, Zone VIII) and deepened into bedrock by about 7.9 inches (20 cm) (see Figure 23, CS 3), for a channel depth of 17.7 inches (45 cm). The bottom of CS 3 would have been comprised of bedrock and cemented caliche. Next, this channel was raised about 9.8 inches (25 cm) by lining it with medium-sized (3.9- to 5.9-inch [10- to 15-cm] diameter) limestone cobbles (see Figure 23, CS 4). CS 4 would have been 4.3 ft (1.3 m) wide and 11.8 inches (30 cm) deep. The last channel in the sequence is the upper one (7.9 inches [20 cm] below current ground surface), which measures 7.5 ft (2.3 m) wide and about 11.8 inches (30 cm) deep (see Figure 23, CS 5).

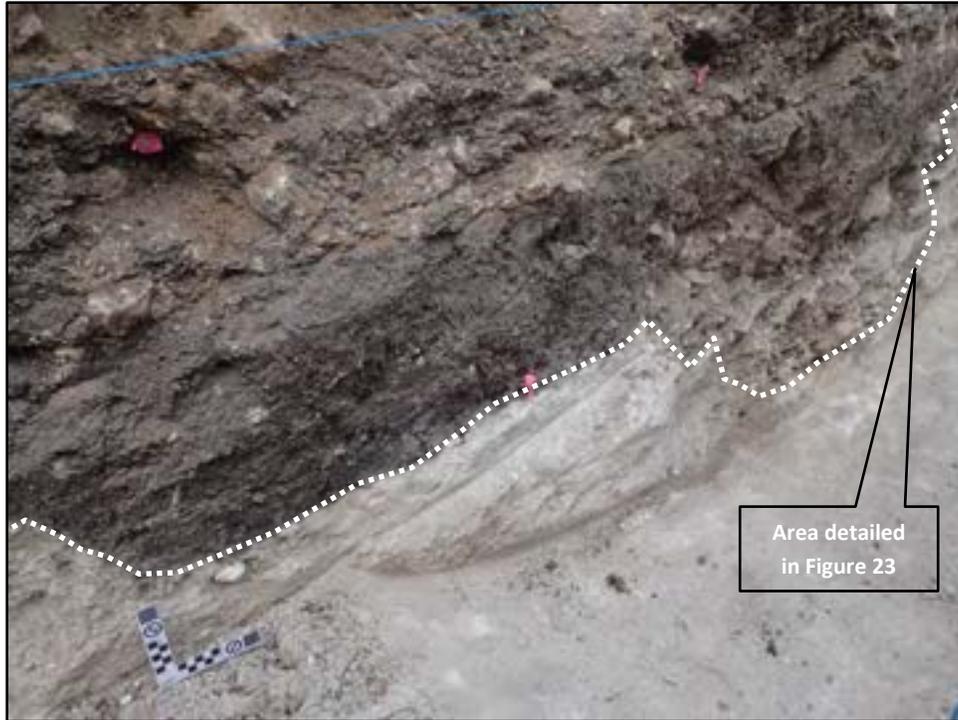
Figure 24: BHT 2 South wall profile detail of bedrock cut, facing southwest.

Most clearly evident in the southern wall profile, the acequia channel had been cut into bedrock, and the deepest cut in the center had been filled with gravel and sealed with caliche cement or plaster (Figures 24 and 25). In the north wall, the bedrock cut was maximally about 12.30 ft (3.75 m) wide, while in the south wall it was about 7.9 ft (2.40 m), measuring from the eastern side of Construction Sequence 2 (CS 2) to the western side of CSs 1, 2, and 3 (see Figure 23). The deepest channel in the north profile was cut into the bedrock at about 5.91 ft (1.80 m) below surface in the north wall and at 5.25 ft (1.60 m) in the south wall of BHT 2, where the channel was 3.30 ft (1 m) wide. The uppermost acequia channel in the south wall profile is between 7.9 to 19.7 inches (20 to 50 cm) below surface. The variations between the north and south wall profiles are likely related to modifications made to the acequia through time and separate fill episodes evident in Zones III, IV, VI, VII, VIII, and IX. Additionally, the exact alignment of the acequia could not be determined in BHT 2, but it appeared to be north-northeast to south-southwest orientation, based on the alignment of the deepest channels in both the north and south wall profiles of BHT 2. However, this would be at odds with the mapped route that is aligned north-northwest to south-southeast.

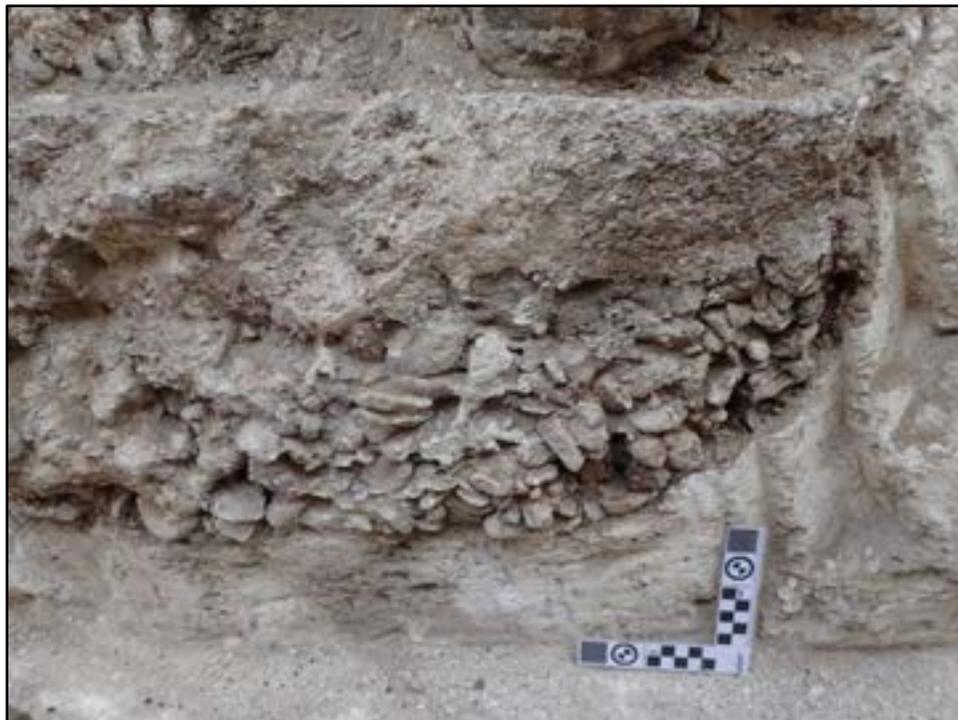
Figure 25: BHT 2 South wall profile detail of central bedrock cut with gravel fill and plaster seal, facing south.

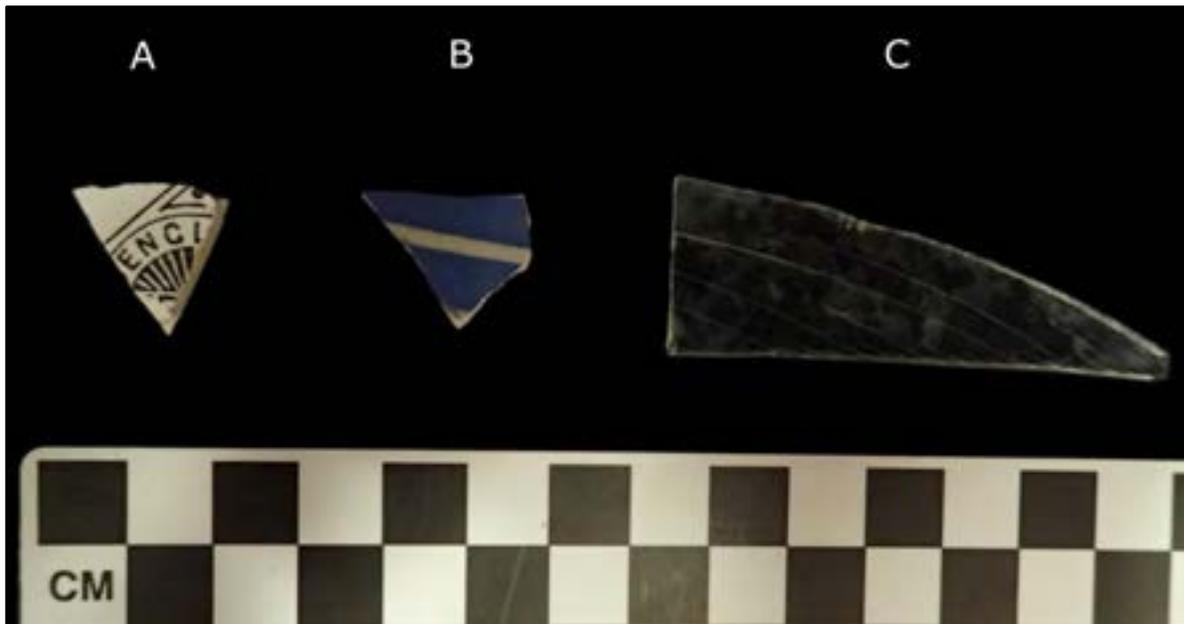
**Figure 26: A) Ironstone; B) blue-banded annular ware; and C) window pane glass from the south wall profile of BHT 2.**

Cultural material was evident in Zones III, IV, and VI of the south wall profile. Diagnostic artifacts include an English ironstone fragment with a partial maker's mark and a sherd of blue-banded whiteware (or annular ware) that were collected from the interface between Zones III and IV; and a 0.01-inch (2.52-millimeter [mm]) thick window pane fragment from the juncture of Zone VI (homogenous, very dark grayish brown [10YR3/2] clay fill) and bedrock (Figure 26; see Figure 22). The partial maker's mark includes the letters, "ENGL" in an arc over a stylized sunrise pattern and an apparent triangle with a dot inside centered above the lettering. Ironstone dates from 1840 to the present, while blue-banded whiteware from England date between 1830 and 1860 (Brown 1982). Afterwards, similar versions produced in the United States continue in popularity into the twentieth century (Brown 1982).

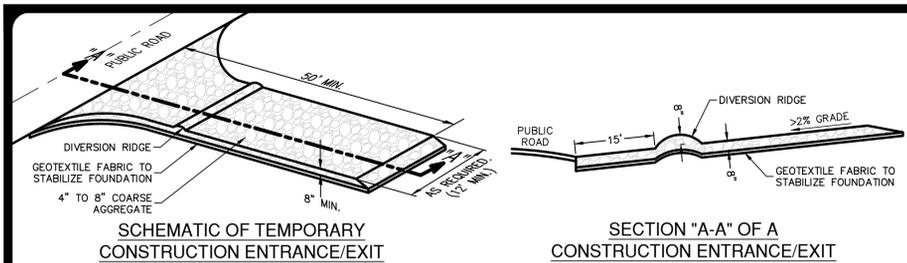
**STABILIZED CONSTRUCTION ENTRANCE/EXIT DETAIL**

**MATERIALS**

1. THE AGGREGATE SHOULD CONSIST OF 4-INCH TO 8-INCH WASHED STONE OVER A STABLE FOUNDATION AS SPECIFIED IN THE PLAN.
2. THE AGGREGATE SHOULD BE PLACED WITH A MINIMUM THICKNESS OF 8-INCHES.
3. THE GEOTEXTILE FABRIC SHOULD BE DESIGNED SPECIFICALLY FOR USE AS A SOIL FILTRATION MEDIA WITH AN APPROXIMATE WEIGHT OF 6 OZ/YD<sup>2</sup>, A MULLEN BURST RATING OF 140 LB/IN<sup>2</sup>, AND AN EQUIVALENT OPENING SIZE GREATER THAN A NUMBER 50 SIEVE.
4. IF A WASHING FACILITY IS REQUIRED, A LEVEL AREA WITH A MINIMUM OF 4-INCH DIAMETER WASHED STONE OR COMMERCIAL ROCK SHOULD BE INCLUDED IN THE PLANS. DIVERT WASTEWATER TO A SEDIMENT TRAP OR BASIN.

1. AVOID CURVES ON PUBLIC ROADS AND STEEP SLOPES. REMOVE VEGETATION AND OTHER OBJECTIONABLE MATERIAL FROM THE FOUNDATION AREA. GRADE CROWN FOUNDATION FOR POSITIVE DRAINAGE.

4. IF THE SLOPE TOWARD THE ROAD EXCEEDS 2%, CONSTRUCT A RIDGE, 6-INCHES TO 8-INCHES HIGH WITH 3:1 (H:V) SIDE SLOPES, ACROSS THE FOUNDATION APPROXIMATELY 15 FEET FROM THE ENTRANCE TO DIVERT RUNOFF AWAY FROM THE PUBLIC ROAD.

5. PLACE GEOTEXTILE FABRIC AND GRADE FOUNDATION TO IMPROVE STABILITY, ESPECIALLY WHERE WET CONDITIONS ARE ANTICIPATED.
6. PLACE STONE TO DIMENSIONS AND GRADE SHOWN ON PLANS. LEAVE SURFACE SMOOTH AND SLOPE FOR DRAINAGE.

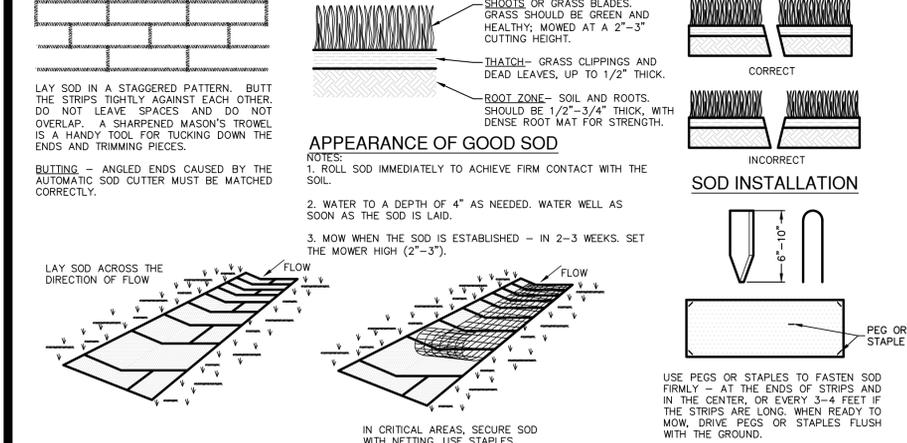
**SOD INSTALLATION DETAIL**

**GENERAL INSTALLATION (VA. DEPT. OF CONSERVATION, 1992)**

1. SOD SHOULD NOT BE CUT OR LAID IN EXCESSIVELY WET OR DRY WEATHER. SOD ALSO SHOULD NOT BE LAID ON SOIL SURFACES THAT ARE FROZEN.
2. DURING PERIODS OF HIGH TEMPERATURE, THE SOIL SHOULD BE LIGHTLY IRRIGATED IMMEDIATELY PRIOR TO LAYING THE SOD, TO COOL THE SOIL AND REDUCE ROOT BURNING AND DIEBACK.

3. THE FIRST ROW OF SOD SHOULD BE LAID IN A STRAIGHT LINE WITH SUBSEQUENT ROWS PLACED PARALLEL TO AND BUTTING TIGHTLY AGAINST EACH OTHER. LATERAL JOINTS SHOULD BE STAGGERED TO PROMOTE MORE UNIFORM GROWTH AND STRENGTH. CARE SHOULD BE EXERCISED TO ENSURE THAT SOD IS NOT STRETCHED OR OVERLAPPED AND THAT ALL JOINTS ARE BUTTED TIGHT IN ORDER TO PREVENT VOIDS WHICH WOULD CAUSE DRYING OF THE ROOTS (SEE FIGURE ABOVE).

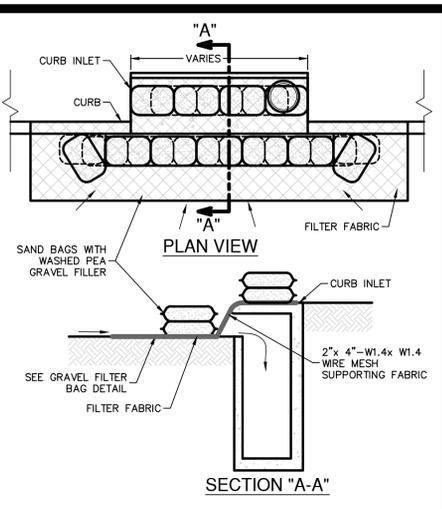
**BAGGED GRAVEL CURB INLET PROTECTION DETAIL**

1. CONTRACTOR TO INSTALL 2"x4"-W1.4xW1.4 WIRE MESH SUPPORTING FILTER FABRIC OVER THE INLET OPENING. FABRIC MUST BE SECURED TO WIRE BACKING WITH CLIPS OR WIRE TIES AT THIS LOCATION. SAND BAGS FILLED WITH WASHED PEA GRAVEL SHOULD BE PLACED ON TOP OF WIRE MESH ON TOP OF THE INLET AS SHOWN ON THIS DETAIL TO HOLD WIRE MESH IN PLACE. SANDBAGS FILLED WITH WASHED PEA GRAVEL SHOULD ALSO BE PLACED ALONG THE GUTTER AS SHOWN ON THIS DETAIL TO HOLD WIRE MESH IN PLACE. SAND BAGS TO BE STACKED TO FORM A CONTINUOUS BARRIER AROUND INLETS.
2. THE BAGS SHOULD BE TIGHTLY ABUTTED AGAINST EACH OTHER TO PREVENT RUNOFF FROM FLOWING BETWEEN THE BAGS.
3. CHECK PLACEMENT OF DEVICE TO PREVENT GAPS BETWEEN DEVICE AND CURB.
4. INSPECT FILTER FABRIC AND PATCH OR REPLACE IF TORN OR MISSING.
5. STRUCTURES SHOULD BE REMOVED AND THE AREA STABILIZED ONLY AFTER THE REMAINING DRAINAGE AREA HAS BEEN PROPERLY STABILIZED.

1. INSPECTION SHOULD BE MADE WEEKLY AND AFTER EACH RAINFALL. REPAIR OR REPLACEMENT SHOULD BE MADE PROMPTLY AS NEEDED BY THE CONTRACTOR.
2. REMOVE SEDIMENT WHEN BUILDUP REACHES A DEPTH OF 3 INCHES. REMOVED SEDIMENT SHOULD BE DEPOSITED IN A SUITABLE AREA AND IN SUCH A MANNER THAT IT WILL NOT ERODE.
3. CHECK PLACEMENT OF DEVICE TO PREVENT GAPS BETWEEN DEVICE AND CURB.
4. INSPECT FILTER FABRIC AND PATCH OR REPLACE IF TORN OR MISSING.

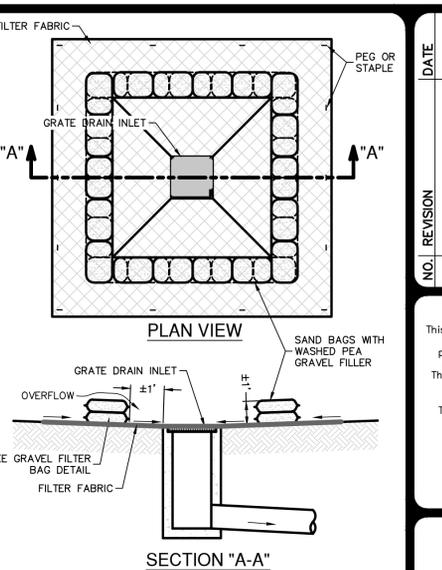
**GRAVEL FILTER BAG DETAIL**

**GENERAL NOTES**

1. THE FILTER BAG MATERIAL SHALL BE MADE OF POLYPROPYLENE, POLYETHYLENE OR POLYAMIDE WOVEN FABRIC, MIN. UNIT WEIGHT OF 4 OUNCES/SY, HAVE A MULLEN BURST STRENGTH EXCEEDING 300 PSI AND ULTRAVIOLET STABILITY EXCEEDING 70%.
2. THE FILTER BAG SHALL BE FILLED WITH CLEAN, MEDIUM WASHED PEA GRAVEL TO COARSE GRAVEL (0.31 TO 0.75 INCH DIAMETER).
3. SAND SHALL NOT BE USED TO FILL THE FILTER BAGS.
