# Intensive Archaeological Survey of the Hemisfair Martinez Street Surface Parking Lot Project and a Segment of the Acequia del Alamo/Acequia Madre (41BX8), San Antonio, Bexar County, Texas

Antiquities Permit No. 7511  
Principal Investigator:  
Mary Jo Galindo, Ph.D., RPA

Report Authors:  
Mary Jo Galindo, Ph.D., RPA;  
Katie Hill, M.A.; and Jacob I. Sullivan, B.S.

January 2017

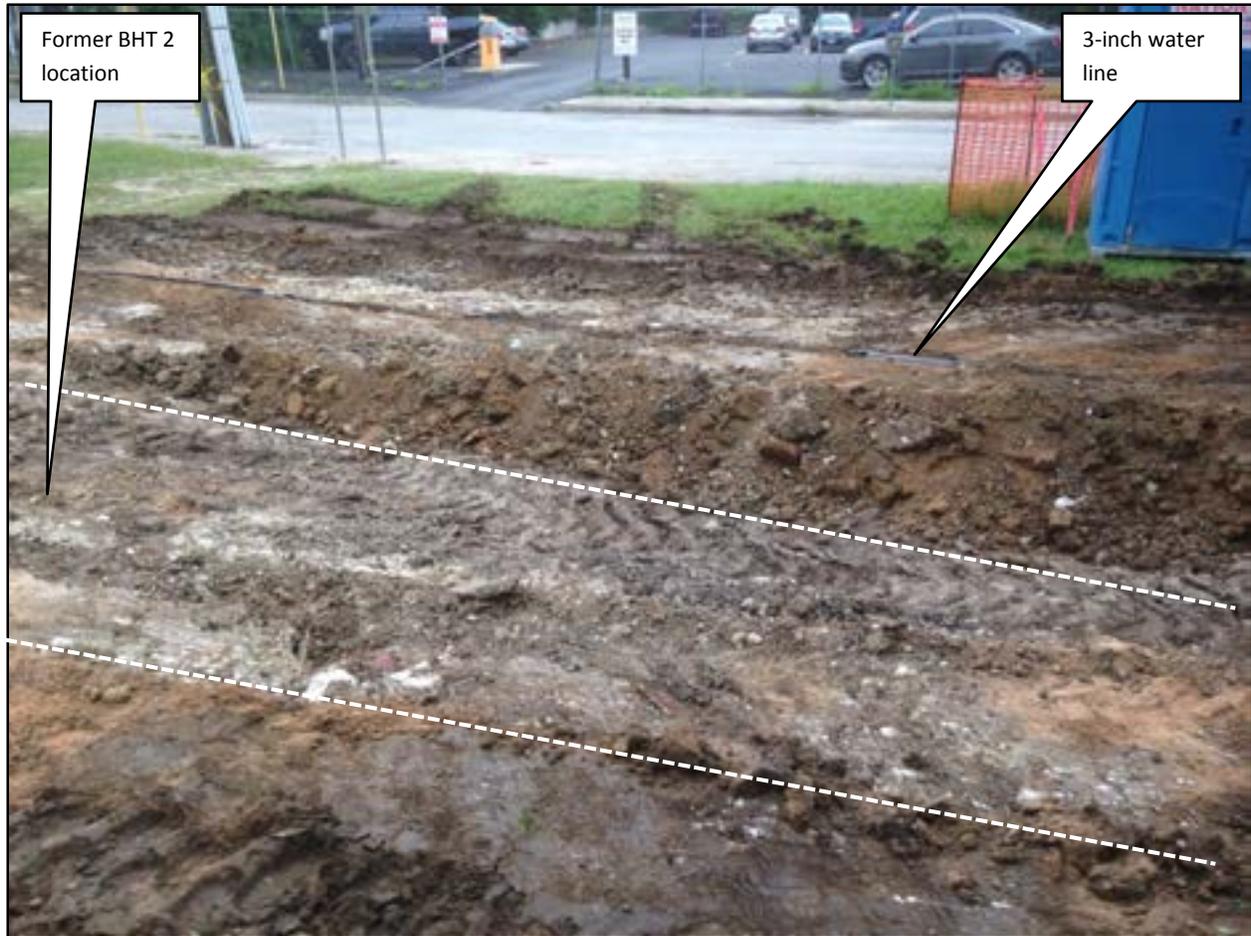
The monitoring encountered brown (10YR4/3) loam fill (Zone I) over yellowish brown (10YR5/6) sand fill (Zone II) as it was removed from roughly the top 5.91 to 9.84 inches (15 to 25 cm) below surface (Figure 4). An extensive irrigation system was revealed that was associated with the Zone II sand, pockets of which were observed to extend downward into Zone III. A dark gray brown (10YR4/2) to light yellowish

**Figure 4. Acequia Buffer overview, facing southeast.**

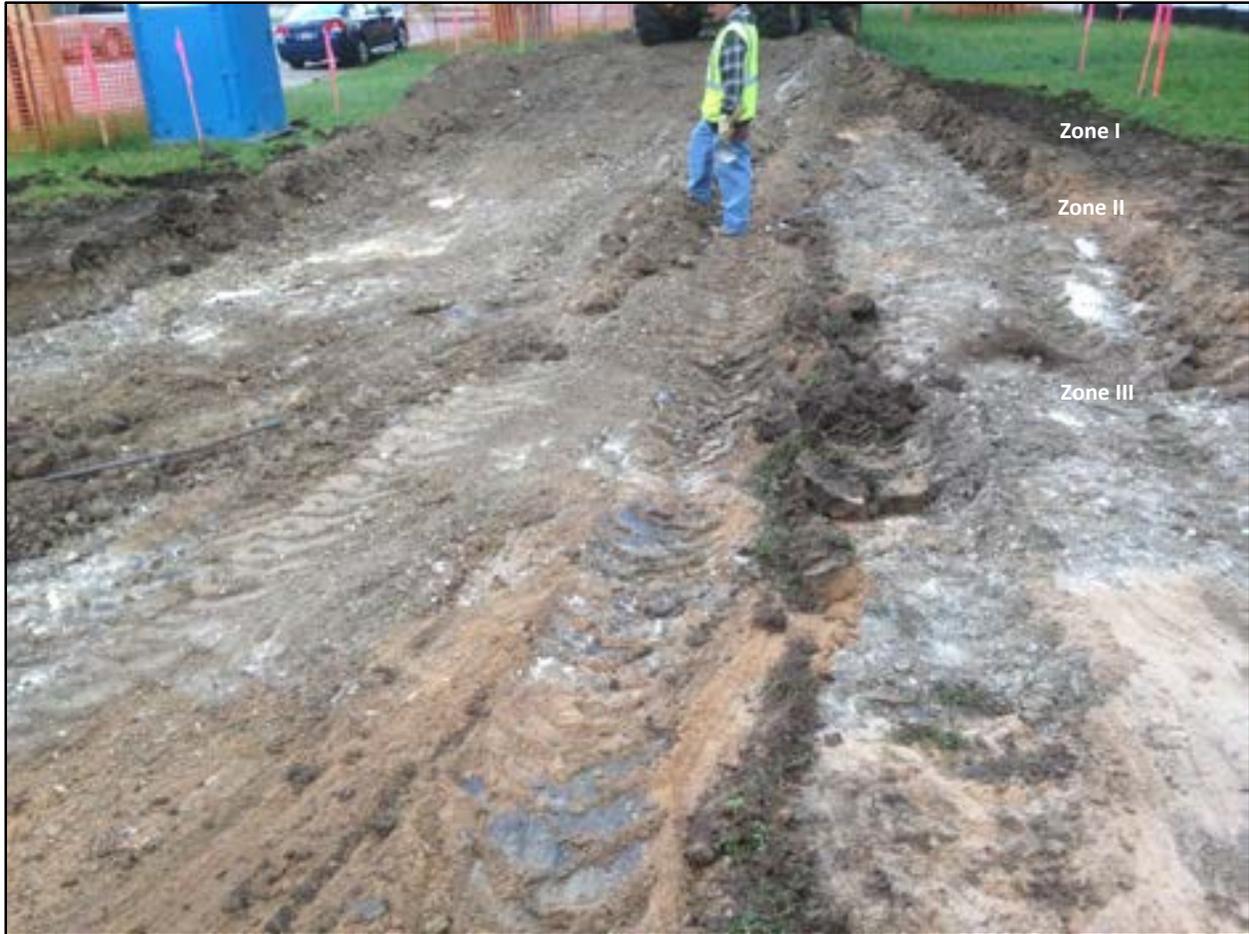
Grading proceeded to 12 inches (30 cm) below surface. At this point, the backfill outline of BHT 2 was still visible, and the recorded location of CS 5 in its western end was noted. Grading proceeded for another three 2-inch lifts (total of 6 inches [15 cm]) immediately south of BHT 2, but no trace of an

**Figure 5. Acequia Buffer overview, facing west. BHT 2 former location corresponds to the tire track in central foreground.**

acequia channel corresponding to CS 5 was encountered during the archaeological monitoring of construction for the Hemisfair Martinez Street Surface Parking Lot Project (Figure 5).
