Restoration and Previous Archaeology
At the Spanish Governor's Palace, San Antonio, Bexar
County, Texas.

By
Kristi M. Ulrich

Prepared by
Center for Archaeological Research-
The University of Texas at San Antonio

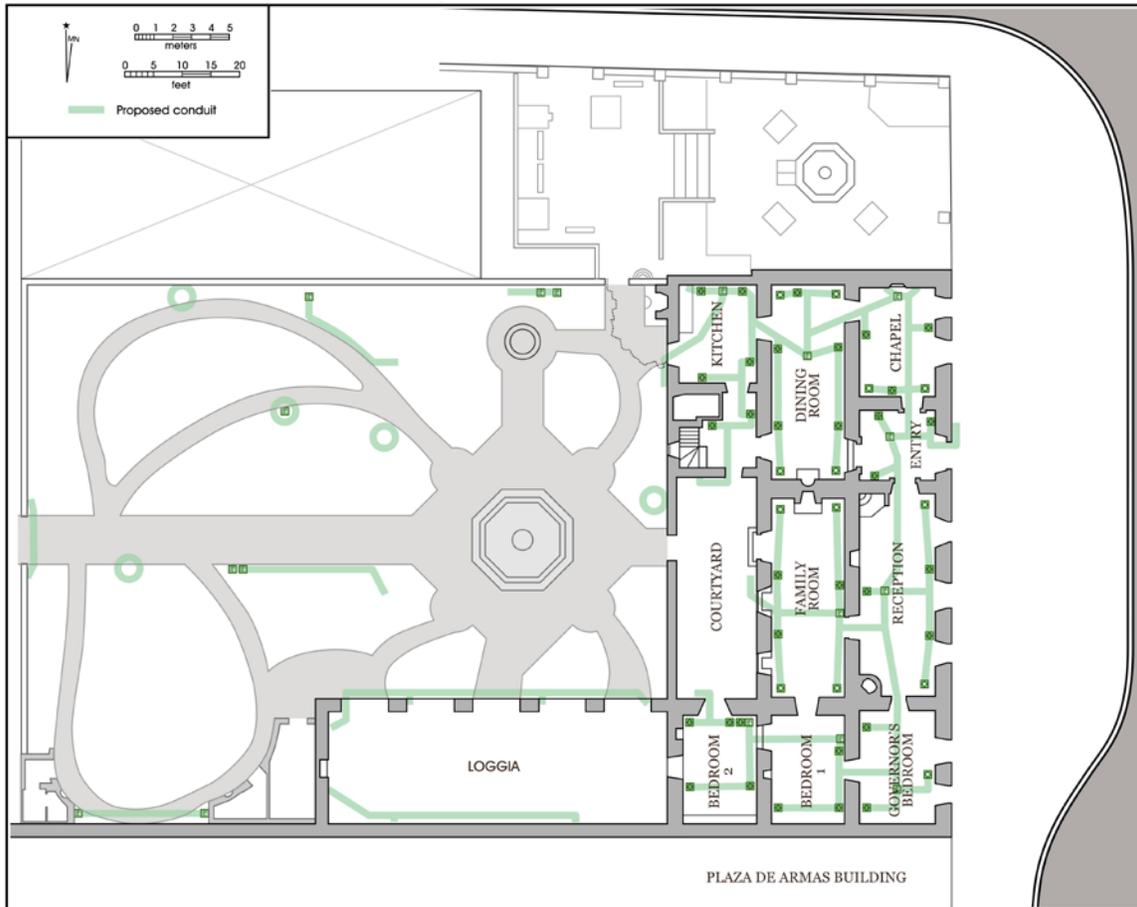
Figure 1. Plan map of the Governor's Palace and residence showing proposed conduit routes.

Robey Architecture, Inc., plans to install electrical lines within the rooms of the Spanish Governor's Palace, as well as in the rear courtyard as shown in Figure 1. Impacts derived from the installation of the electrical wiring will consist of trenching and the excavation of holes for in-ground lights, floor outlets and pull-boxes. According to the engineering schematics, the trenches allowing the installation of the wiring will be 6-inches deep and 6-inches wide. The installation of the in-ground lighting will necessitate excavation to a depth of 1-foot 8-inches to accommodate the necessary hardware and wiring. A total of 13 in-ground light units are to be installed. Floor outlets and pull-boxes will be installed to a depth of 7.25-inches below the floor and will necessitate holes measuring approximately 4.25 inches in diameter. The conduits connecting these pieces of hardware will be installed immediately below the existing pavers.

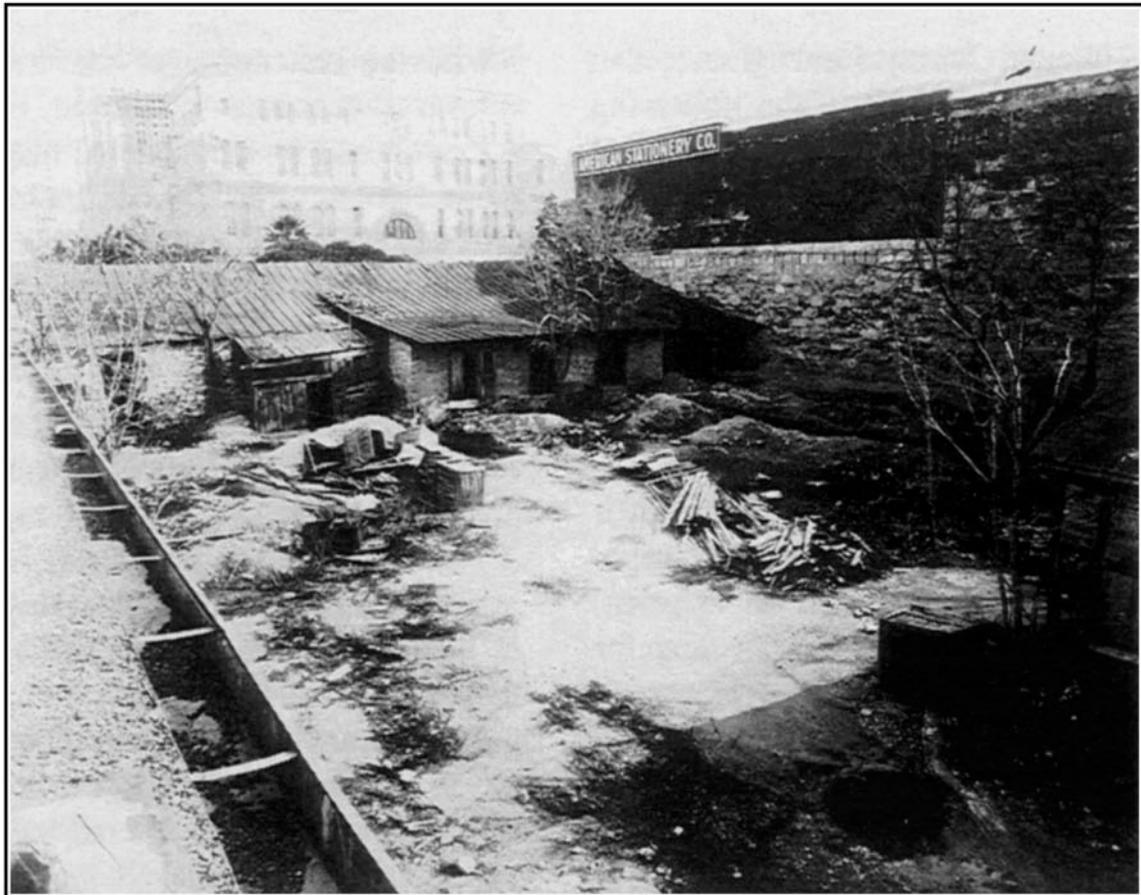
Figure 2. *Back yard and wall of the Spanish Governor's Palace, prior to restoration. Looking from the west.* From the *San Antonio Light* (22 December 1929) collection, the Institute of Texan Cultures.

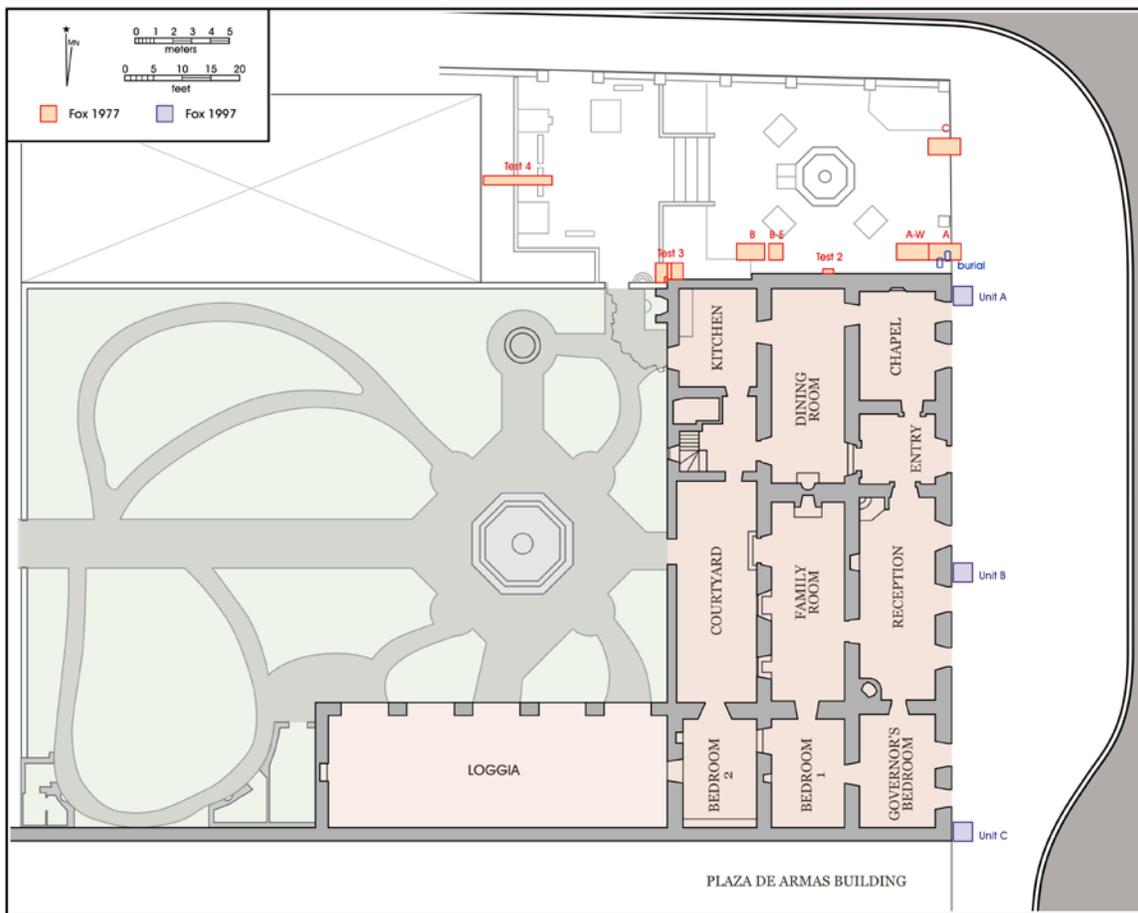
Figure 3. Plan map of previous archaeology at the Governor's Palace and residence.

Two archaeological investigations were conducted at the Spanish Governor's Palace (Figure 3). The first investigation was conducted in 1976 by The University of Texas at San Antonio-Center for Archaeological Research (UTSA-CAR) (Fox 1977). CAR archaeologists excavated test units just north of the north wall of the Palace (Figure 2, in red). When CAR initiated the project, the property was covered with broken bricks, concrete rubble and other construction debris. Four test pits (labeled Test 1 through Test 4) and three systematically excavated areas (Areas A, B, and C) were opened over the course of the project (Fox 1977). The location of Test 1 was not shown on original project maps. However, Test 1 is described as a shovel test located near the northeast corner of the site excavated to examine the extent of disturbance caused by the removal of a slab. The excavation indicated that in that area the soil was disturbed to a depth of 30 cm below surface.

Test 2 was located along the center of the north wall. The unit was excavated to examine the construction of the slab. Test 3 was excavated at the exterior of northwest corner of the Palace. The test unit was excavated to determine if the wall dated to the 18th century and extended further north. A wall was located, but appeared to be much narrower in comparison to Spanish Colonial walls. In addition, artifacts encountered dated to the 19th and early 20th century. Some colonial material was found in mixed context and probably represents an admixture of materials during reconstruction. Test 4 was located north of the north wall of the Palace, and has no bearing on the current project.

The second archaeological investigation that occurred at the Spanish Governor's Palace was conducted by UTSA-CAR in 1996 (Fox 1997) (Figure 3, in blue). The purpose of the excavations was to gather more information on the foundation of the front wall of the structure prior to the city fixing the roof and exterior walls of the Palace. Three units were excavated during this project. Each of the units was centered on a drain spout coming from the roof to a pipe beneath the sidewalk. The current sidewalk was placed on top of a layer of gravel and the pavers that were installed during restoration. The layers of sidewalk and gravel base were removed prior to excavating the units.

The stratigraphy of the deposits exposed by the archaeology indicates that the upper portion of the deposits (the upper 18.5 inches in places) contained disturbed materials. Near the northeast corner of the complex (Area A on Figure 3), the first intact floor was noted at a depth of 18.5 inches and the second was found at 23 inches below datum or roughly 8.5 inches and 13 inches below surface, respectively. Whether this stratigraphic sequence applies to what is found inside the reconstructed rooms and the courtyard is not known. Remnants of the floors or other deposits may be found closer to the surface or buried even deeper than 8.5 inches depending on whether deposits were graded prior to reconstruction or fill was added as part of the site preparation. Cultural materials found immediately below the pavers may be entirely disturbed or they may represent materials sealed between the flooring episodes. Unfortunately, the documents available to the CAR staff did not have detailed information related to the levels of impact resulting from the reconstruction activities.
